RE: Recall Number 03V-257 Defect Information Report (additional information)  
(Hyundai Campaign 061)

# HYUNDAI Technical Service Bulletin

Group	CAMPAIGN
Number	03-01-009
Date	JULY, 2003
Model	ELANTRA AND TIBURON

Subject	<b>REAR BRAKE TUBE REPOSITIONING CAMPAIGN 061</b>
---------	---

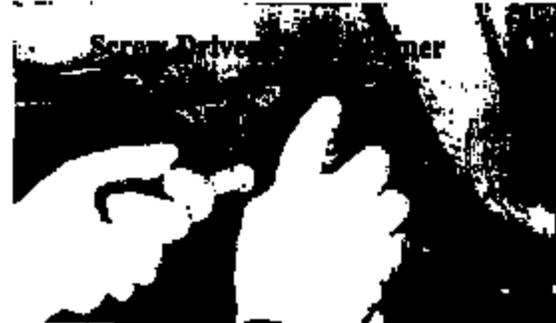
7. Apply the surface treatment on the steering gear box mounting bracket and the rear brake tube contact area evenly as shown (apply 3 light squirts).

gap open for at least 3~4 minutes or until the surface treatment is dry.

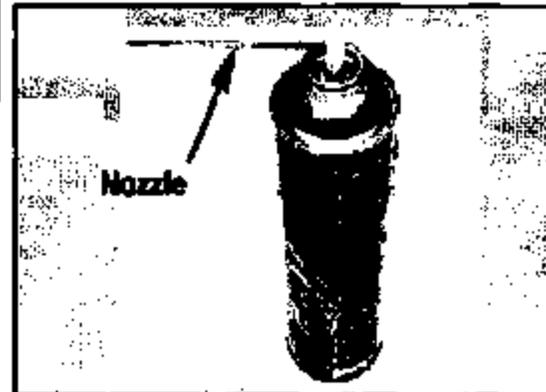
8. Before applying the anti-corrosion wax (CT-21), insert the nozzle into the spray tip.

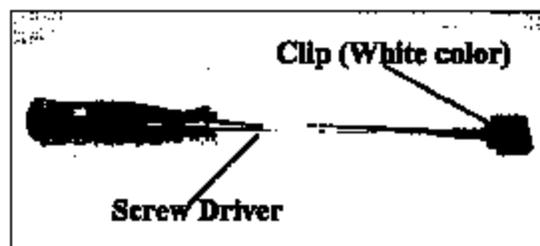
10. Prepare the brake tube clip as shown.

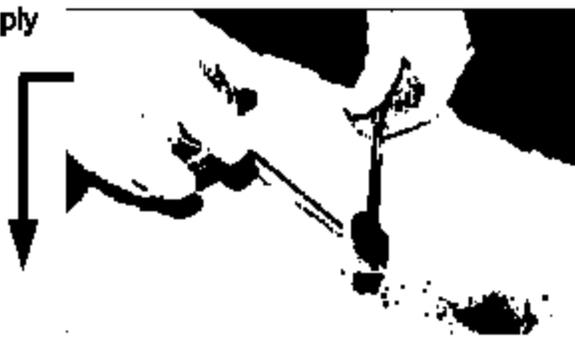
11. Before installing the brake tube clip, apply anti-corrosion wax inside the clip as shown.

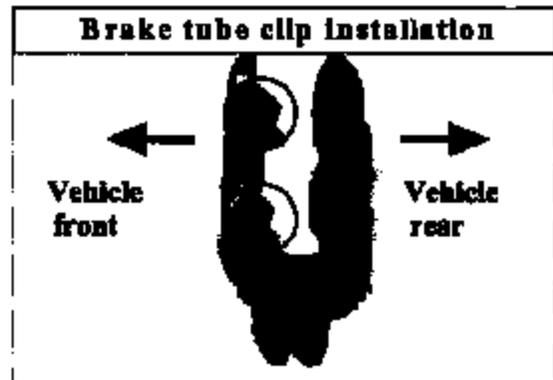
Repeat installation of the brake tube clip on the other side of the vehicle.

14. Apply the anti-corrosion wax on the rear brake tubes and brake tube clips on both sides.

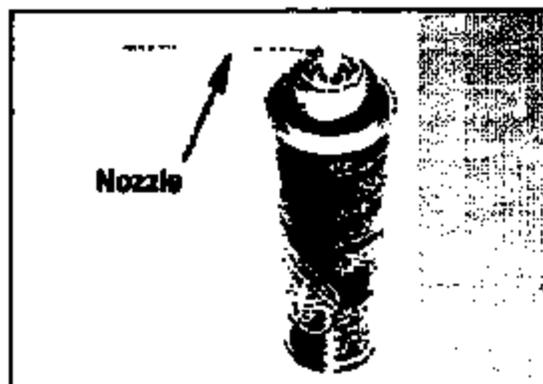
surface treatment on the bracket and the rear brake tube contact area evenly as shown (apply 3 light squirts).

**NOTE: Keep the gap open for at least 3-4 minutes or until the surface treatment is dry.**

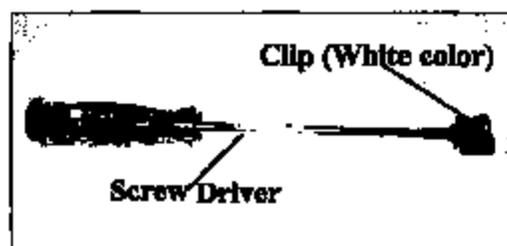
10. Prepare the brake tube clip as shown.

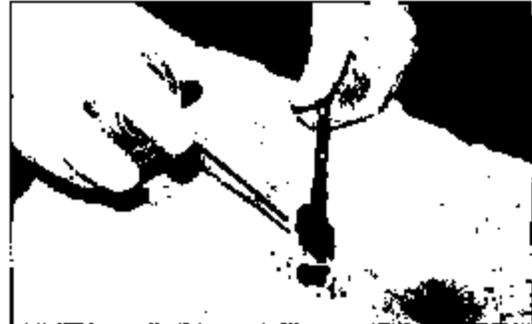
11. Before installing the brake tube clip, apply the anti-corrosion wax inside the clip as shown.

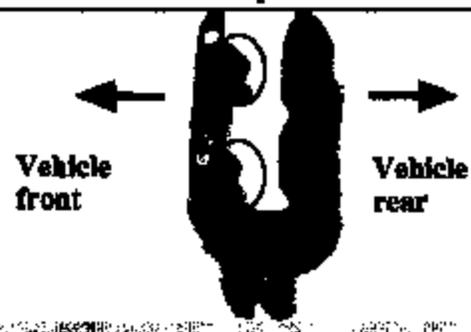
Brake tub clip installation

13. Install the brake tube clip on the rear brake tubes where the surface treatment and anti-corrosion wax were applied.

**NOTE:** The brake tube clip is directional. The locking tabs inside the clip should face toward the vehicle front.

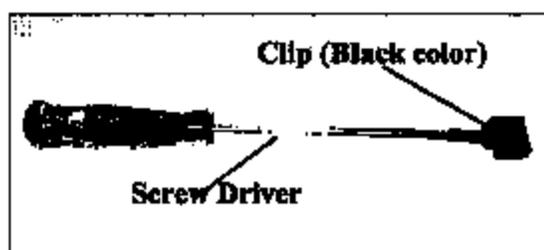
5. Prepare the brake tube clip as shown.

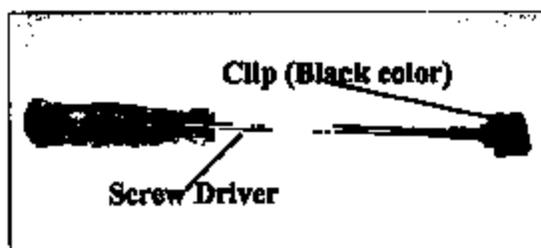
5. Prepare the brake tube clip as shown.
