HYUNDAI Technical Service Bulletin

| Subject REAR BRAKE TUBE REPOSITIONING CAMPAIGN 081 | Group CAMPAIGN |
| Model ELANTRA AND TIBURON | |

This bulletin provides the procedures that reposition the rear brake tubes to prevent contact with the front suspension cross member's steering gear box mounting brackets. The photos below show the areas where the rear brake tubes may contact the steering gear box mounting brackets.

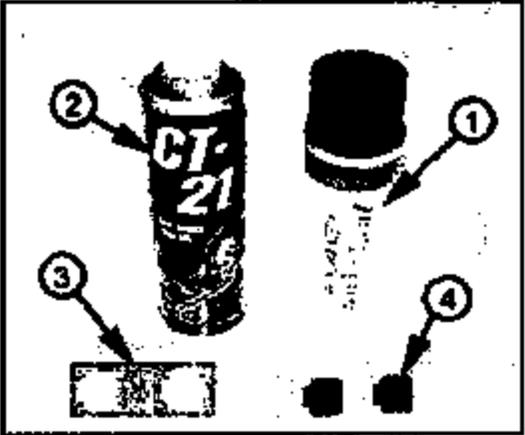
| PART NAME | PART NUMBER | PHOTO |
|--|---|--|
| ① Surface treatment (Zinc spray) | 00306-2D000 | |
| ② Anti-corrosion wax (CT-21) | 00305-2D000 | |
| ③ Brake tube clip (White - Elantra) | 58799-2D000 | |
| ④ Brake tube clip (Black - Tiburon) | 58799-2C000 | |

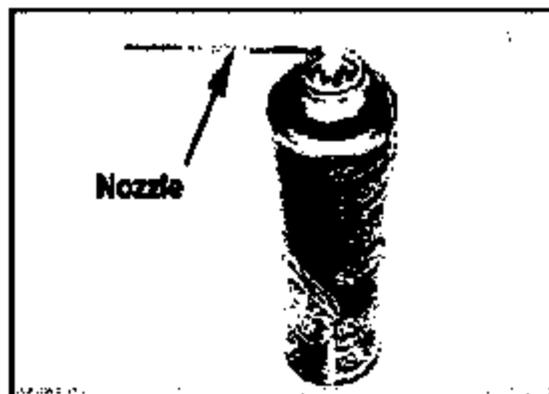
9. Evenly apply anti-corrosion wax on the steering gear box mounting bracket and the rear brake tube contact area (apply 5 to 6 light squirts).

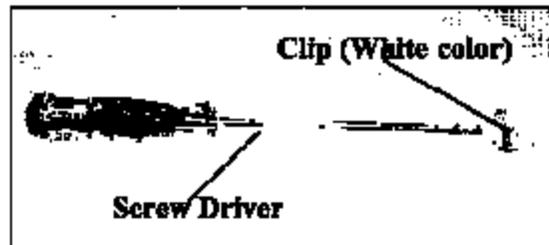
11. Before installing the brake tube clip, apply anti-corrosion wax inside the clip as shown.

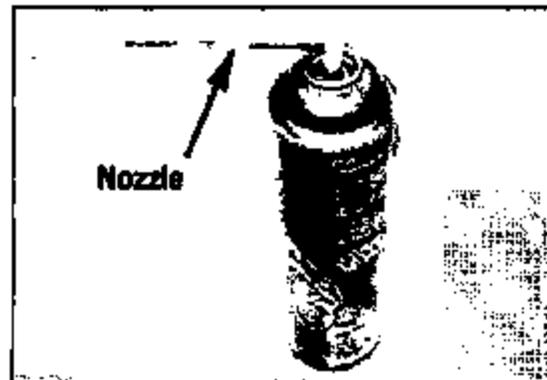
7. Apply the surface treatment on the bracket and the rear brake tube contact area evenly as shown (apply 3 light squirts).

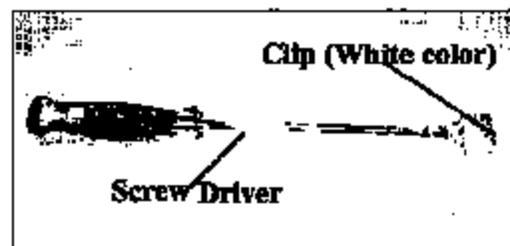
10. Prepare the brake tube clip as shown.

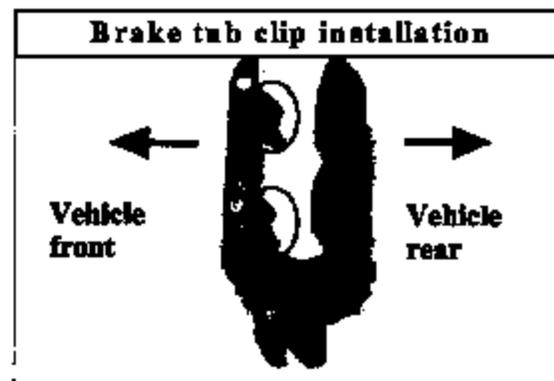
NOTE: The brake tube clip is directional. The locking tabs inside the clip should face toward the vehicle front.

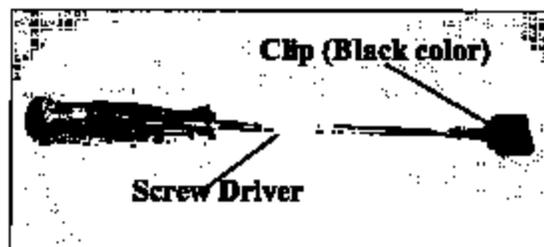
5. Prepare the brake tube clip as shown.

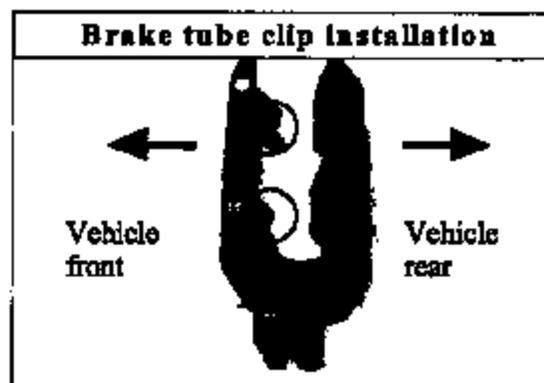
NOTE: The brake tube clip is directional. The locking tabs inside the clip should face toward the vehicle front.

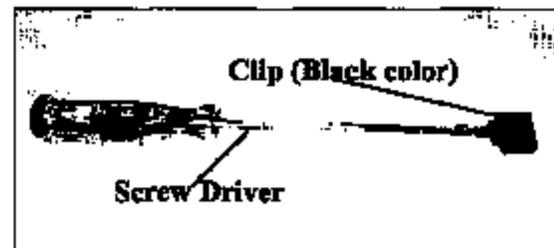
5. Prepare the brake tube clip as shown.

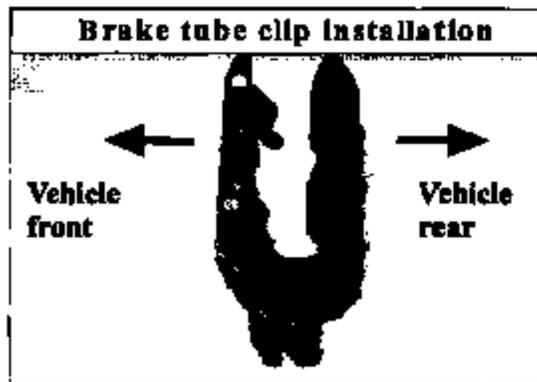
NOTE: The brake tube clip is directional. The locking tabs inside the clip should face toward the vehicle front.
