TECHNICAL SERVICE BULLETIN

Victory Motorcycle Bulletin Number: **V-03-04(A)**

SUBJECT: FUEL TANK VENT OBSTRUCTED (U.S. 49 STATE, CANADA, and UK MODELS)

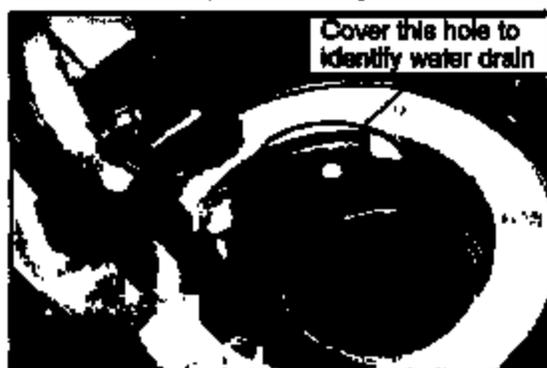
Attach a pressure pump

4. Attach a hand pump (i.e. a Mity Vac PV-43646) to the hard line on the fuel tank side as shown using an appropriate adaptor that seals tightly on the line.

NOTE: If the hand pump has both pressure and vacuum pump capability, set the dial to "Pump" or connect the hose to the pump's pressure fitting.

5. Pump air into the line. Air should be heard escaping from the fuel cap area. If the pump does not build pressure (indicating a clear vent) but you do not hear air escaping from the filler neck or from the water drain hole, check to be sure the hose is connected to the fitting on the bottom of the fuel tank.
6. To determine which line you have, place your finger over the water drain opening which is located to the left of the gas cap opening. If the airflow stops you have located the water drain line. If the airflow continues, you have located the tank vent line and it is open. You should be able to hear the air escaping out the fuel tank filler neck.
