GENERAL MOTORS NORTH AMERICA
Safety Center

00V-309(01)

PRODUCT CAMPAIGN BULLETIN

SUBJECT: INSPECTION OF FUEL TANK SERIAL NUMBER AND REPLACEMENT, IF NECESSARY

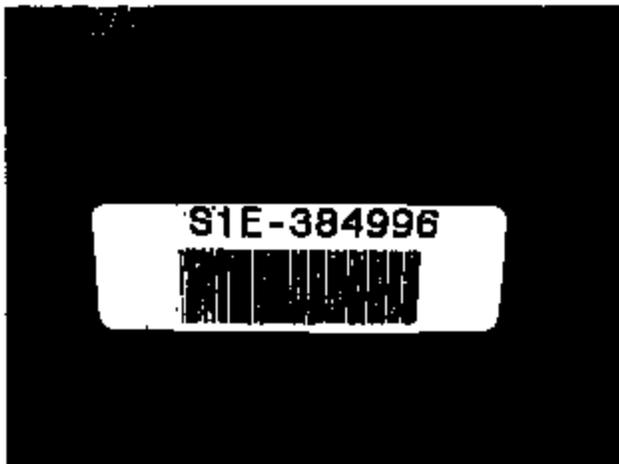
1. Raise vehicle on hoist.
2. Locate fuel tank bar-code label on rear of tank assembly near fuel filler inlet. (Refer to illustration.) If fuel tank mounting strap partially covers fuel tank bar-code label, it will be necessary to support fuel tank and lower fuel tank mounting strap to read serial number.

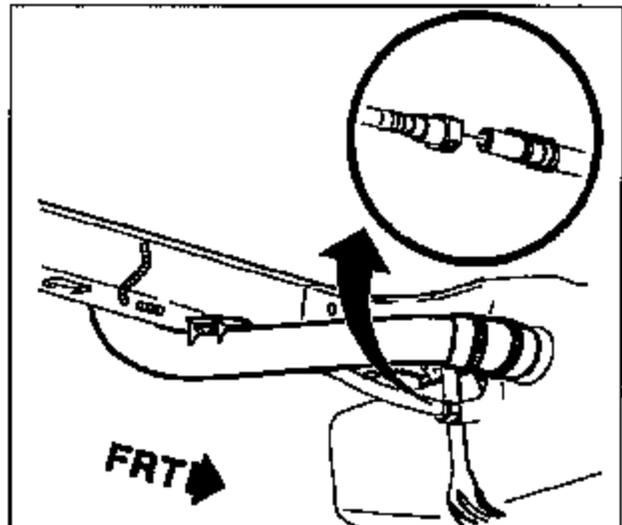
8103CH724-03A02

6. Remove fuel filler pipe lower bracket attachment screw (10 mm hex) at underbody left hand side rail.
7. Remove quarter panel grommet from fuel filler pipe.
 - 7.1 Move fuel filler pipe as far rearward as possible in fuel door opening.
 - 7.2 Go through wheelhouse opening with one hand while guiding quarter panel grommet through fuel door opening and over fuel filler pipe.
8. Raise vehicle and disconnect EVAP canister vent pipe at 5/8 in. quick connect to canister vent hose.

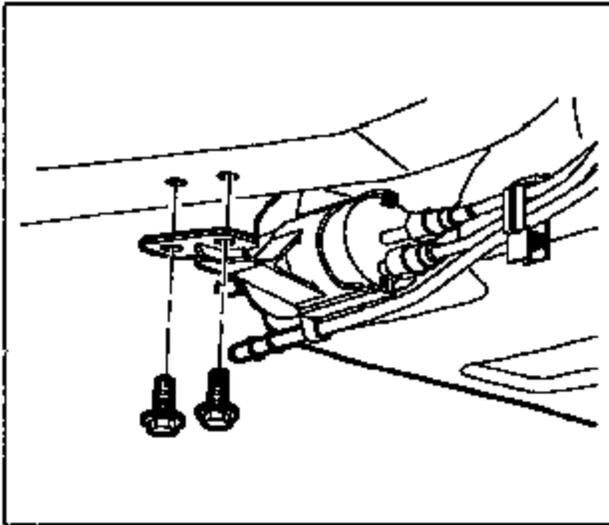
01AC072450AA1

10. Disengage filler pipe hose from fuel tank and remove fuel filler pipe from vehicle. Keep fuel filler pipe as level as possible when removing from tank. Fuel fill check valve may contact inlet neck of tank so use care when removing. If fuel fill check valve is dislodged from fuel filler pipe, it may remain in tank.
11. Remove two screws (10 mm hex) that attach fuel filter/pressure regulator bracket to vehicle.
12. Disconnect fuel feed line (90° quick-connect) from outlet of filter/pressure regulator.
13. Disconnect fuel vapor/canister purge line at 90° quick-connect adjacent to fuel filter/pressure regulator.
14. Slide filter/regulator bracket out from under brake lines.

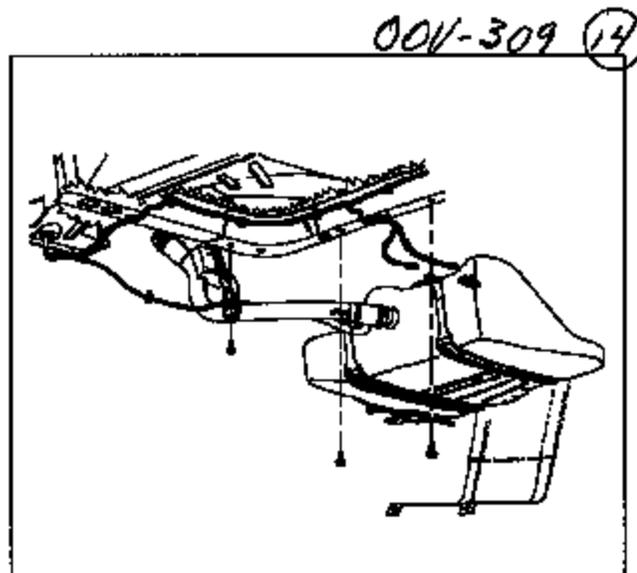
BMGC-77485AA1

15. With aid of an assistant, remove two tank retaining strap bolts (15 mm hex) and lower tank enough to disconnect the two electrical connectors to the fuel pump and tank pressure sensor.
16. Remove fuel tank from vehicle.

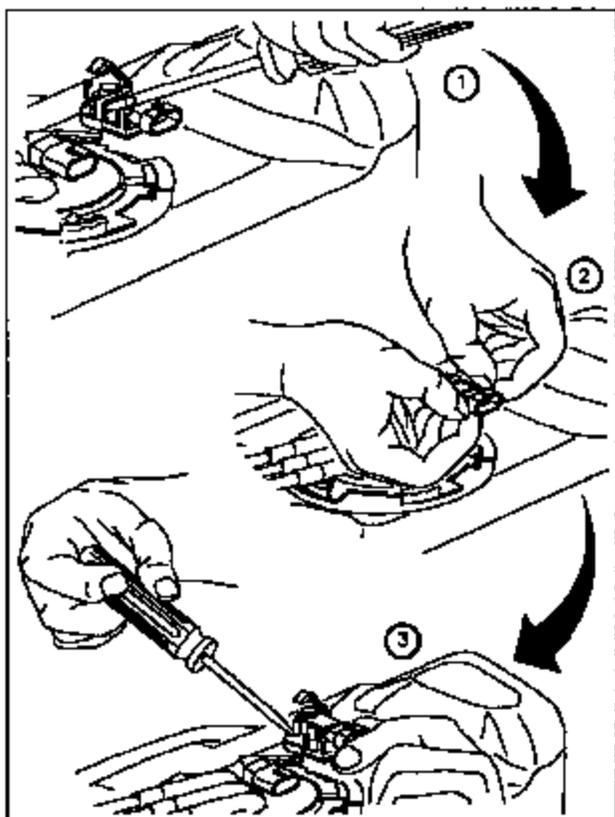
S100H72466/81

17. Inspect fill limit vent valve (FLVV) on top rear surface of fuel tank for a yellow paint marking. The yellow marking can be any kind of yellow marking. (Yellow dot, yellow line, yellow check mark, etc.).
- If yellow paint mark is present on FLVV, fuel tank must be replaced. Continue to next step.
 - If yellow paint mark is not present on FLVV, reinstall fuel tank. Continue to "Install Fuel Tank Assembly" on page 16 of this bulletin.
18. Obtain replacement parts. (Refer to "PARTS INFORMATION" in this bulletin.)

1. Cut tie strap and use a flat blade screwdriver to unlatch fuel tank pressure sensor retaining arm. (1)
2. Use fingertips and light pressure to disengage fuel tank pressure sensor from locating tangs at end of connector housing. (2)
3. Use a flat blade screwdriver to remove fuel tank pressure sensor from fuel tank mounting pad. (3)
4. Install fuel tank pressure sensor on mounting pad of replacement fuel tank assembly.
5. Ensure proper alignment of locating tangs at connector end of fuel tank pressure sensor.
6. Install a new tie strap and latch fuel tank pressure sensor retaining arm.

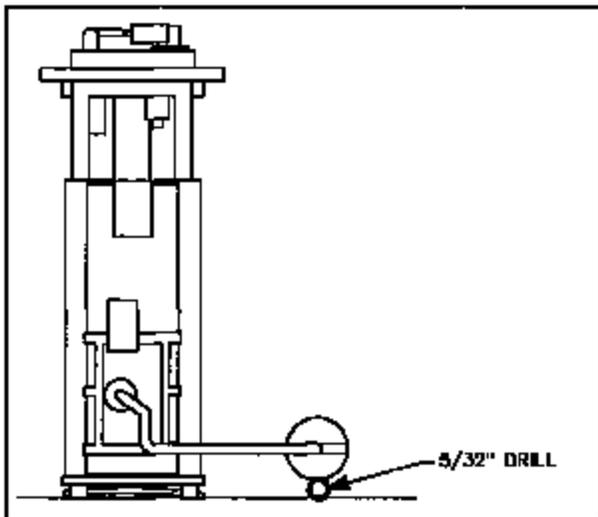
BMPD0060-4A

6. Discard the fuel pump module to tank seal.
7. Inspect fuel tank and clean the fuel tank seal groove of any foreign debris and install a new seal.

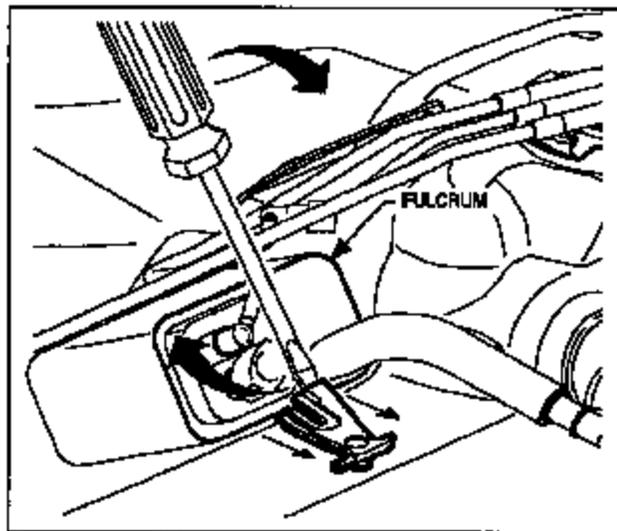
SMCCT7248BA/2

1. Disconnect the 5/8 in. 90° fuel tank vapor inlet hose fitting from EVAP canister.
2. Remove EVAP canister retainer clip at top of canister.
3. Install EVAP canister in mounting pocket on top of replacement fuel tank assembly.
4. Install EVAP canister retainer clip at top of canister. Ensure retainer clip is installed over lower flange of canister before snapping into place.

- (1) Canister Purge
- (2) Vapor
- (3) Vent

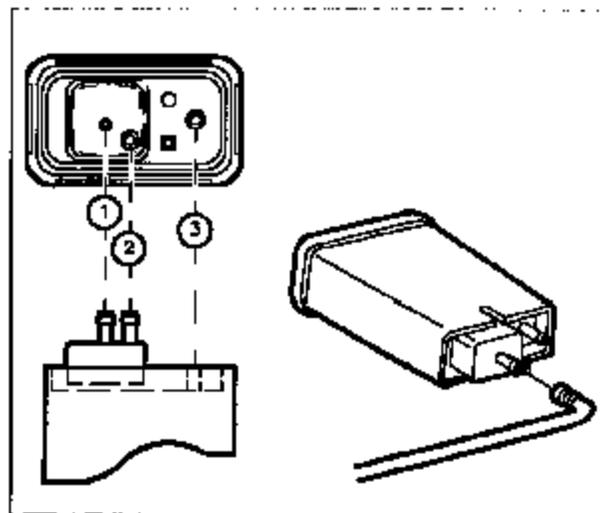
SMCCT7248BA/1

5. Install the 5/8 in. 90° vapor line fitting to TANK port on EVAP canister.

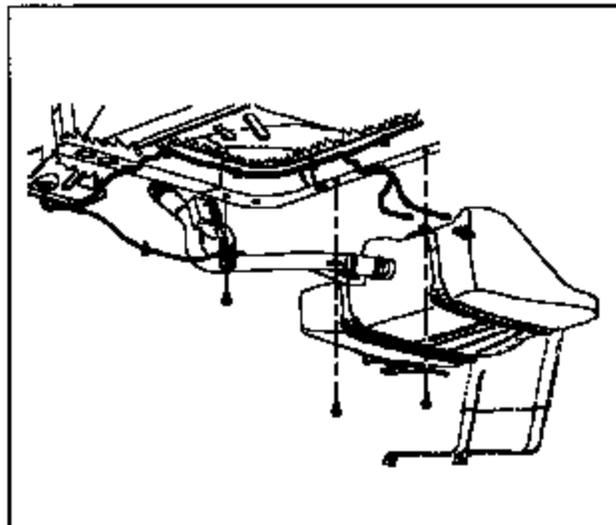
BM3G-75455AA1

1. With aid of an assistant, position fuel tank under vehicle.
2. Attach electrical connectors to fuel pump and tank pressure sensor.

NOTICE: Position the fuel tank solidly against the left hand underbody side rail prior to tightening the strap mounting bolts. A small white locator button on the left side of the fuel tank shell should be tight against the left side rail at the completion of installation.

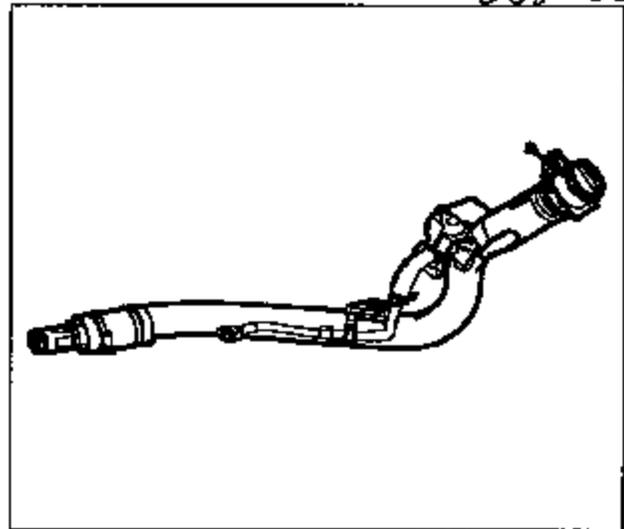
EM50H72408AA1

- 8. Position filler pipe into wheel opening with top of pipe within body panel opening.
- 9. Install fuel filler pipe into fuel tank opening.
- 10. Lower vehicle and move fuel filler pipe to rear of fuel door opening. Starting with front portion, install quarter panel grommet around fuel filler neck and work down through fuel door opening.
