**Regarding: 03V-309 Expansion of Recall**

# Technico BULLETIN

## RECALL

## 2001~2003 XV16 MODELS FACTORY MODIFICATION CAMPAIGN

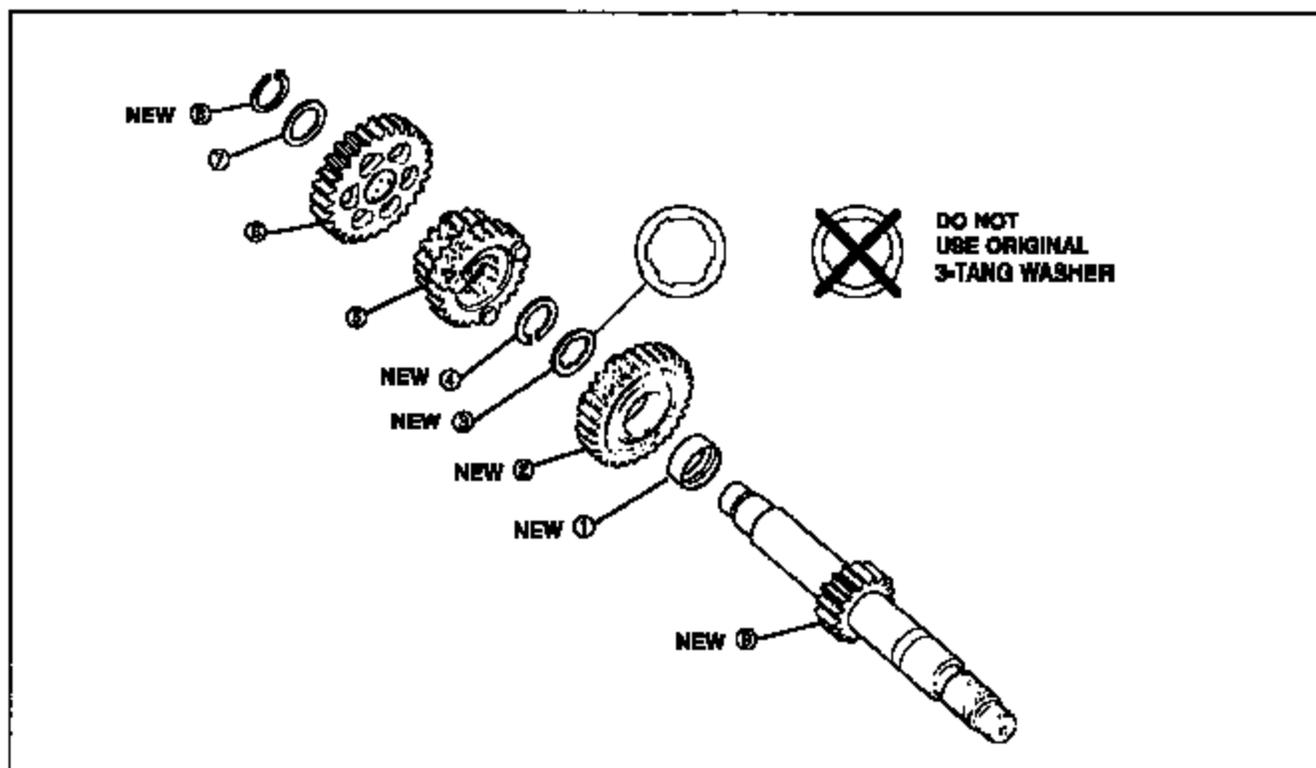
### Main Shaft Modification:

- Completely disassemble the main shaft. The Washer ⑦, 5th Pinion Gear ⑥, and 2nd/3rd Pinion Gear ⑤ will be reused.
- Install the components on the new-type Main Shaft ① in the following order. Lubricate all components with engine oil. Be sure circlips are installed with the sharp edge of the inner diameter facing away from the mating washer.

- ① Collar – NEW
- ② 4th Pinion Gear – NEW
- ③ Washer – NEW
- ④ Circlip – NEW
- ⑤ 2nd/3rd Pinion Gear – Reuse original part
- ⑥ 5th Pinion Gear – Reuse original part
- ⑦ Washer – Reuse original part
- ⑧ Circlip – NEW

### **⚠ WARNING**

Be sure to use all of the new parts in the kit. Otherwise, the transmission can still fail. Be sure that you are installing the new washer ③. It is thicker than the original and can be easily identified by its six tangs on the inner diameter instead of the three on the original washer.

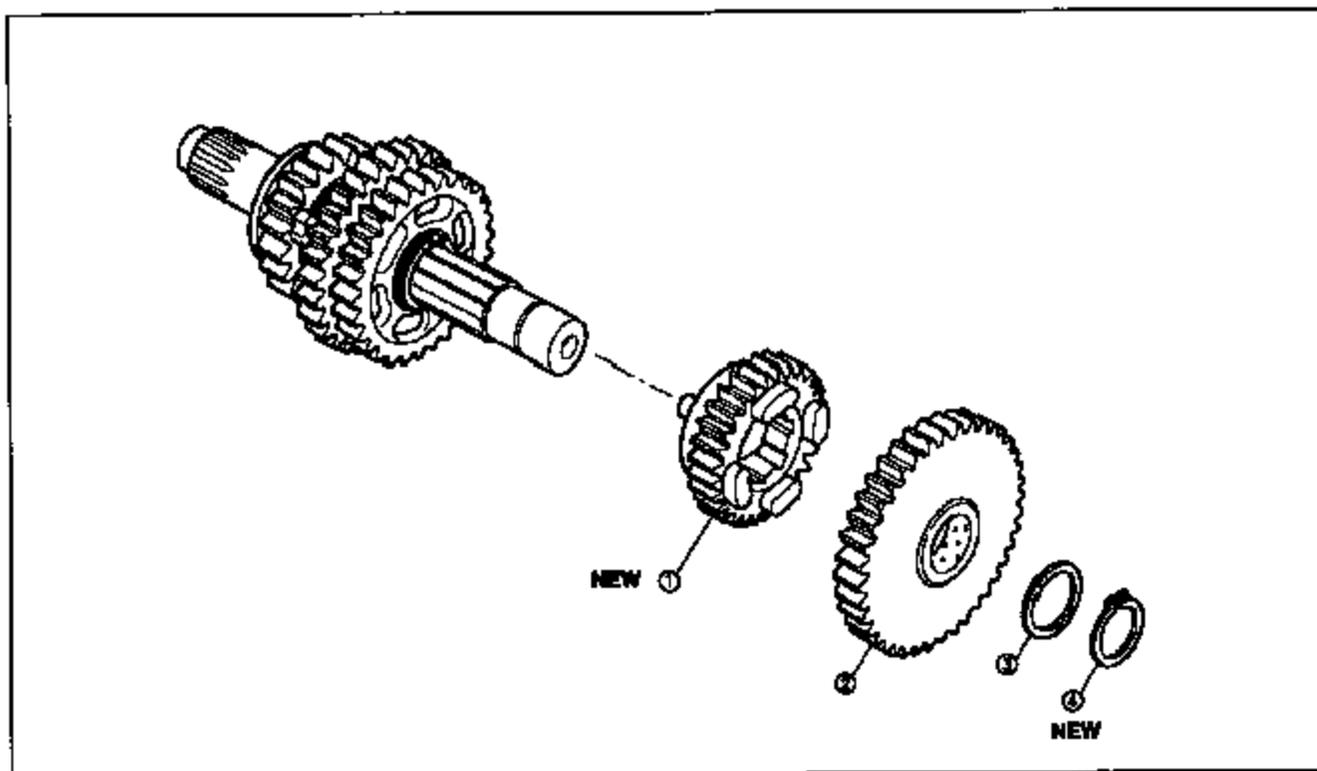
### Drive Shaft Modification:

- Remove the circlip and washer from the Drive Shaft, then remove the 1st Wheel Gear and the 4th Wheel Gear. Do not disassemble the rest of the components on the shaft.
- Install the components on the original Drive Shaft in the following order. Lubricate all components with engine oil. Be sure the circlip is installed with the sharp edge of the inner diameter facing away from the mating washer.

- ① 4th Wheel Gear – NEW
- ② 1st Wheel Gear – Reuse original part
- ③ Washer – Reuse original part
- ④ Circlip – NEW

### **⚠ WARNING**

**Be sure to use all of the new parts in the kit. Otherwise, the transmission can still fail.**

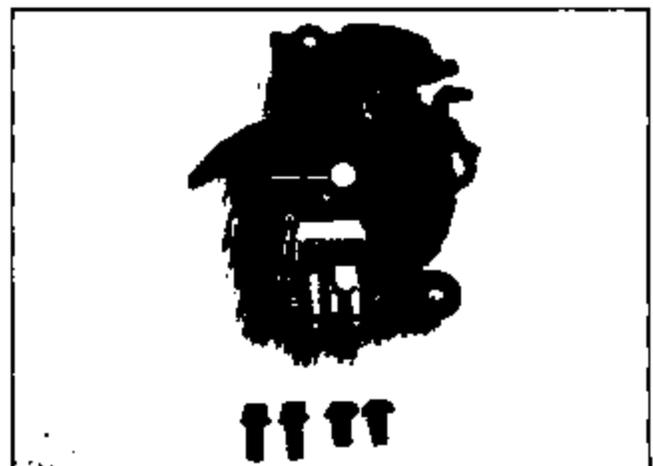
### Upper Left Engine Mount Removal:

- Remove the A.I. System vacuum hose from the control valve.
- Remove the A.I. System intake box from the air box (two Phillips screws). Leave the hose attached to the box.
- Remove the fuel return lines from the pressure regulator. Depress the gray buttons on each side of the connectors and slide them off the regulator fittings.
- Remove the four mounting bolts and the mount. Leave the fuel pressure regulator and A.I. System valves attached.

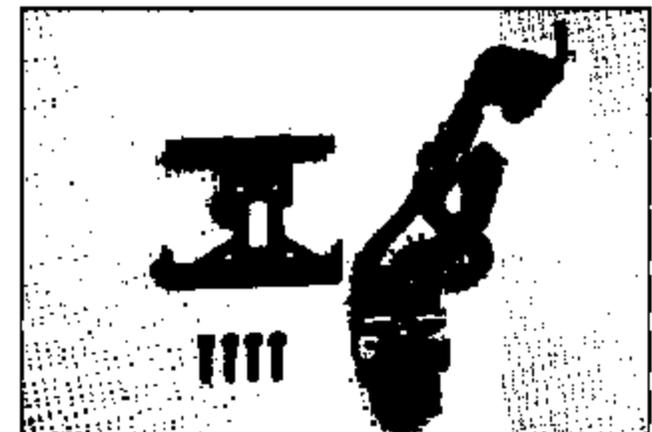
### **Liner Control Valve Removal:**

- Remove the four ignition coil mounting bolts and remove the ignition coils.
- Remove the liner control valve hoses and disconnect the electrical coupler.
- Remove the liner control valve by removing the two mounting bolts.
- Remove the liner control valve mounting bracket by removing the two mounting bolts.

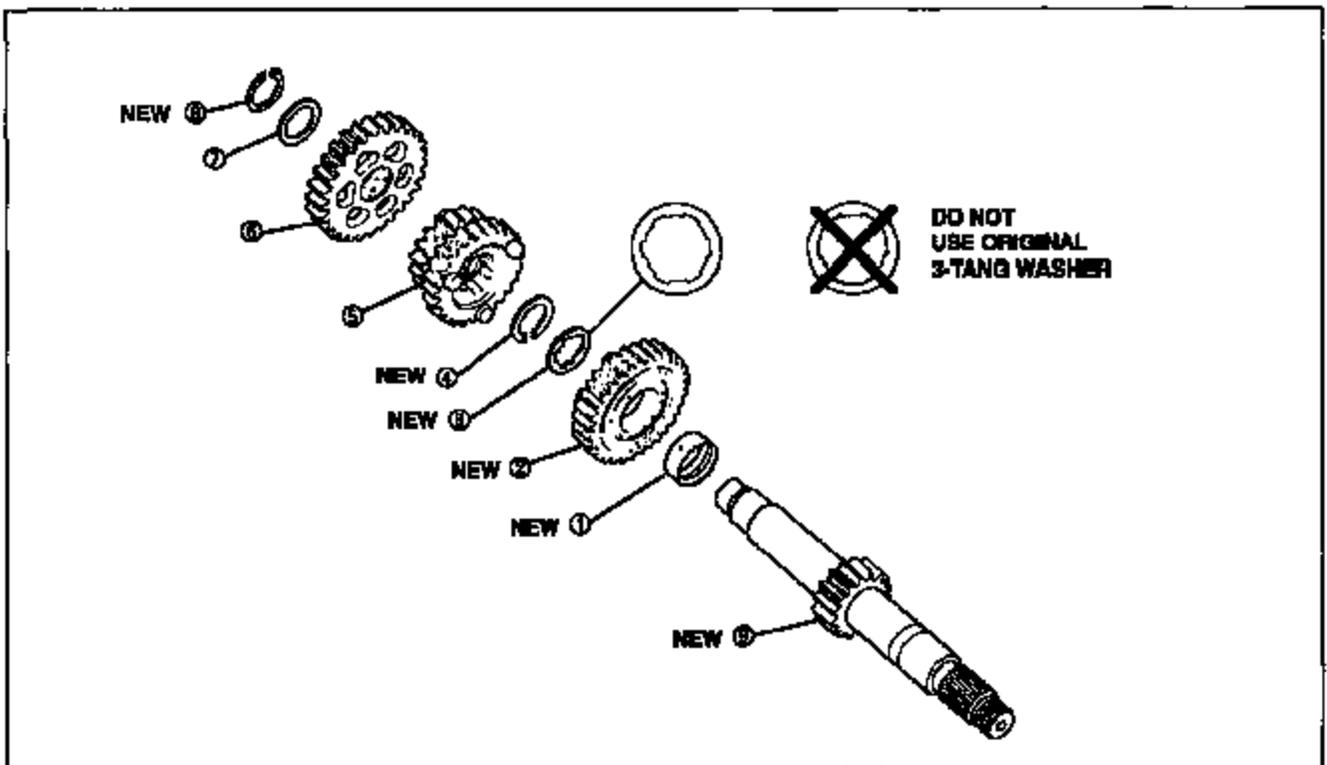
### Main Shaft Modification:

- Completely disassemble the main shaft. The Washer ⑦, 5th Pinion Gear ⑥, and 2nd/3rd Pinion Gear ⑤ will be reused.
- Install the components on the new-type Main Shaft ⑨ in the following order. Lubricate all components with engine oil. Be sure circlips are installed with the sharp edge of the inner diameter facing away from the mating washer.

- ① Collar – NEW
- ② 4th Pinion Gear – NEW
- ③ Washer – NEW
- ④ Circlip – NEW
- ⑤ 2nd/3rd Pinion Gear – Reuse original part
- ⑥ 5th Pinion Gear – Reuse original part
- ⑦ Washer – Reuse original part
- ⑧ Circlip – NEW

#### **⚠ WARNING**

Be sure to use all of the new parts in the kit. Otherwise, the transmission can still fall. Be sure that you are installing the new washer ③. It is thicker than the original and can be easily identified by its six tangs on the inner diameter instead of the three on the original washer.

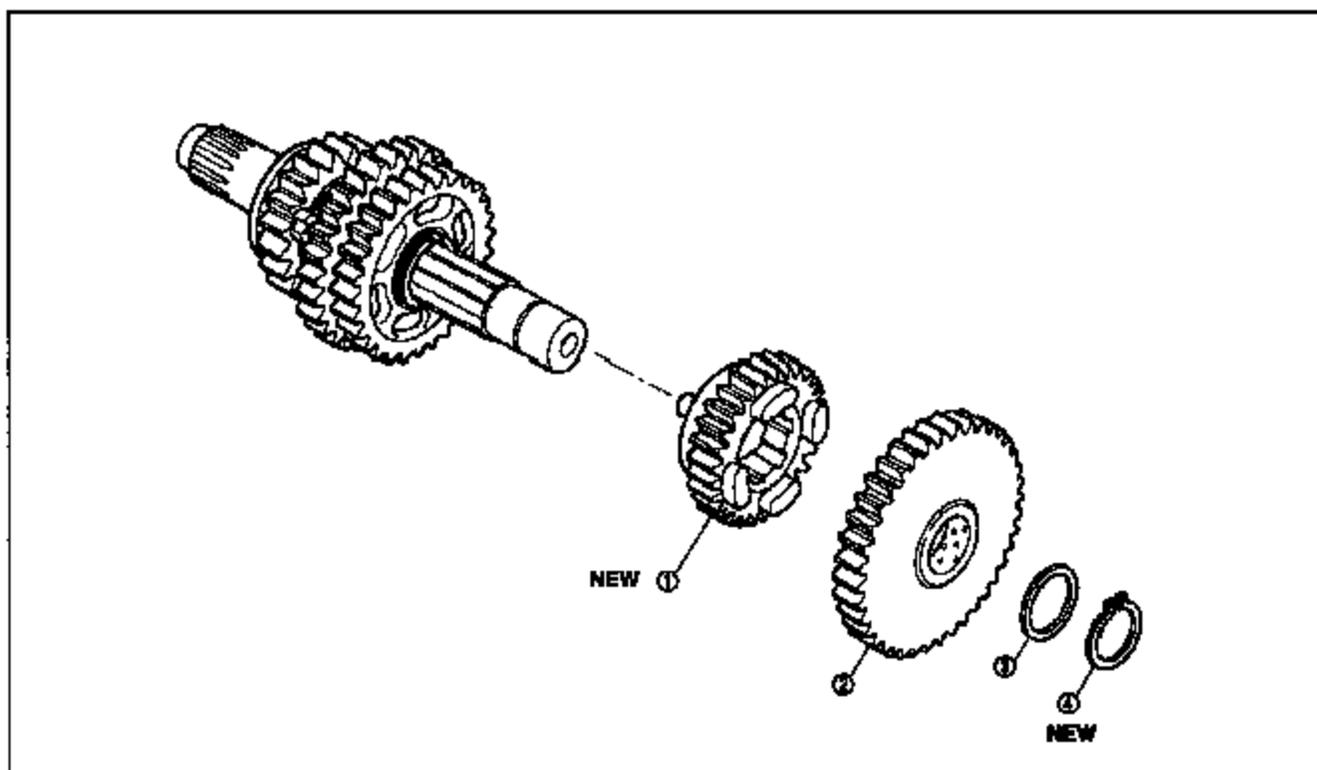
### Drive Shaft Modification:

- Remove the circlip and washer from the Drive Shaft, then remove the 1st Wheel Gear and the 4th Wheel Gear. Do not disassemble the rest of the components on the shaft.
  - Install the components on the original Drive Shaft in the following order. Lubricate all components with engine oil. Be sure the circlip is installed with the sharp edge of the inner diameter facing away from the mating washer.
- ① 4th Wheel Gear – NEW
  - ② 1st Wheel Gear – Reuse original part
  - ③ Washer – Reuse original part
  - ④ Circlip – NEW

### **⚠ WARNING**

**Be sure to use all of the new parts in the kit. Otherwise, the transmission can still fail.**
