INTERNATIONAL TRUCK AND ENGINE CORPORATION
4201 WINFIELD ROAD, WARRENVILLE, IL 60685

NONCOMPLIANCE RECALL 01516

June 2003

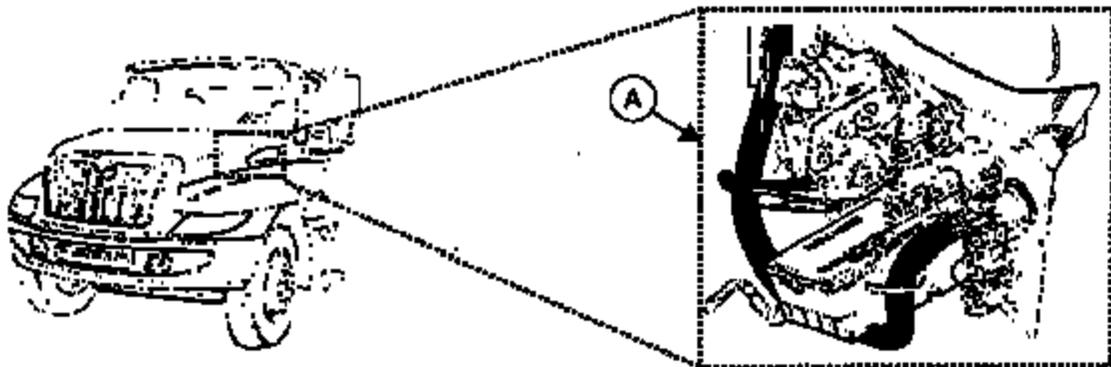
Figure 1

- A. Open Hood and locate the Power Distribution Center mounted on the left side of the cowl, near the left side inner fender panel (see figure 1).

View in direction of arrow A

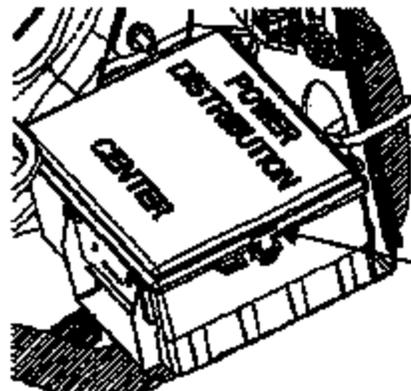
Figure 2

- B. Remove Power Distribution Center (PDC) top by depressing tabs on front and rear of box lid (See figure 2).

*Depress Tabs
Both Front and
Rear*

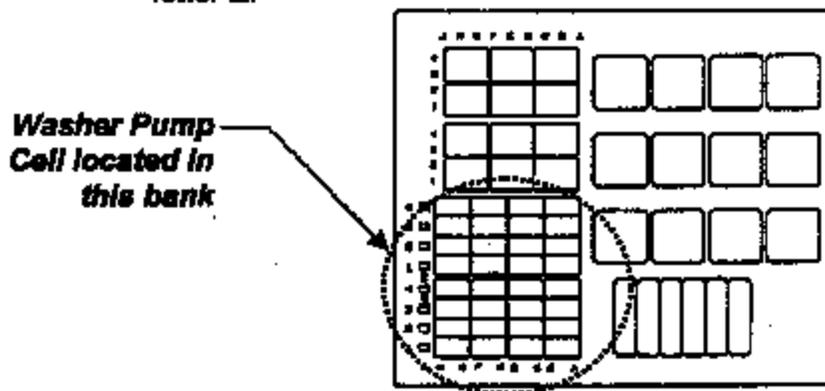
Figure 3

- C. Locate the PDC Fuse Identity Label on the underside of the lid.
- D. Locate cell labeled, "5A WASHER PUMP," in the lower left bank of cells (see figure 3).
- *If your washer pump cell indicates, "10A WASHER PUMP," you do not need this recall. Skip down to letter K for instructions on filling out the, "AUTHORIZATION FOR RECALL SERVICE," card.*
 - *If your washer pump cell indicates, "5A WASHER PUMP," then continue to letter E.*

- E. Thoroughly clean and dry the area in and around the, "5A WASHER PUMP," cell so the new label will adhere properly
- F. Place the new label over the, "5A WASHER PUMP," cell so it now indicates, "10A WASHER PUMP."
- G. Locate and remove the 5-ampere washer pump fuse in the PDC. Replace with included 10-ampere fuse.
