**YAMAHA MOTOR CORPORATION, U.S.A.**

**Regarding: 03V-309  
Yamaha Recall of XV 16/17 Motorcycles Regarding Transmission**

SUBJECT: 2,826 2001 XV1600AN and XV1600ANC Road Star motorcycles and  
2001 XV1600ASN and XV1600ASNC Midnight Star motorcycles manufactured  
between November 2000 and January 2001. In the transmission, the  
second/third pinion gear may be incorrectly machined which could cause  
abnormal wear that eventually results in a broken retainer circlip.

SUBJECT: Additional models are being added to this campaign: 2001 XV16 (Road Star, Midnight Star and Road Star Silverado), 2002-2003 XV16 (Road Star, Road Star Limited Edition, Midnight Star, and Road Star Silverado), 2002-2003 XV 17 PCP, PCPC, PCR, PCRC (Road Star Warrior) motorcycles. In the transmission, the second/third pinion gear may be incorrectly machined which could cause abnormal wear that eventually results in a broken retainer circlip.

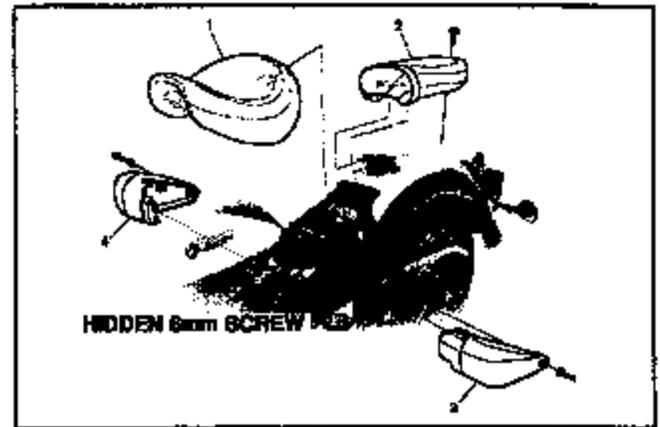
### Side Cover Removal:

Before attempting to remove the right side cover, remove the left cover first to access the hidden 6mm bolt.

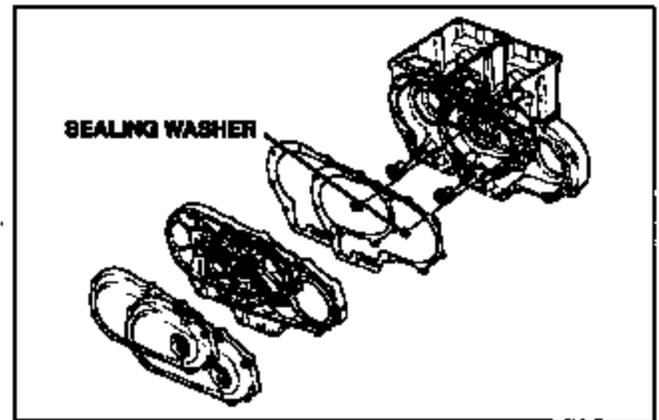
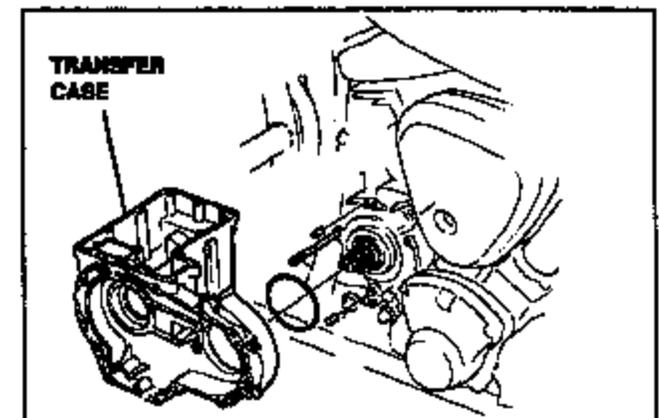
### Transfer Case Removal:

- Remove the transfer case bracket first. Then remove the outer chrome cover, inner cover, and drive-sprocket nut.

**NOTE:** There is a sealing washer between the inner case and the transfer case at the 8mm stud. Be sure to replace it during re-assembly.

- Remove the drive pulley cover and remove the drive pulley nut.
- Loosen the drive belt tension.
- Remove the drive pulley, inner cover, collar, and O-ring.

- Slide the transfer case out from the right side.

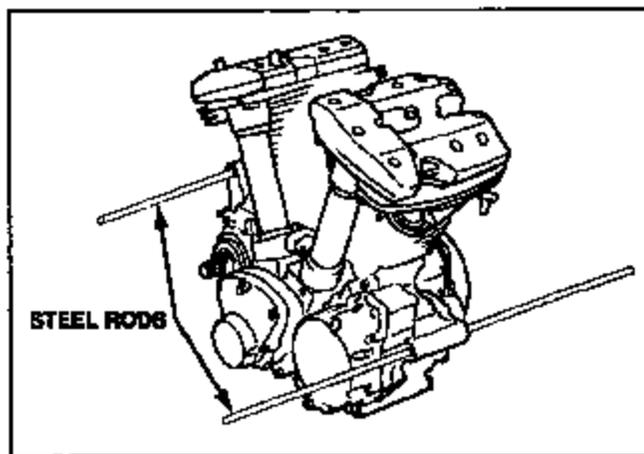
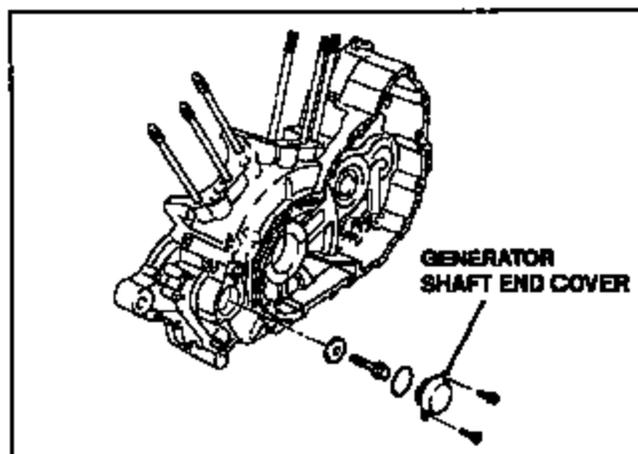
- Remove both top ends

**NOTE:** Do not remove the push rod tubes from the crankcase. Remove only one circlip from the piston for quicker piston pin removal.

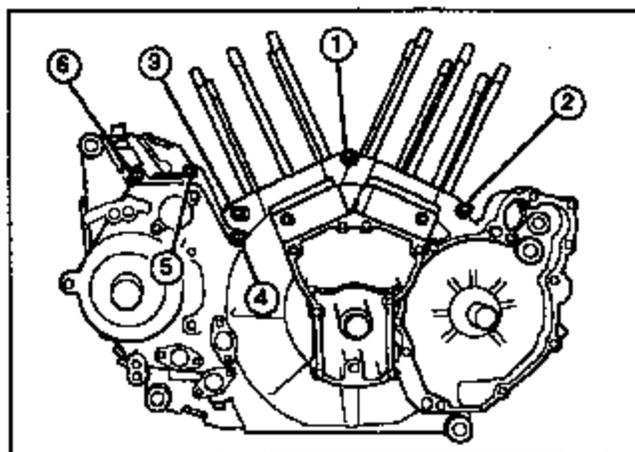
- Remove the right side crankcase bolts (three 8mm and three 6mm) only.

**NOTE:** Do not remove the cam cover or generator cover.

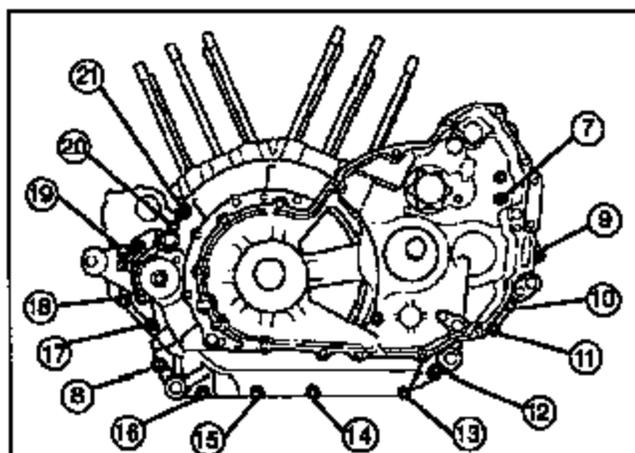
- Tilt the engine to the right and rest the cam cover against a block covered with cardboard or other protective material to protect the engine finish. Remove the left-side crankcase bolts (6mm bolts, quantity 15).

- Align the shift cam segment with the segment-shaped hole in the crankcase.

- While holding the crankshaft against the right crankcase, remove the left crankcase half.

**Be sure to hold the crankshaft against the right case half to prevent disengagement of the camshaft drive gear.**

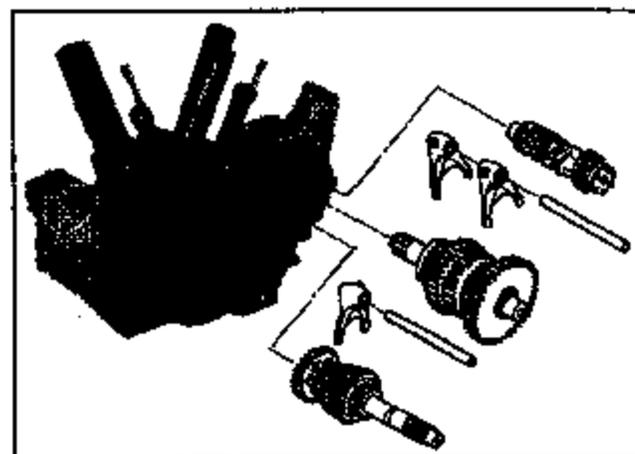
- Remove the shift fork shafts, shift forks, and transmission.

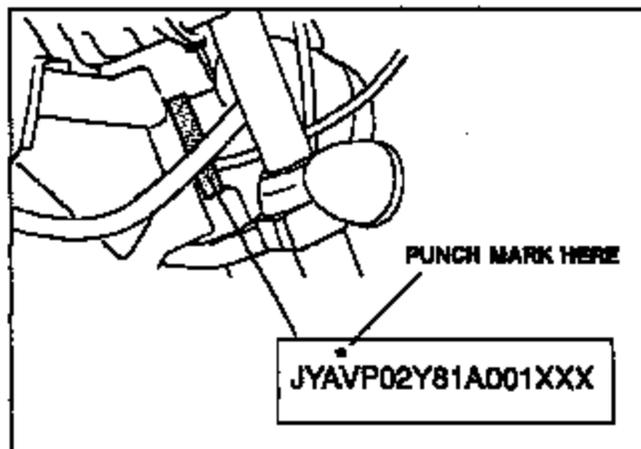
## IDENTIFICATION PROCEDURE

After modifying a unit, make a punch mark above the frame number (VIN) on the steering head pipe as shown in the illustration below.

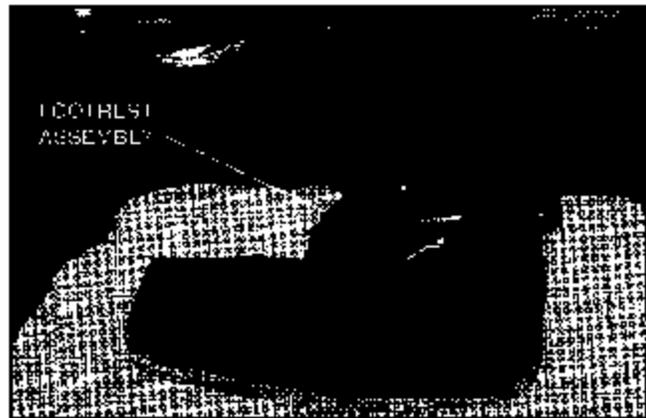
### Right-Hand Footrest Removal:

- Disconnect and remove the brake light switch.
- Remove the forward-most tie wrap around the brake hose and frame.
- Remove the footrest assembly.

**NOTE:** Leave the brake hose attached. Move the hose to the underside of the foot rest mount and support it as necessary so that it is out of the way

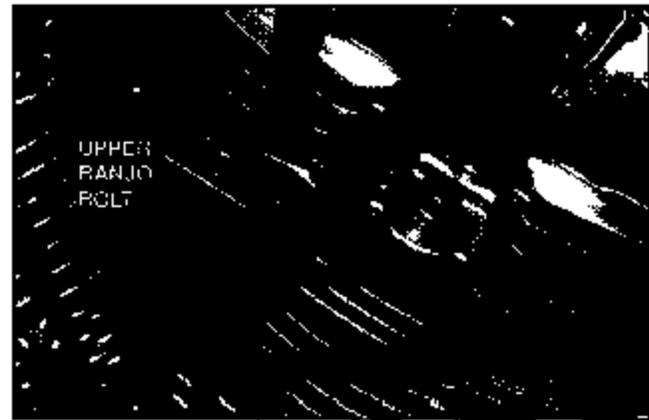
### Cylinder Head Oil Pipe Removal/ Installation:

- Slightly loosen all three banjo bolts before removing them to prevent oil line deformation.

**NOTE:** When loosening the upper banjo bolts, hold the line in place using a wrench at the flat surface on the fitting.

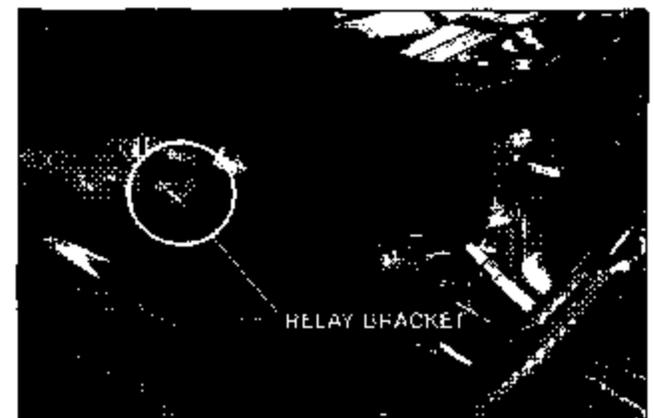
**NOTE:** Leave the relays connected. Simply move them out of the way to allow room for transfer case removal.

- Slide the transfer case out from the right side.

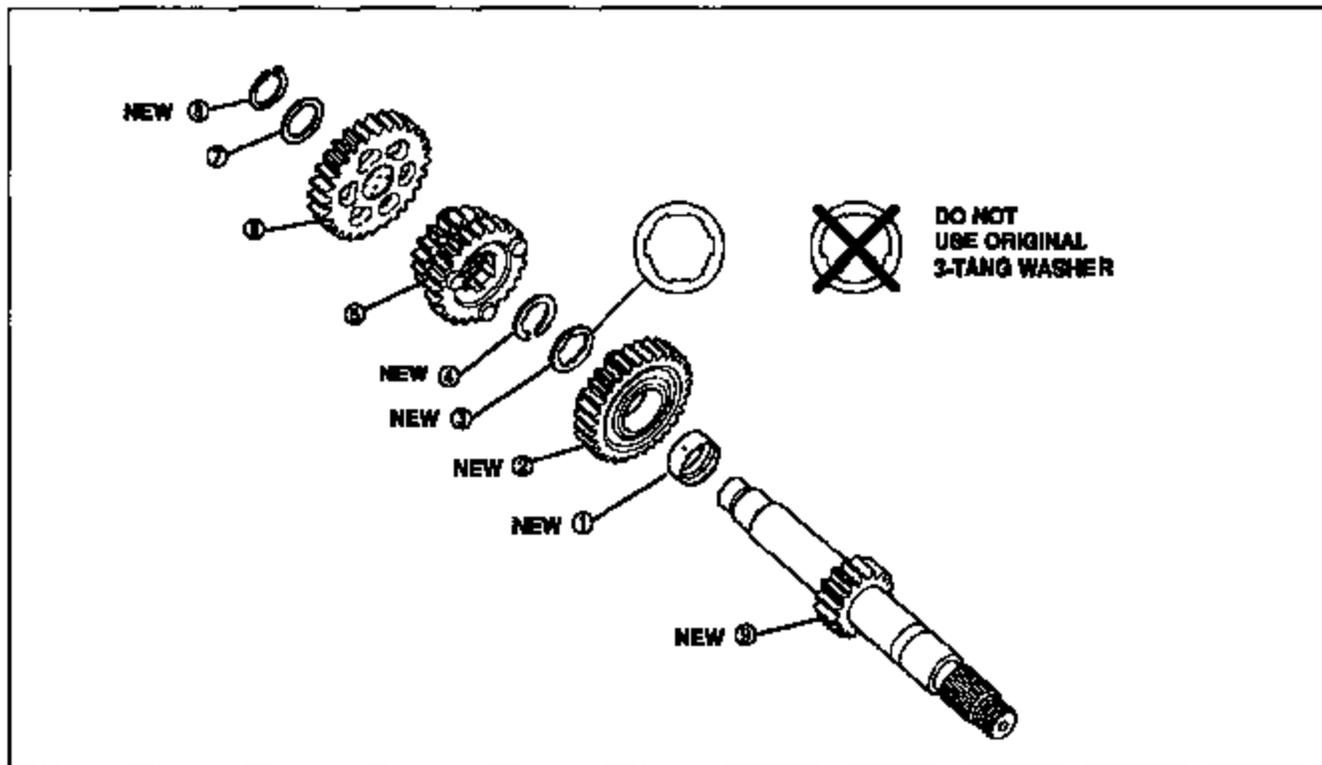
### Main Shaft Modification:

- Completely disassemble the main shaft. The Washer ⑦, 5th Pinion Gear ⑥, and 2nd/3rd Pinion Gear ⑤ will be reused.
- Install the components on the new-type Main Shaft ⑨ in the following order. Lubricate all components with engine oil. Be sure circlips are installed with the sharp edge of the inner diameter facing away from the mating washer.

- ① Collar – NEW
- ② 4th Pinion Gear – NEW
- ③ Washer – NEW
- ④ Circlip – NEW
- ⑤ 2nd/3rd Pinion Gear – Reuse original part
- ⑥ 5th Pinion Gear – Reuse original part
- ⑦ Washer – Reuse original part
- ⑧ Circlip – NEW

Be sure to use all of the new parts in the kit. Otherwise, the transmission can still fail. Be sure that you are installing the new washer ③. It is thicker than the original and can be easily identified by its six tangs on the inner diameter instead of the three on the original washer.

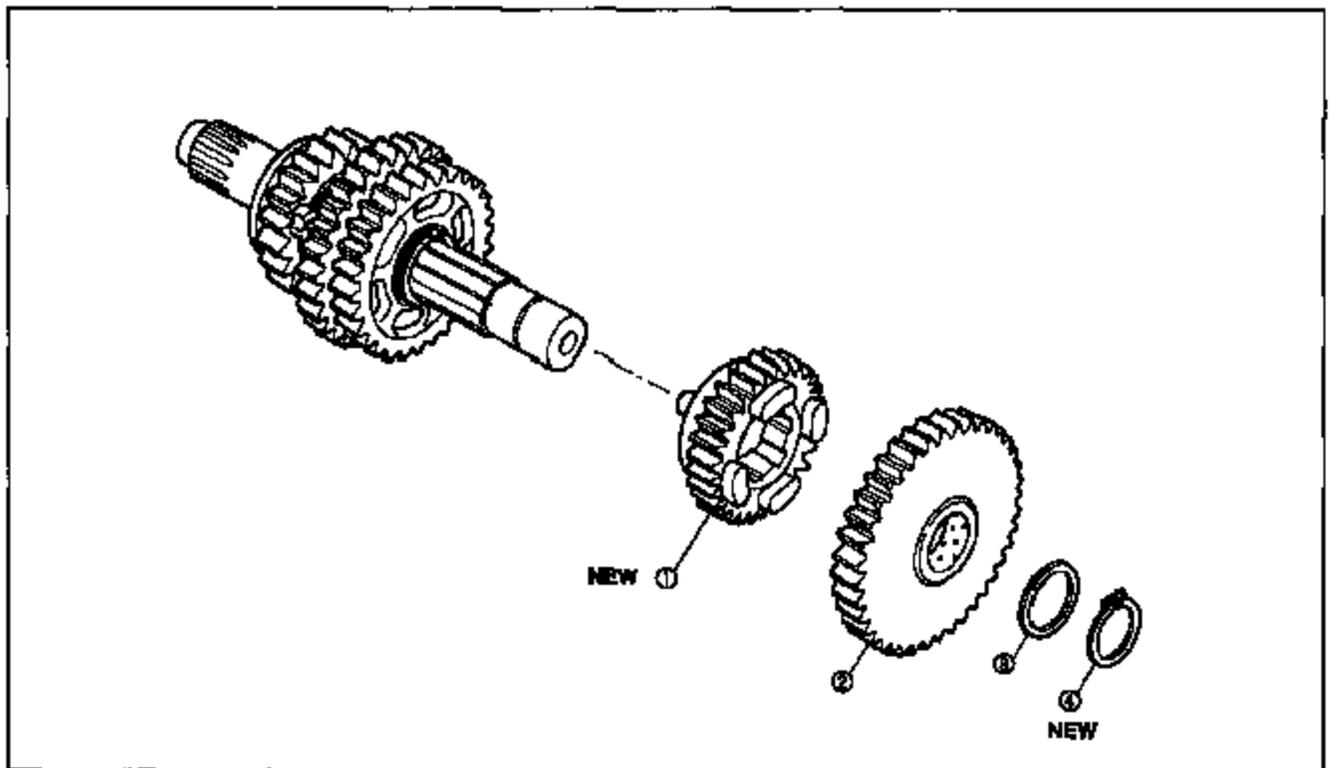
- ① 4th Wheel Gear – NEW
- ② 1st Wheel Gear – Reuse original part
- ③ Washer – Reuse original part
- ④ Circlip – NEW

**Be sure to use all of the new parts in the kit. Otherwise, the transmission can still fail.**

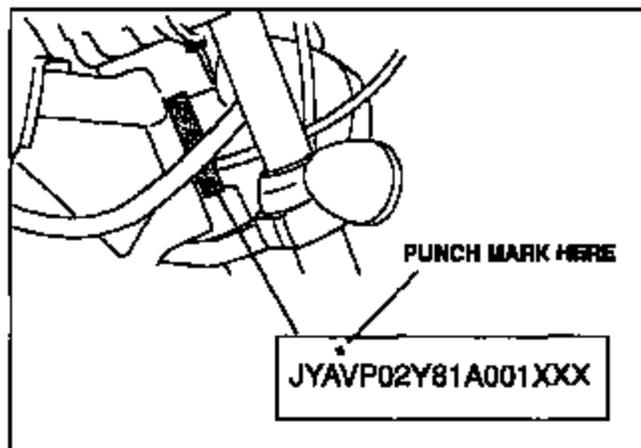
After modifying a unit, make a punch mark above the frame number (VIN) on the steering head pipe as shown in the illustration below.

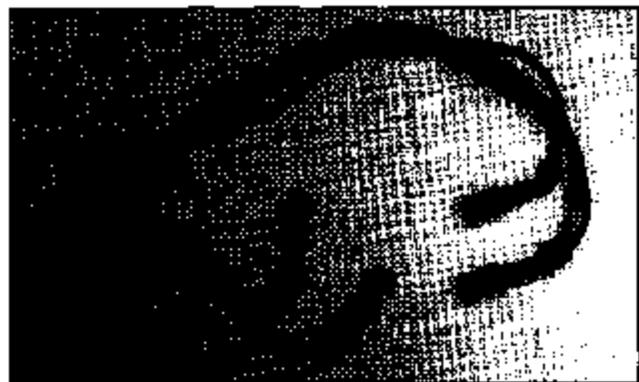
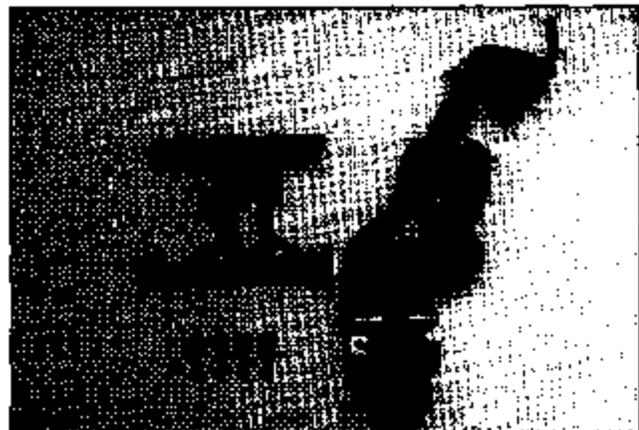
### **Liner Control Valve Removal:**

- Remove the four ignition coil mounting bolts and remove the ignition coils.
- Remove the liner control valve hoses and disconnect the electrical coupler.
- Remove the liner control valve by removing the two mounting bolts.
- Remove the liner control valve mounting bracket by removing the two mounting bolts.

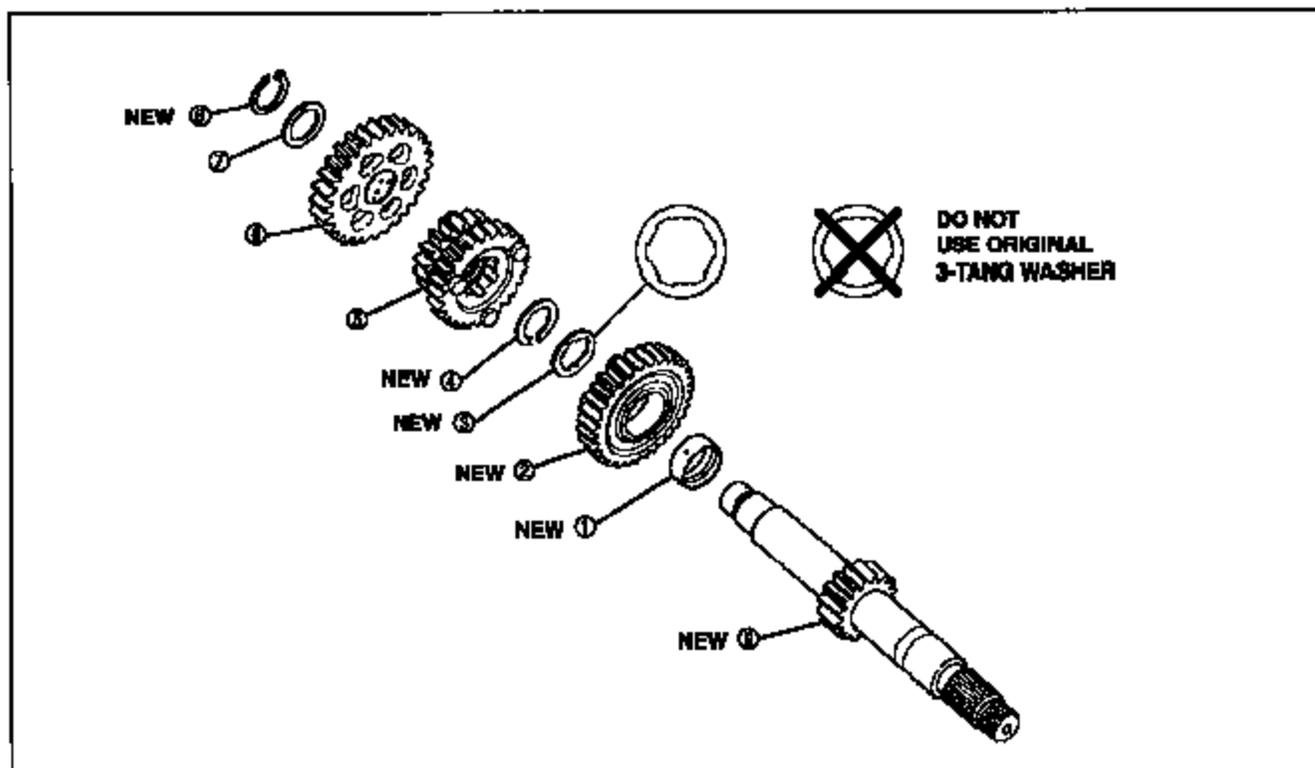
### Main Shaft Modification:

- ① Collar – NEW
- ② 4th Pinion Gear – NEW
- ③ Washer – NEW
- ④ Circlip – NEW
- ⑤ 2nd/3rd Pinion Gear – Reuse original part
- ⑥ 5th Pinion Gear – Reuse original part
- ⑦ Washer – Reuse original part
- ⑧ Circlip – NEW

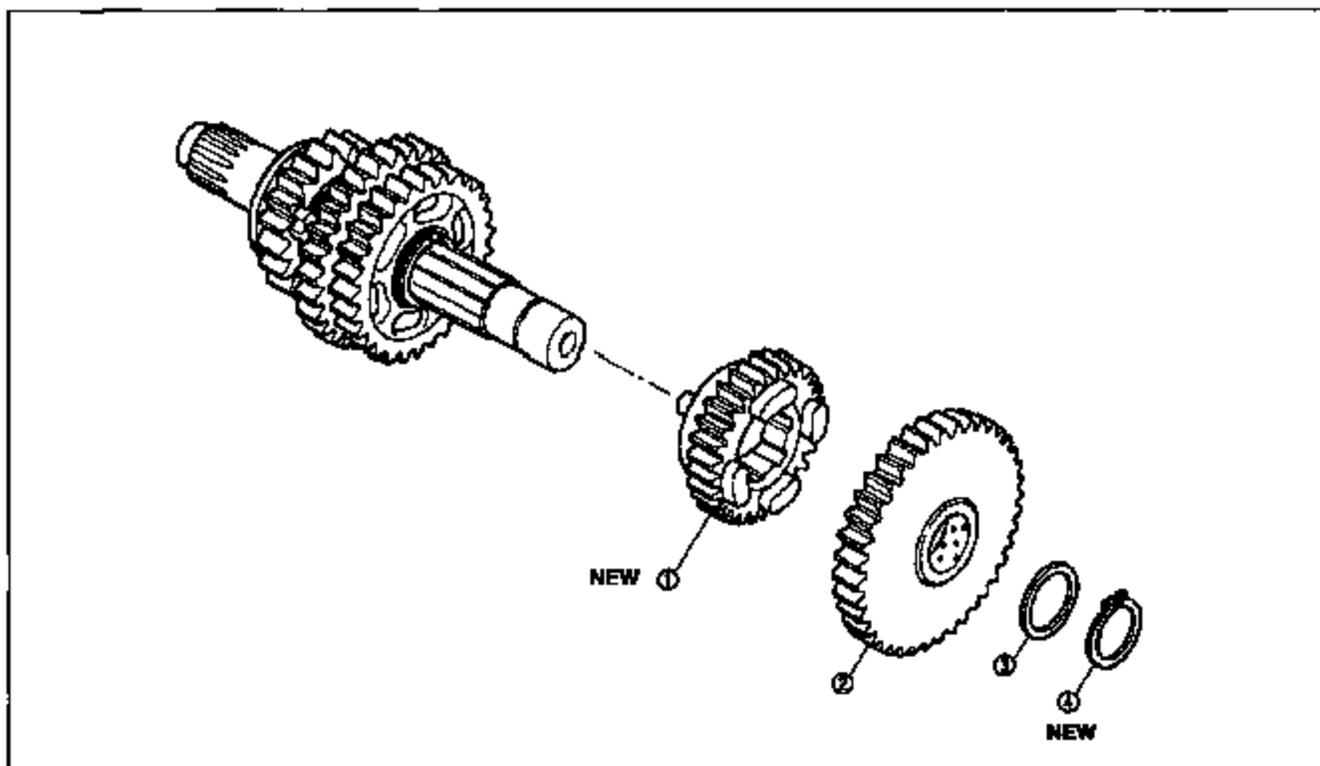
- Remove the circlip and washer from the Drive Shaft, then remove the 1st Wheel Gear and the 4th Wheel Gear. Do not disassemble the rest of the components on the shaft.
  - Install the components on the original Drive Shaft in the following order. Lubricate all components with engine oil. Be sure the circlip is installed with the sharp edge of the inner diameter facing away from the mating washer.
- ① 4th Wheel Gear – NEW
  - ② 1st Wheel Gear – Reuse original part
  - ③ Washer – Reuse original part
  - ④ Circlip – NEW

**Be sure to use all of the new parts in the kit. Otherwise, the transmission can still fail.**

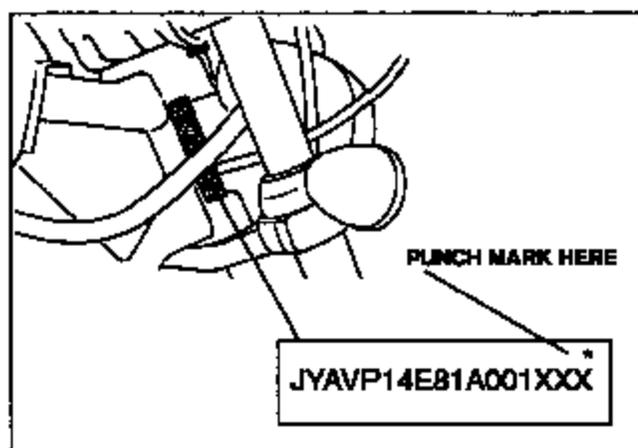
After modifying a unit, make a punch mark above the frame number (VIN) on the steering head pipe as shown in the illustration below.
