Subject: Safety Recall 00V-228 NSA-11paw
(Ford Number 00S21)

SUBJECT: DEMONSTRATION / DELIVERY HOLD Safety Recall 00S21: Certain 2000 Model Year Cars and Light Trucks - Seat Belt Buckle Assembly Inspection

SEAT BELT BUCKLE INSPECTION AND REPLACEMENT

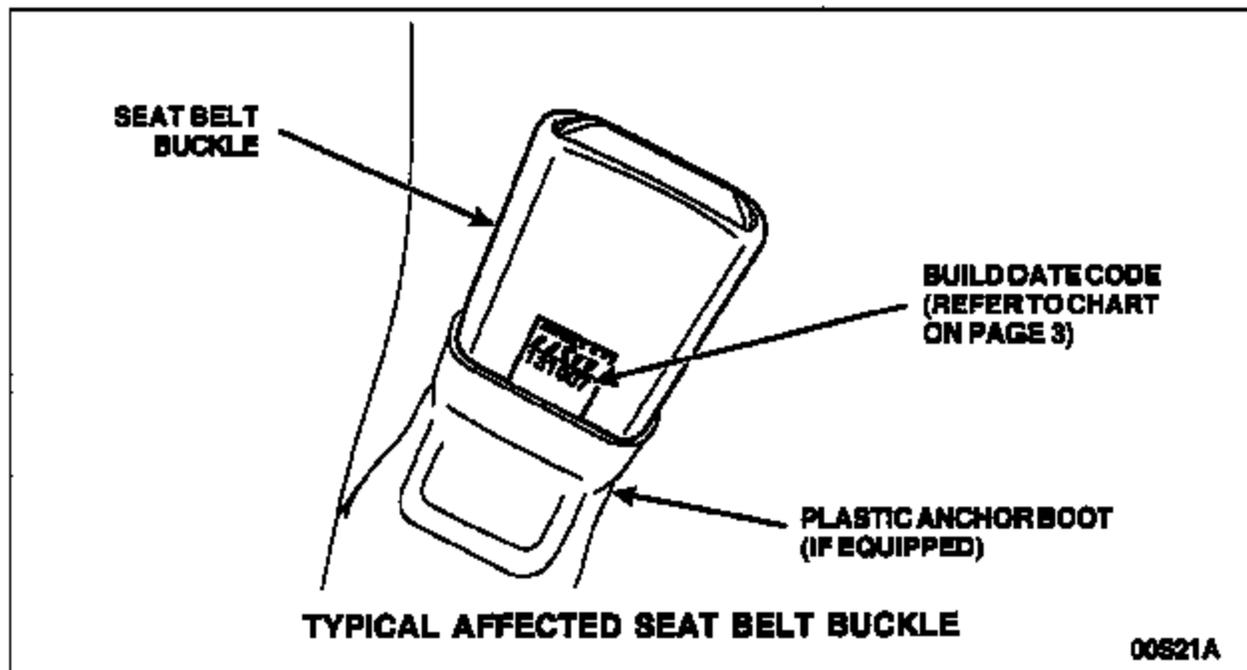
FIGURE 1

1. Refer to the Build Date Code Inspection chart on page 3 to identify the seat belt buckle(s) that require inspection.
2. Inspect the build date code located on the seat belt buckle end(s). Refer to Figure 1. If the build date code is covered by the plastic anchor boot, proceed as follows:
 - Remove the seat belt buckle from the vehicle. Refer to the service procedures in section 501-20A of the appropriate Workshop Manual.
 - Separate the seat belt buckle from the plastic anchor boot to access the build date code. If the plastic anchor boot is damaged during separation, replace the seat belt buckle assembly regardless of the build date code.

- If the build date code matches that listed in the chart, replace the seat belt buckle assembly. Refer to the service procedures in section 501-20A of the appropriate Workshop Manual.
- If the build date code does not match those listed in the chart, the seat belt buckle does not require replacement. Assemble and install the seat belt buckle, if removed. Refer to the service procedures in section 501-20A of the appropriate Workshop Manual.

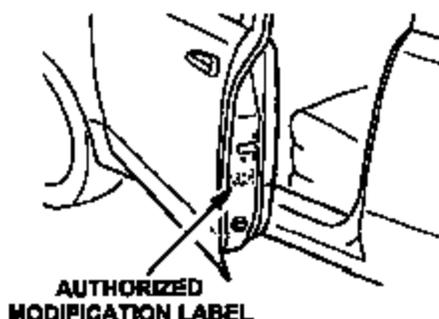
- Be sure to verify the recall number as the vehicle may have multiple labels.

- If MDCS displays **RECALL: 95010 N** and an Authorized Modification Label is **not present**, the recall has not been performed. Proceed to "B. REPAIR PROCEDURE."
- If MDCS displays **RECALL: 95010 N** and an Authorized Modification Label is **present**, contact the Warranty Department at (800) 682-8779. They will update the vehicle history.
- If MDCS displays **RECALL: 95010 D** and an Authorized Modification Label is **not present**, proceed to "C. AUTHORIZED MODIFICATION LABEL INSTALLATION."
- If MDCS displays **RECALL: 95010 D** and an Authorized Modification Label is **present**, the recall has already been completed. Return the vehicle to the customer or inventory.
- If MDCS does not display **RECALL: 95010 N** or **RECALL: 95010 D**, this recall does not apply to the vehicle. Return vehicle to the customer or inventory.

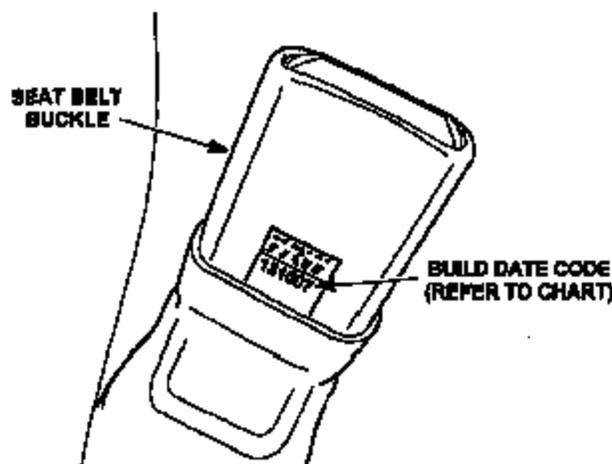
BUILD DATE CODE INSPECTION CHART
157002
161001
161002
163001
163002
164002
164003

- Recall does not apply to driver's side seat belt assembly.
- If the build date code matches the chart below, replace the seat belt buckle assembly. Refer to Workshop Manual (section 08-11).

- Apply threadlock (P/N ZZL1-89-232) or equivalent to fasteners when installing seat belt buckle assemblies.
- If the build code does **NOT** match those listed in the chart below, the seat belt buckle does not require replacement; return vehicle to customer or inventory.

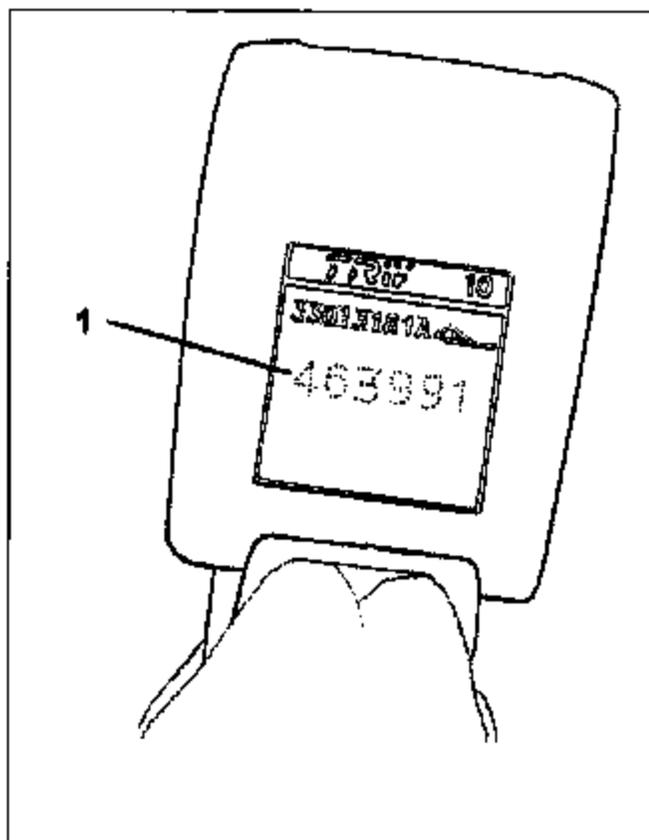
- The suspect seat belt buckle(s) in an involved vehicle can be inspected for suspect date codes(s) (1). See illustration.
- The suspect seat belt buckle(s) in an involved vehicle cannot be inspected and must be replaced.

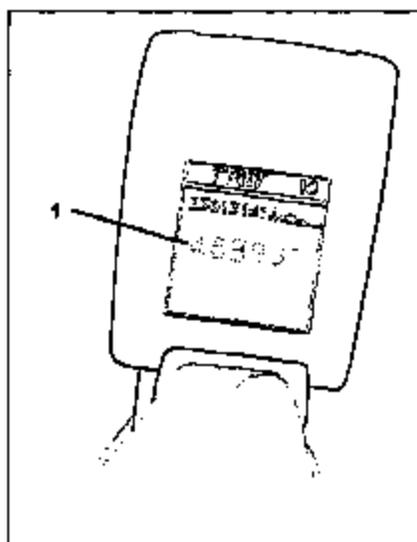
- Refer to the Vehicle Seating Position Decision Table to determine which seating positions need to be inspected and/or replaced for the particular vehicle in question.
- See illustration with example date code. Inspect the seat belt buckle assemblies in the seating positions identified in the table for suspect date codes (see date code table on page 7).
- Replace seat belt buckle assemblies with suspect date codes using the appropriate service procedure(s) following the table. Also, replace any seat belt buckle assemblies which have been identified as "Replace Only - No Inspection Required" in the Vehicle Seating Position Decision Table using the appropriate service procedure.

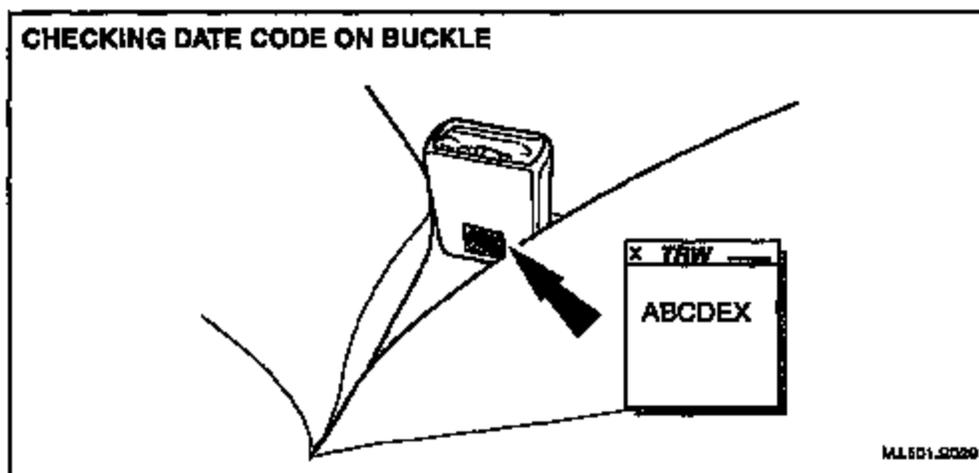
ILLUSTRATION 1

1. Open both front doors.
2. Push back the soft plastic cover on the front safety belt buckle for access to the buckle code. (See Illustration 1).

3. Check and record the buckle code against the affected codes provided in the table. Ensure the code is safe.

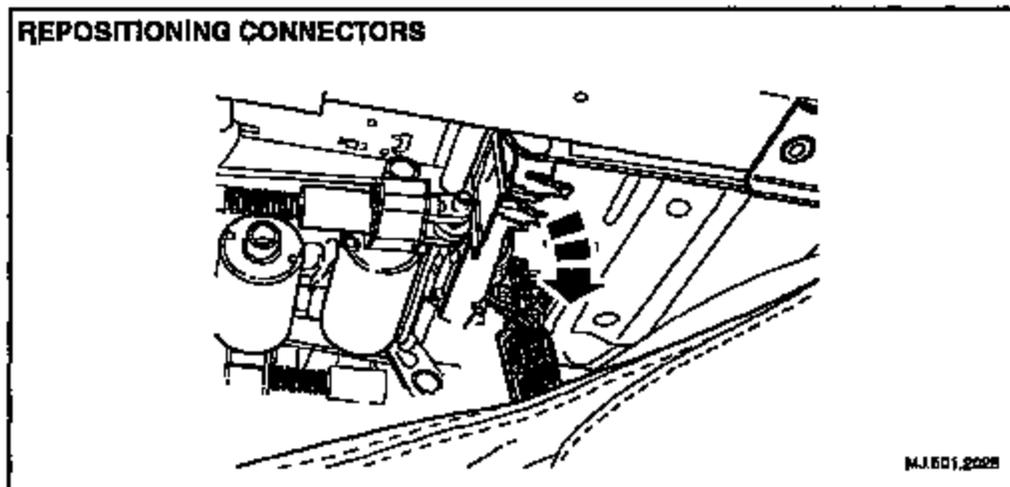
ILLUSTRATION 2

9. Remove the seat harness connectors from their seat frame mounting tangs (Illustration 2). Do not unplug the connector.

The previous operation is required to allow harness more free play when maneuvering the front seat (Illustration 2)

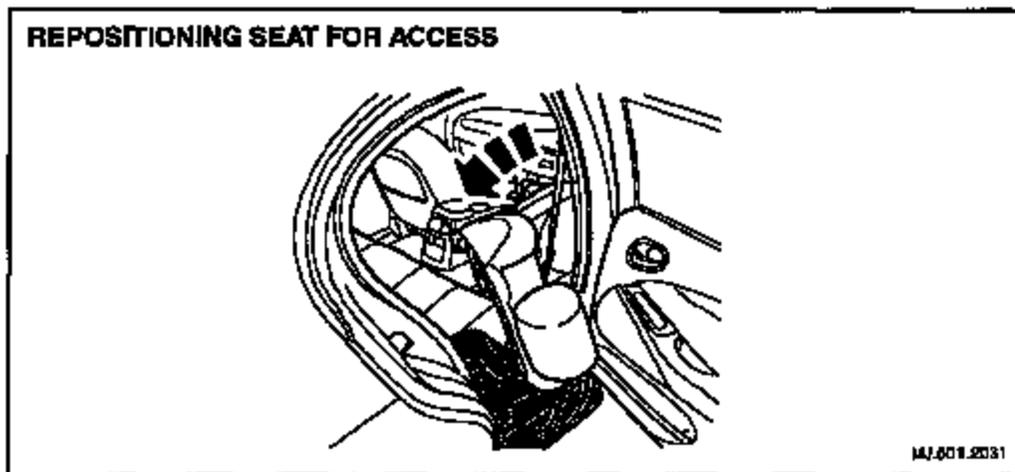
ILLUSTRATION 3

11. Carefully reposition front seat on its side for access to the safety belt buckle. During this operation, the seat back protrudes through the rear door opening. (Illustration 3).

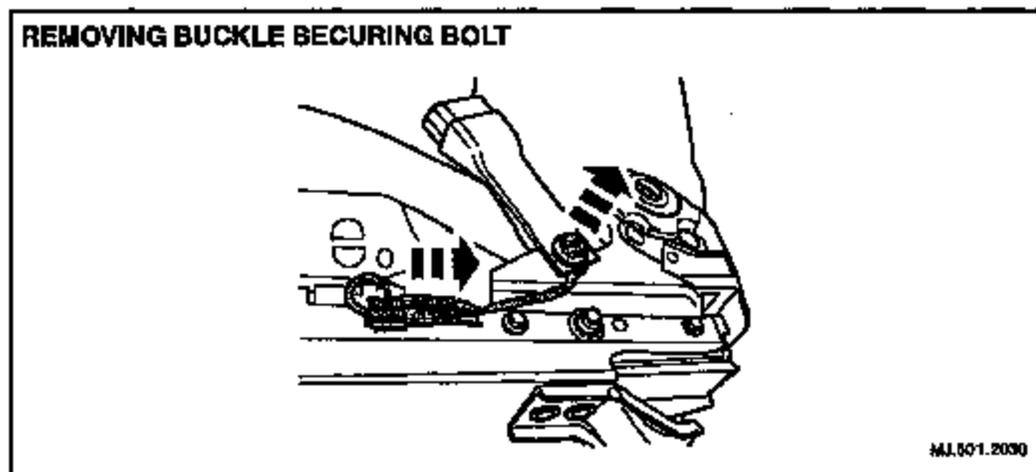
ILLUSTRATION 4

12. Disconnect the front safety belt buckle assembly connector. Loosen and remove the bolt securing the front safety belt buckle. Remove the safety belt buckle assembly and place to one side. (Illustration 4).
13. Install the new safety belt buckle on the front seat – ensure that the buckle lug locates correctly in the seat frame hole.
14. Tighten the new securing bolt for the front safety belt buckle to 40 Nm (29 lb. ft.)
15. Connect the front safety belt buckle connector.
16. Reposition the front seat upright.
17. Engage and seat the front seat harness connectors on their seat frame mounting tangs.
18. Reposition and align the front seat with the body.
19. Remove the protective covering from the rear door opening tread plate area.
20. Install, but do not fully tighten, the rear bolts that secure front seat to the body.

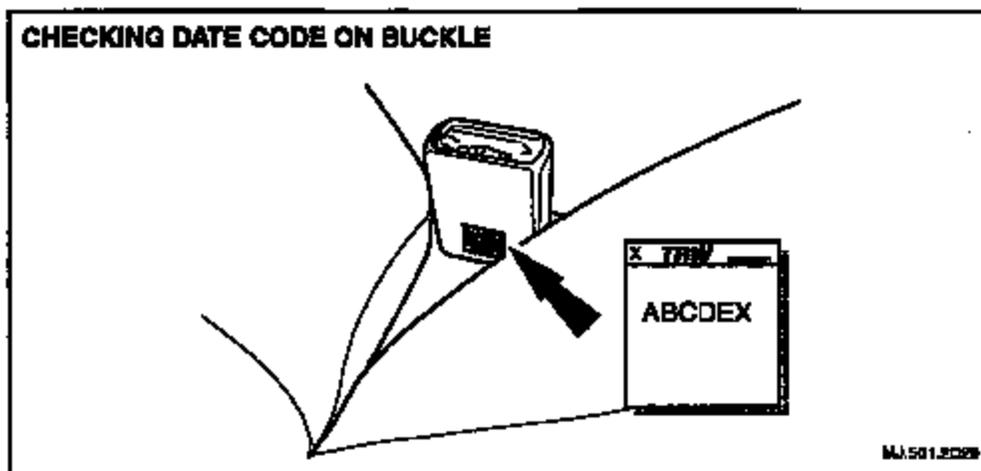
ILLUSTRATION 1

1. Open both front doors.
2. Push back the soft plastic cover on the front safety belt buckle for access to the buckle code. (See Illustration 1).

3. Check and record the buckle code against the affected codes provided in the table. Ensure the code is safe.

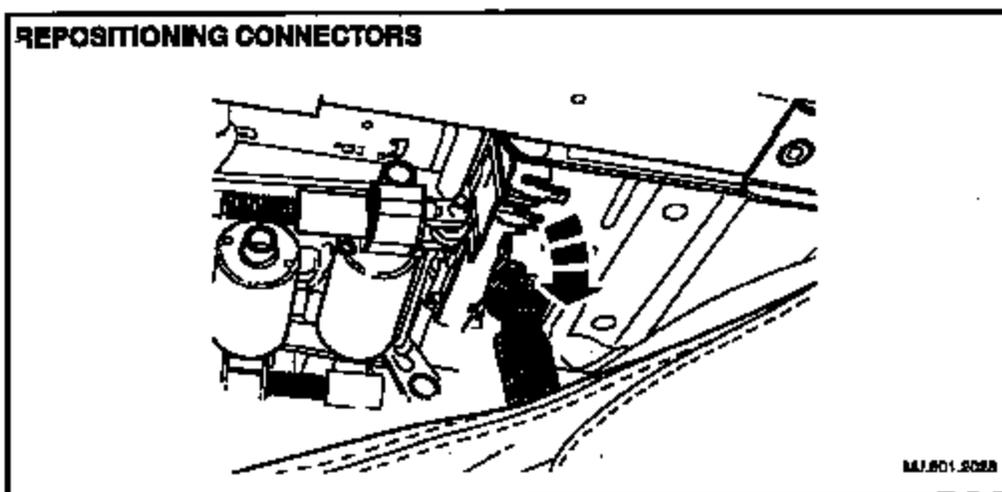
ILLUSTRATION 2

8. Carefully reposition the front seat for access to the seat harness connector.
9. Remove the seat harness connectors from their seat frame mounting tangs (Illustration 2). Do not unplug the connector.

The previous operation is required to allow harness more free play when maneuvering the front seat (Illustration 2)

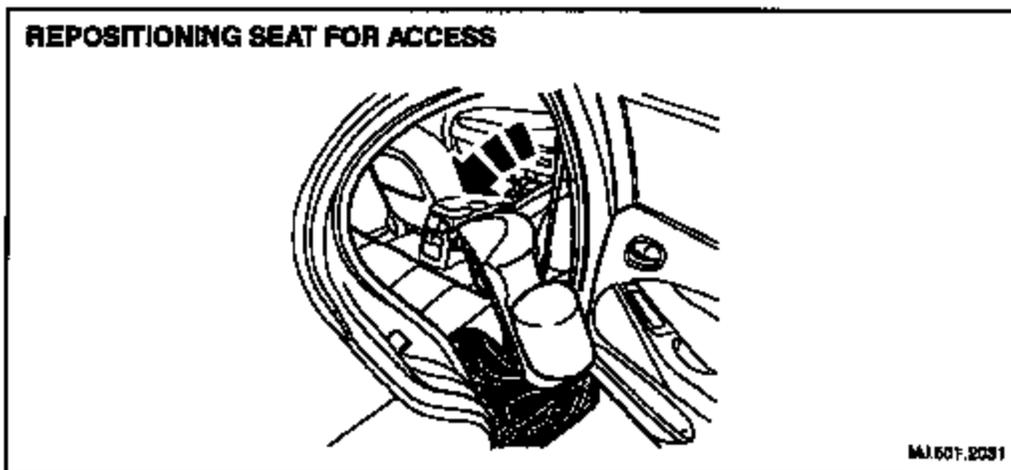
ILLUSTRATION 3

11. Carefully reposition front seat on its side for access to the safety belt buckle. During this operation, the seat back protrudes through the rear door opening. (Illustration 3).

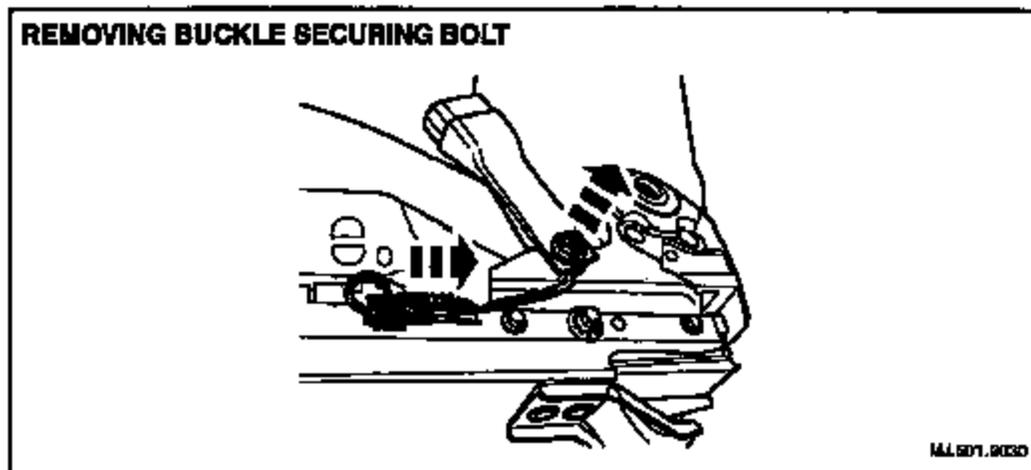
12. Disconnect the front safety belt buckle assembly connector. Loosen and remove the bolt securing the front safety belt buckle. Remove the safety belt buckle assembly and place to one side. (Illustration 4).
13. Install the new safety belt buckle on the front seat – ensure that the buckle lug locates correctly in the seat frame hole.
14. Tighten the new securing bolt for the front safety belt buckle to 40 Nm (29 lb. ft.)
15. Connect the front safety belt buckle connector.
16. Reposition the front seat upright.
17. Engage and seat the front seat harness connectors on their seat frame mounting tangs.
18. Reposition and align the front seat with the body.
19. Remove the protective covering from the rear door opening tread plate area.
20. Install, but do not fully tighten, the rear bolts that secure front seat to the body.

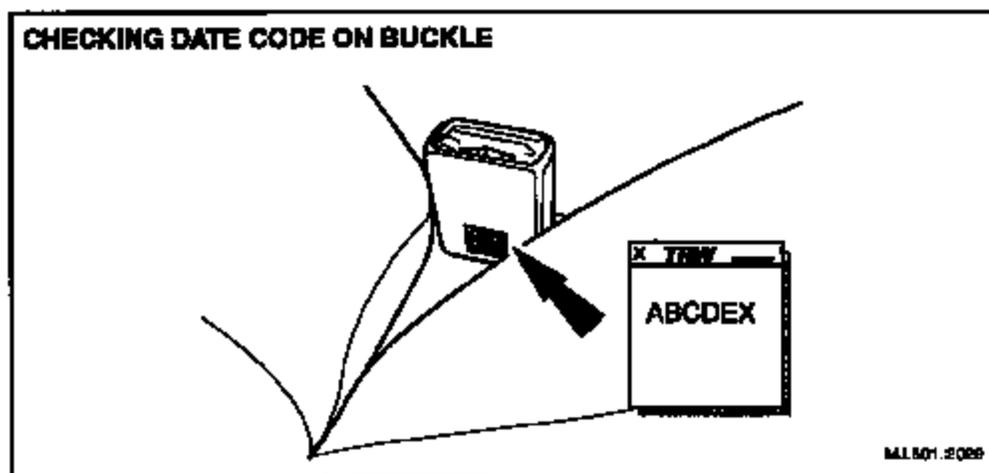
ILLUSTRATION 1

1. Open both front doors.
2. Push back the soft plastic cover on the front safety belt buckle for access to the buckle code. (See Illustration 1).

3. Check and record the buckle code against the affected codes provided in the table. Ensure the code is safe.

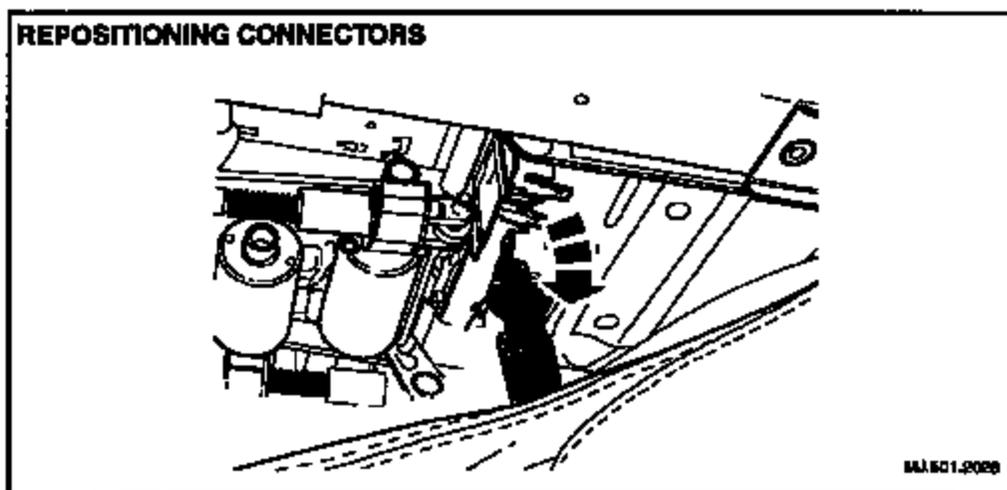
ILLUSTRATION 2

8. Carefully reposition the front seat for access to the seat harness connector.
9. Remove the seat harness connectors from their seat frame mounting tangs (Illustration 2). Do not unplug the connector.

The previous operation is required to allow harness more free play when maneuvering the front seat (Illustration 2)

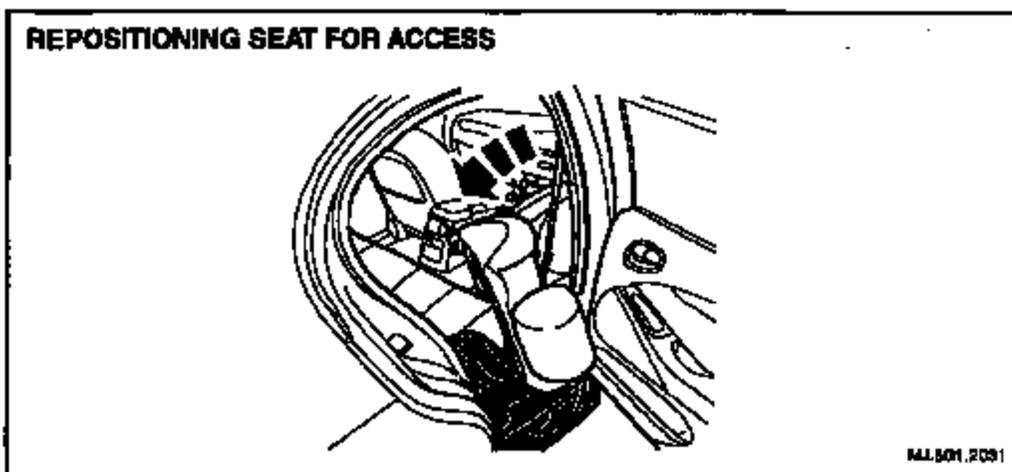
ILLUSTRATION 3

11. Carefully reposition front seat on its side for access to the safety belt buckle. During this operation, the seat back protrudes through the rear door opening. (Illustration 3).

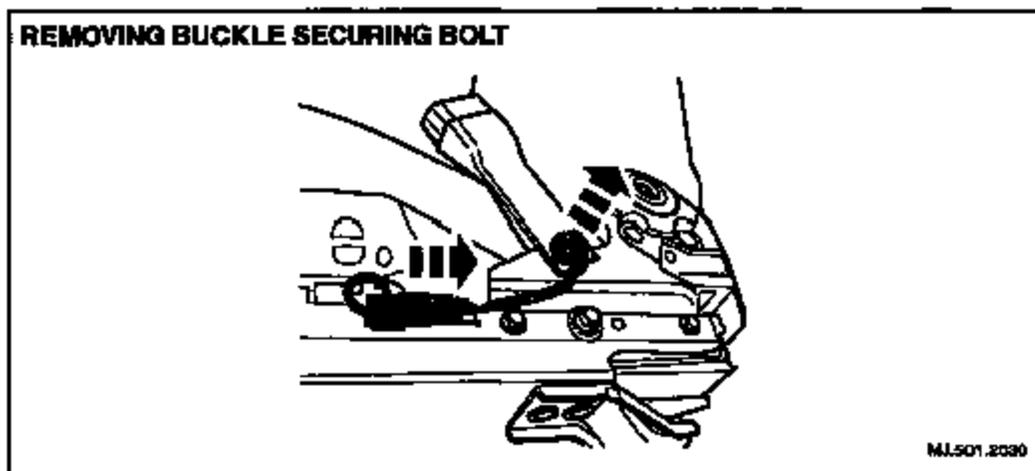
12. Disconnect the front safety belt buckle assembly connector. Loosen and remove the bolt securing the front safety belt buckle. Remove the safety belt buckle assembly and place to one side. (Illustration 4).
13. Install the new safety belt buckle on the front seat – ensure that the buckle lug locates correctly in the seat frame hole.
14. Tighten the new securing bolt for the front safety belt buckle to 40 Nm (29 lb. ft.)
15. Connect the front safety belt buckle connector.
16. Reposition the front seat upright.
17. Engage and seat the front seat harness connectors on their seat frame mounting tangs.
18. Reposition and align the front seat with the body.
19. Remove the protective covering from the rear door opening tread plate area.
20. Install, but do not fully tighten, the rear bolts that secure front seat to the body.

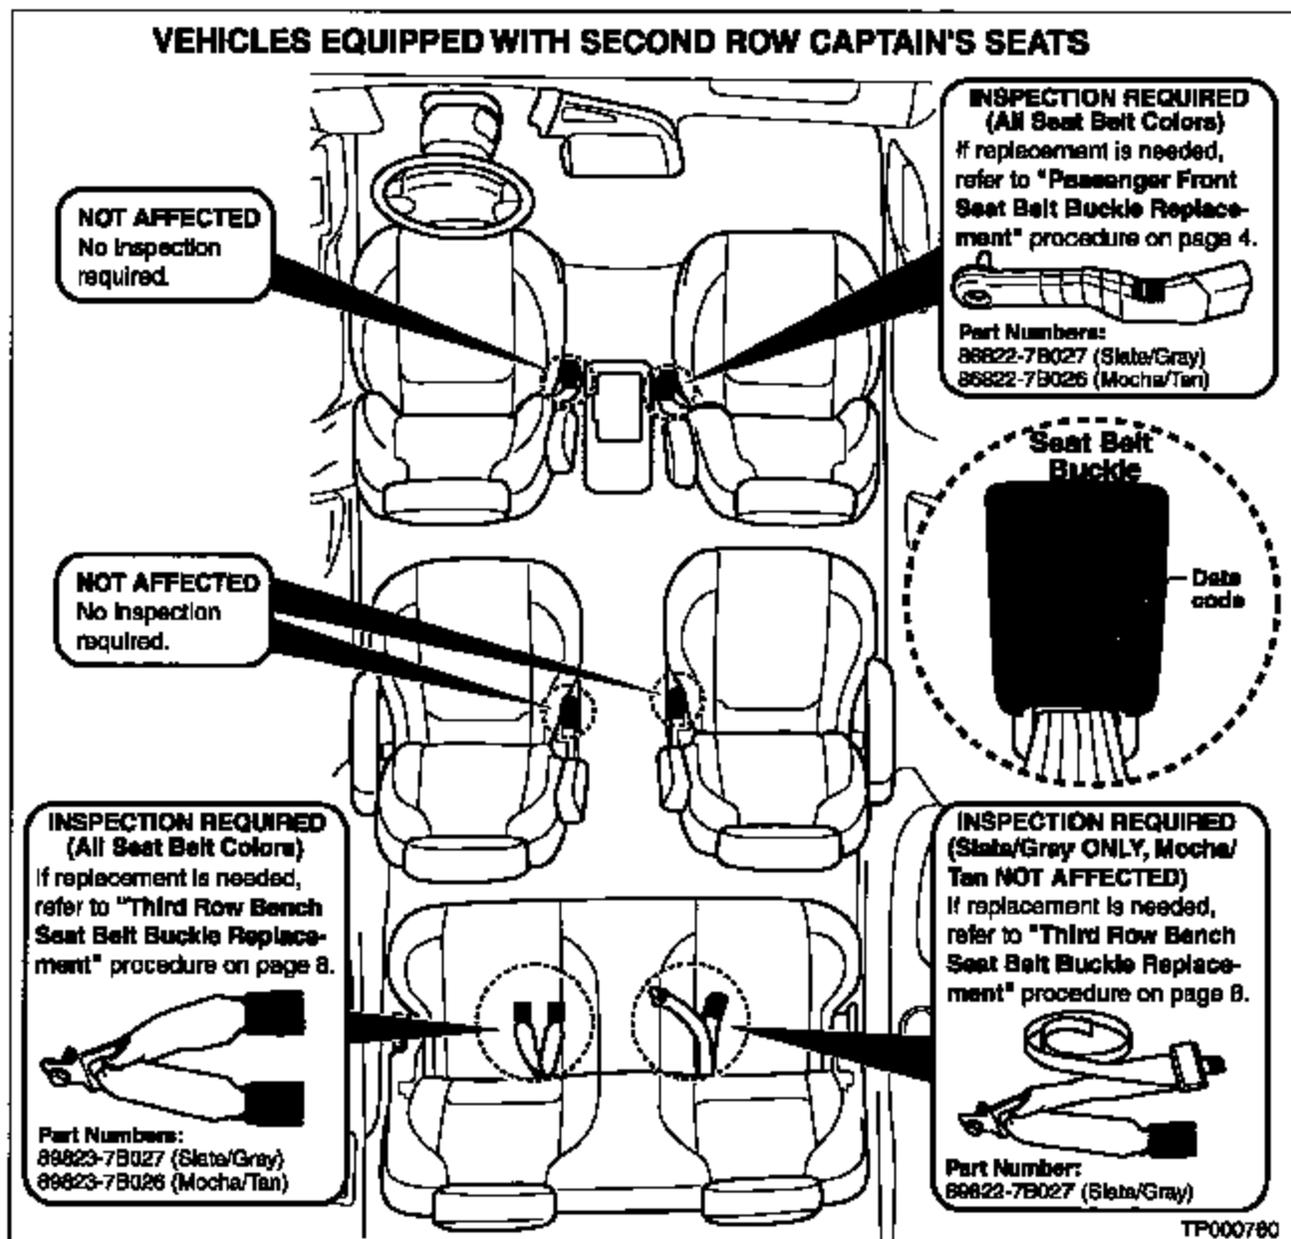
Figure 1 is for vehicles equipped with second row captain's seats. Figure 2 is for vehicles equipped with a second row bench seat.

- If a seat belt buckle has date code 156001 or 157001, replace it. Refer to Figure 1 or Figure 2 for the inspection procedure and the related seat belt buckle P/Ns.
- If none of the seat belt buckles have lot number 156001 or 157001, return the vehicle to the customer and submit a warranty claim for the inspection **ONLY**.

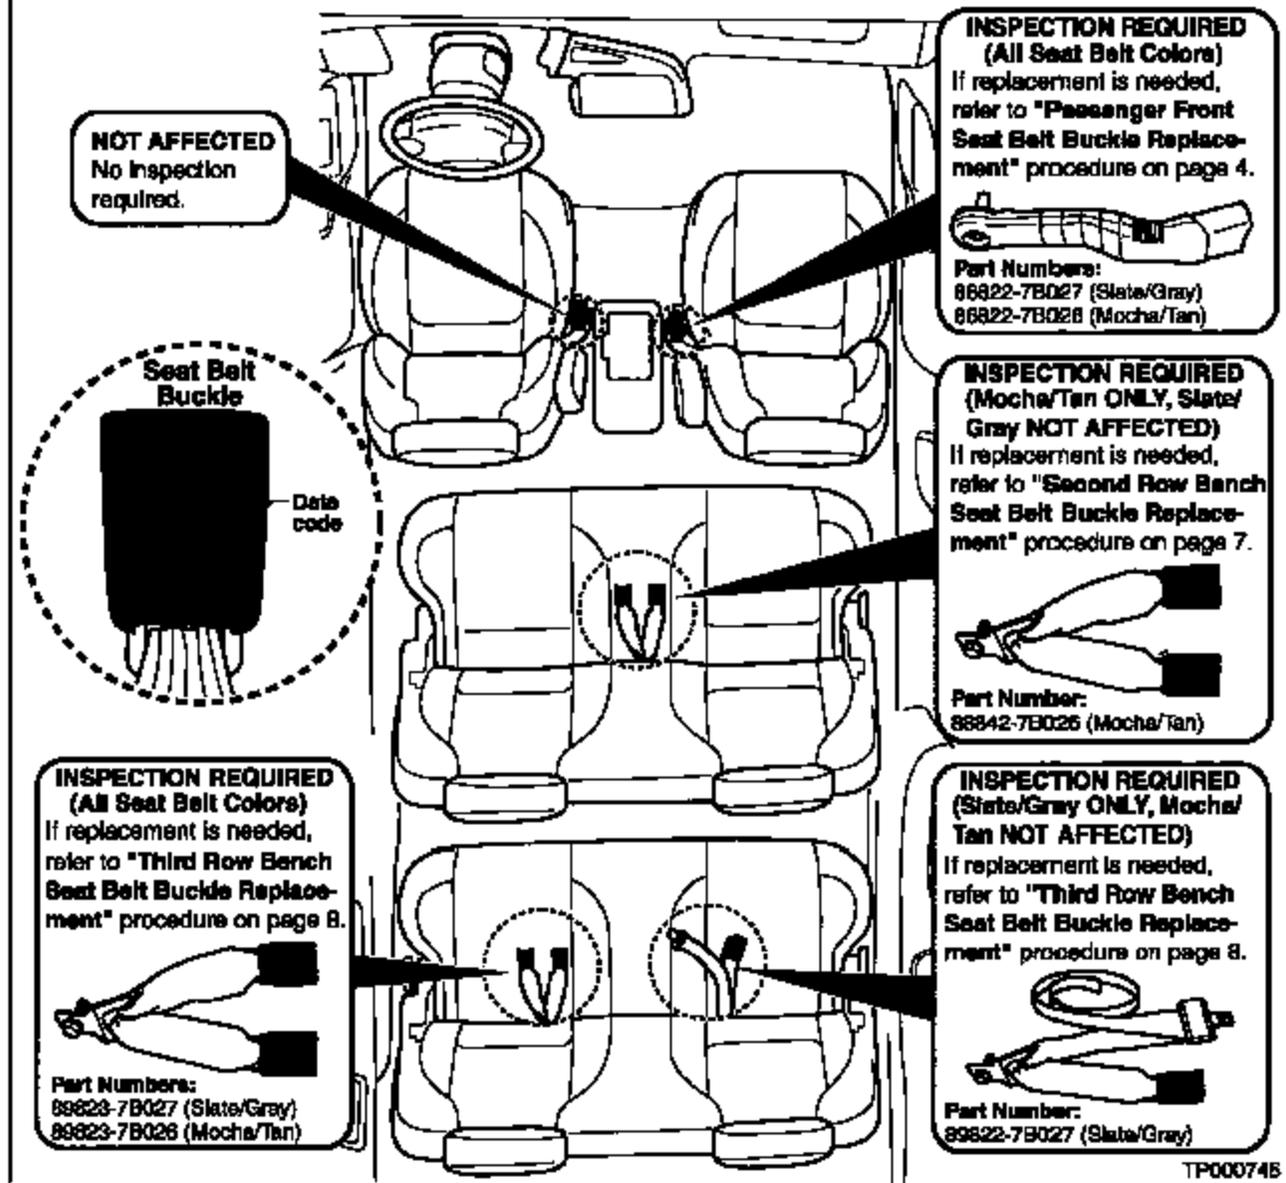
Figure 2

VEHICLES EQUIPPED WITH SECOND ROW BENCH SEAT

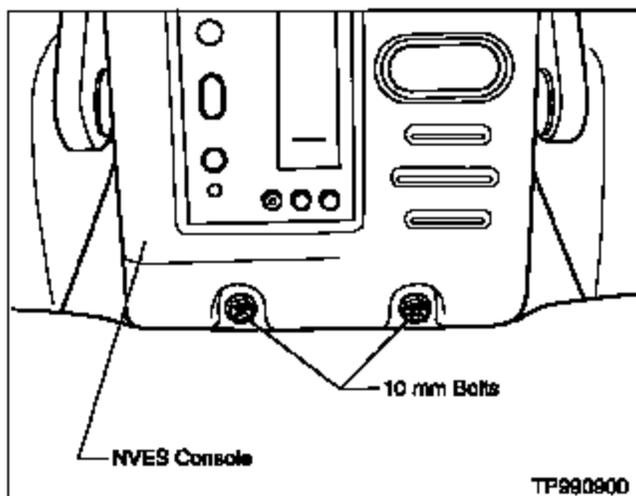
Figure 3

1. Re-position the Nissan Vehicle Entertainment System (NVES) console, located between the front seats, as follows:
 - A. Make sure the ash tray and cup holder tray (located below the A/C controls) are pushed in all the way.
 - B. Re-position the floor mat between the front seats and the second row seating to access the two rear NVES console mounting bolts (see Figure 3).

- C. Remove the two, rear console mounting bolts (see Figure 3).
- D. Pull the console rearward 2 inches so it slides out of the front mounting bracket (see Figure 4).

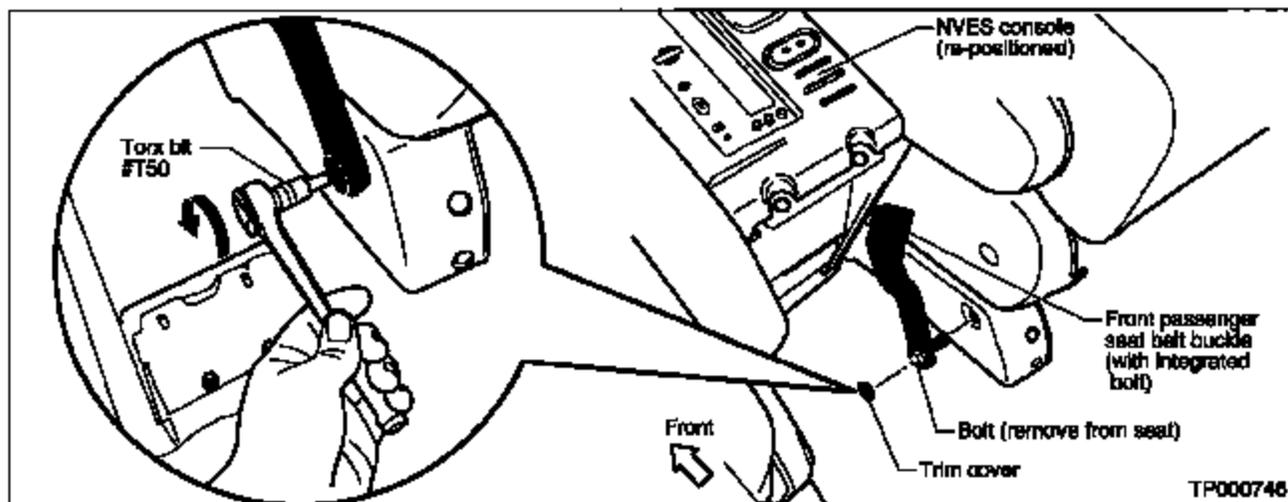
Figure 5

2. Unscrew (using a Torx-bit #T50) and remove the trim cover over the seat belt buckle mounting bolt (see Figure 5).

3. Unscrew the bolt and remove the front passenger seat belt buckle (see Figure 5).
4. Install the new seat belt buckle and tighten the mounting bolt to 34 – 46 Nm (3.5 – 4.7 Kg-m, 25.1 – 33.9 ft-lbs). See Figure 6.

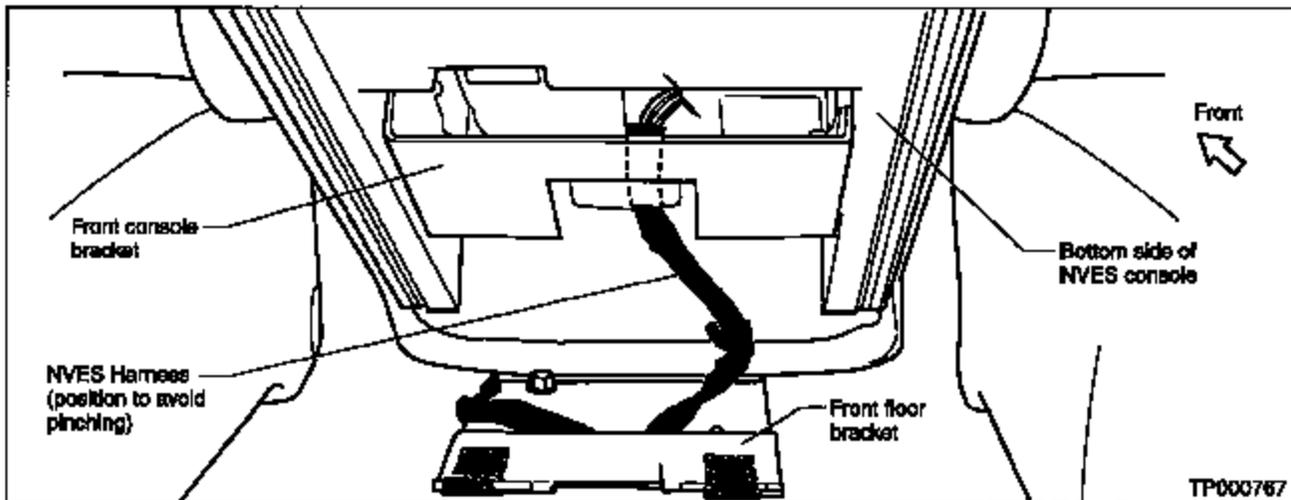
Figure 7

- A. Verify the wire harness (located under the front of the console) is correctly positioned before lowering the console (see Figure 7). Confirming the harness is properly positioned will prevent it from being pinched/damaged.

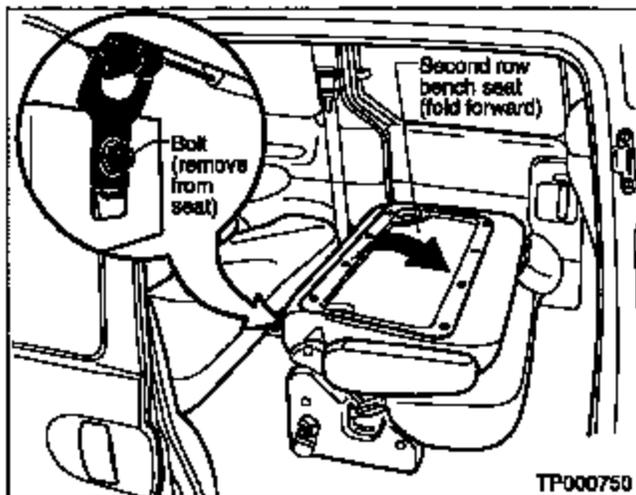
Figure 8

1. Fold the top half of the second row bench seat forward (see Figure 8).

2. Unscrew the bolt and remove the seat belt buckles (see Figure 8).
3. Install the new seat belt buckles and tighten the mounting bolt to 34 – 46 Nm (3.5 – 4.7 Kg-m, 25.1 – 33.9 ft-lbs). See Figure 9.

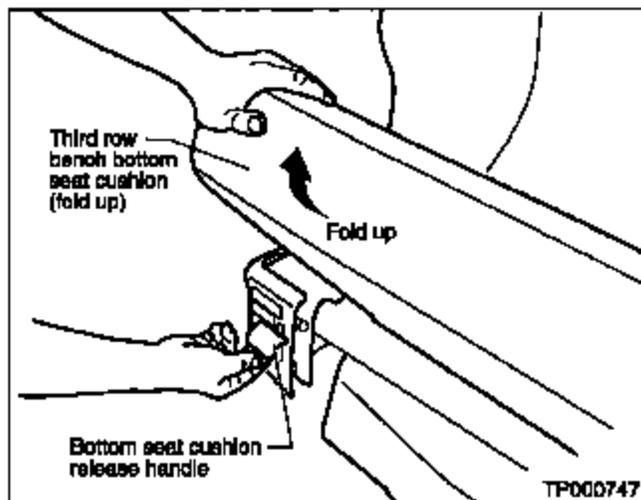
Figure 10

NOTE: Folding up the bottom seat cushion makes it easier to remove and install the seat belt buckles between the bottom and top seat cushions.

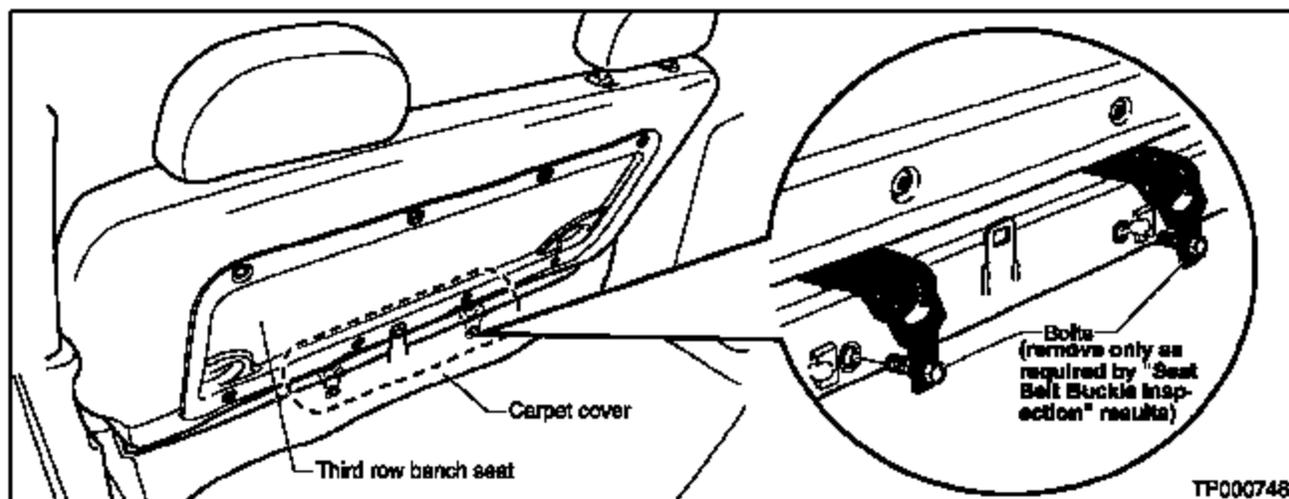
Figure 11

2. Working at the back of the third-row bench seat, remove the bolt(s) and remove the seat belt buckle(s) as required by the Seat Belt Buckle Inspection results (see Figure 11).

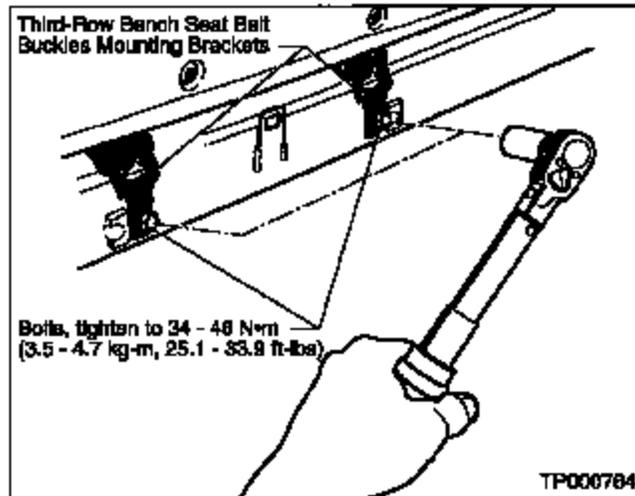
Figure 12

3. Install the new seat belt buckle(s) and tighten the mounting bolt(s) to 34 – 46 Nm (3.5 – 4.7 Kg-m, 25.1 – 33.9 ft-lbs). See Figure 12.

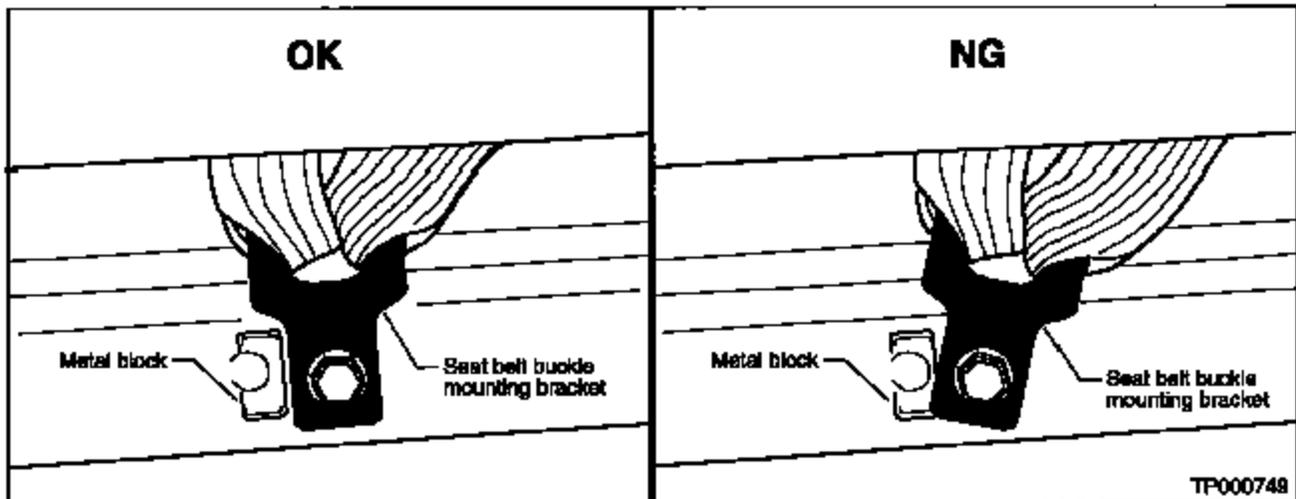
Figure 13

WARNING: Make sure the seat belt buckle mounting bracket(s) is correctly positioned after tightening the mounting bolt(s) (see Figure 13).
