# TECHNICAL SERVICE BULLETIN

## Victory Motorcycle

Bulletin Number: V-03-03(A)

### SUBJECT: FUEL TANK VENT OBSTRUCTION (CALIFORNIA MODELS)

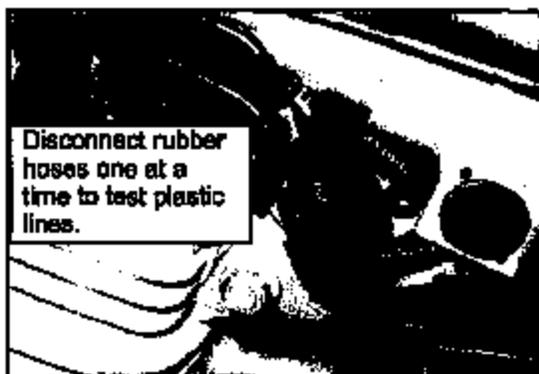
### Locate the fuel tank vent hose and cap cavity drain hose.

1. Remove the left side cover.
2. Locate the two hard plastic lines at the rear left side of fuel tank. One is the water drain from the gas cap depression and the other is the fuel tank vent line. Both hard lines transition to a rubber line at this point.

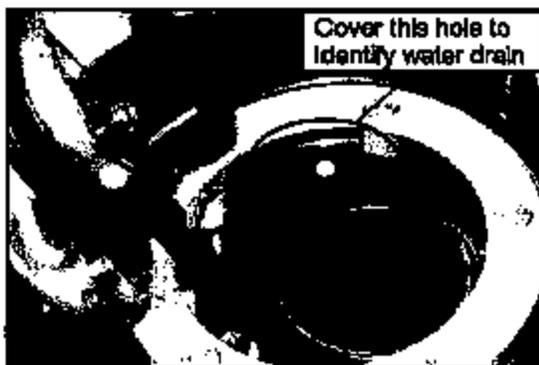
### Attach a pressure pump

4. Attach a hand pump (i.e. a Mity Vac PV-43545) to the hard line on the fuel tank side as shown using an appropriate adaptor that seals tightly on the line.

5. Pump air into the line. Air should be heard escaping from the fuel cap area. If the pump does not build pressure (indicating a clear vent) but you do not hear air escaping from the filler neck or from the water drain hole, check to be sure the hose is connected to the fitting on the bottom of the fuel tank.

6. To determine which line you have, place your finger over the water drain opening which is located to the left of the gas cap opening. If the airflow stops you have located the water drain line. If the airflow continues, you have located the tank vent line and it is open. You should be able to hear the air escaping out the fuel tank filler neck.

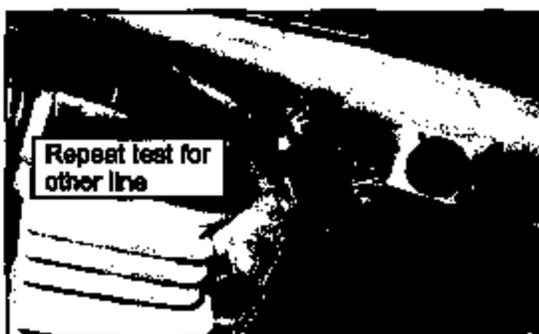
### Determine if further repair is required. File claim Type SB.

7. If both lines are clear, reconnect them, close and lock the fuel cap, and reinstall the side cover. File a warranty claim for inspection only, and use V-03-03 as the bulletin number.
8. If you can not move air through the vent line (pressure builds on the gauge), the fuel tank vent fitting is plugged, and you must replace the fuel tank. Follow the procedure outlined on page 5.3 - 5.11 in the Victory Vegas™ Service Manual PN 9818371, and file a warranty claim for inspection and tank replacement using bulletin number V-03-03A.
