On June 11, 2004, Honda Motor Co., Ltd. (HMC) determined that a safety-related problem exists in the main stand of 2002-2004 model year Honda FSC600 scooters. The following information is submitted pursuant to the requirements of 49 CFR 573.6.

# 2002-2004 Honda FSC600 Main Stand Recall Illustration

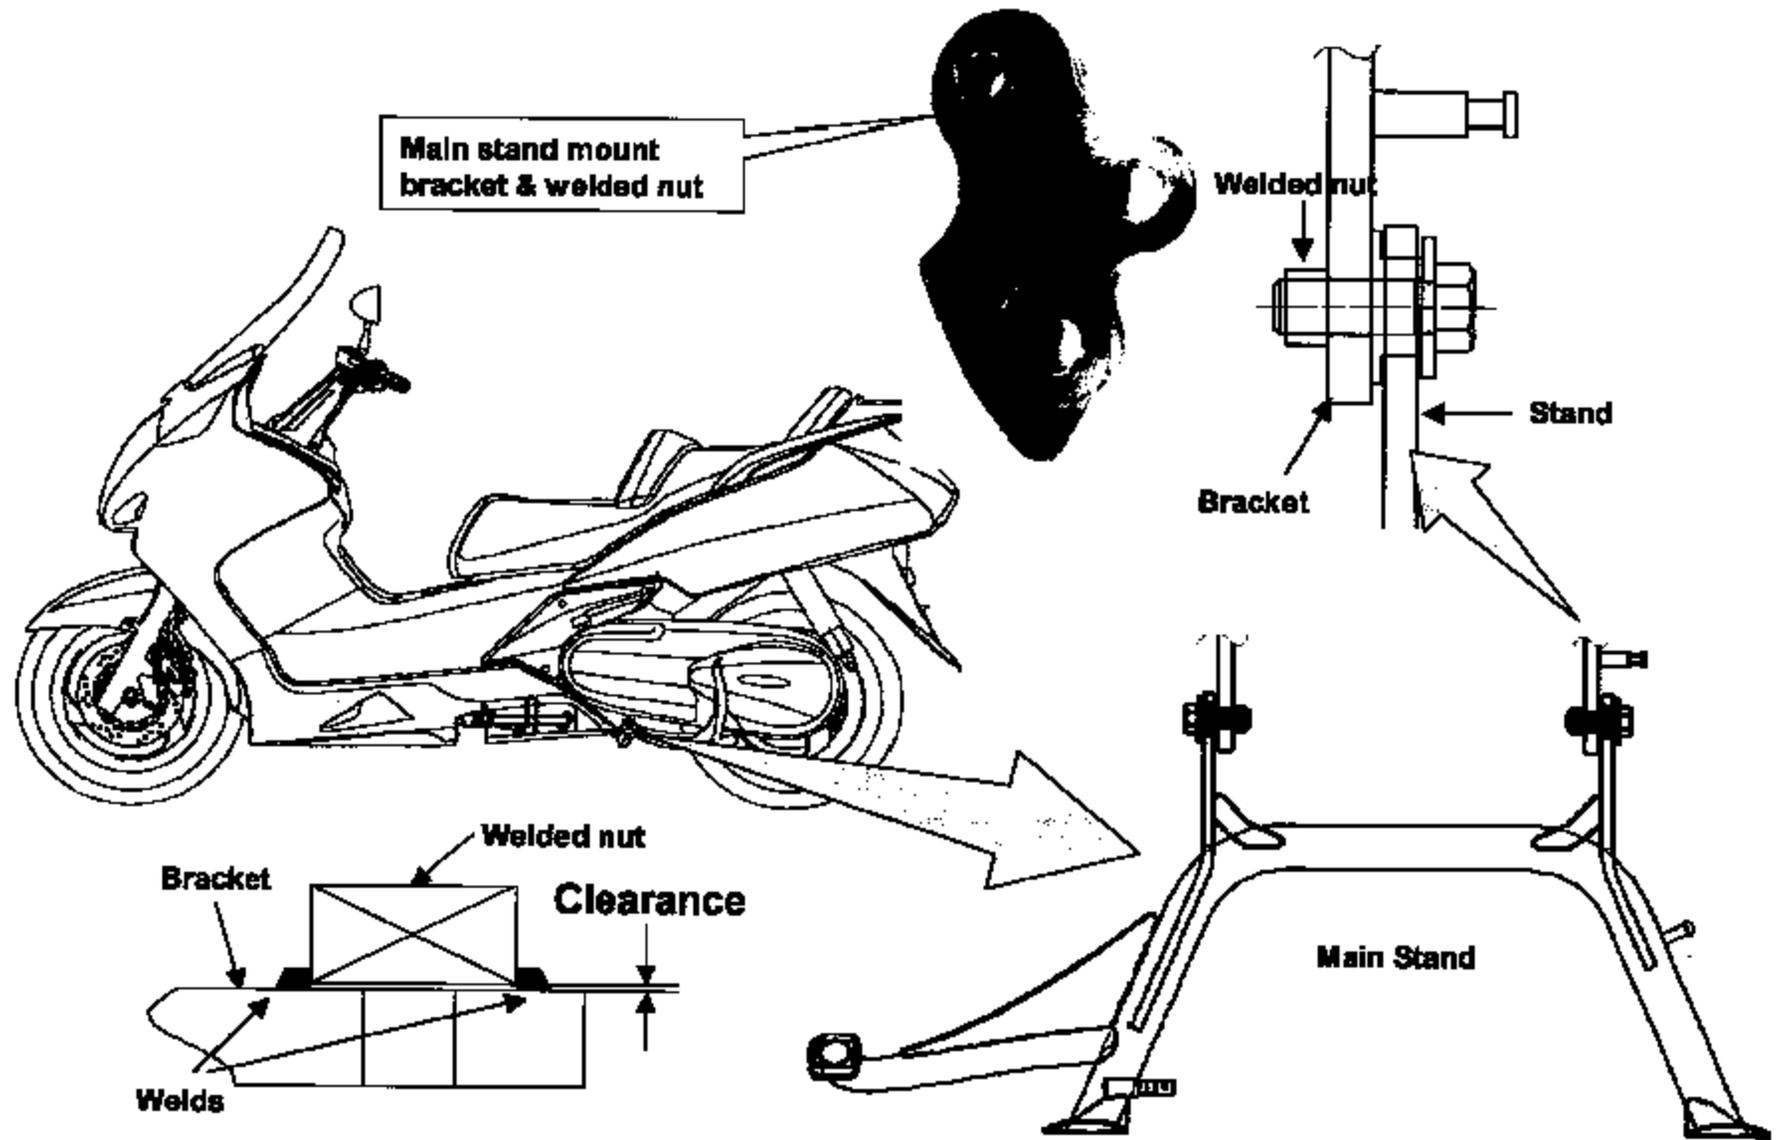
The main stand is attached to the frame with two brackets, nuts and bolts. The nuts are spot-welded to the brackets. If clearance exists between the nut and bracket, the spot welds may be broken when the bolt is torqued (refer to attached illustration). Over time, a bolt can loosen and fall out. The stand could then partially or completely detach from the frame, interfering with or damaging the rear wheel, and increasing the risk of a vehicle crash without warning. A completely detached stand falling on the roadway also creates a hazard for other vehicles.

The owners of all affected vehicles will be notified by mail and asked to take their vehicle to an authorized Honda dealer. The dealer will install new brackets, longer bolts and locknuts, free of charge.
