RECALL CAMPAIGN NO. 41
Ferrari 360 Modena, Spider & Challenge Stradale
“Hydraulic Steering Delivery Pipe”
RECALL CAMPAIGN OVERVIEW

“Hydraulic Steering Delivery Pipe from Pump to Rack”

Technical Instructions

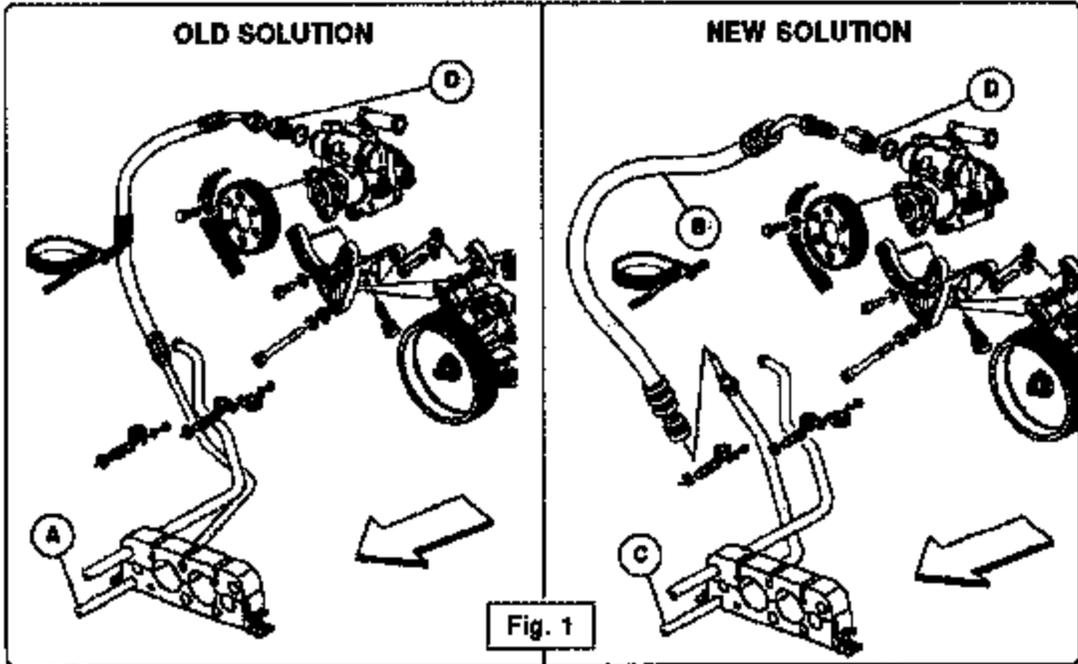
The new design proposes the splitting of the hydraulic steering delivery pipe which runs from the pump to the steering rack (part A in the old design, Fig. 1) into two parts:

- Part B (new solution, Fig. 1) made of a hosing, which runs from the pump to the under-floor C.
- Part C (new solution, Fig. 1) made of a rigid piping, which runs across the entire under-floor.

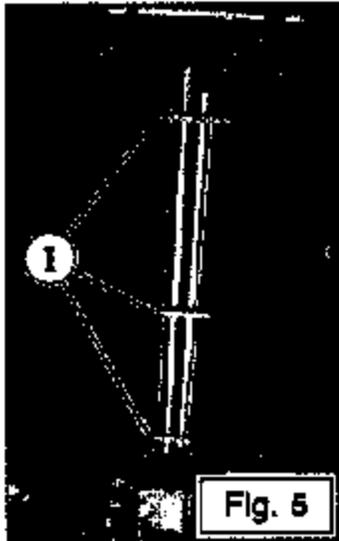
- Remove the rear central and front sections of the under-floor (see **M 2.12** of the service manual).
- Remove the rear movable guard and the waterproof canvas from the luggage compartment as described in section **M 3.06** of the service manual.
- Access to the hydraulic steering delivery pipe union on the pump in the **360 Spider model** is only possible through the engine inspection hatch. Remove the engine inspection hatch following the instructions laid out in section **M 3.05** of the service manual.
- Remove the 3 plates shown as (1) in Figure 5. These plates are in position with the supports retaining the under floor pipes. Please undo the relative fastening screws.

- Detach the sheathed bracket (2) from the bodywork and slide the hydraulic steering delivery pipe (A) (Fig.1) out of the under-floor supports (Fig. 6).

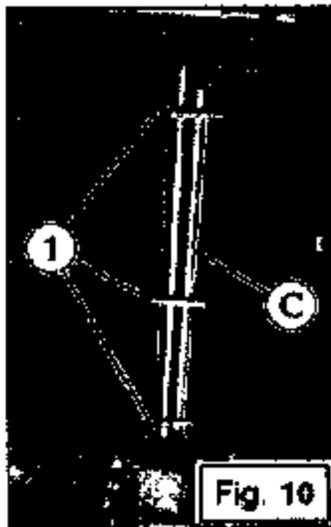
- Fit the new delivery pipe from the jointing to the steering rack (C) into the under-floor supports and refit the 3 original plates (1) (Fig. 10).

- Fasten the rear end of the pipe (C) to the sheathed bracket (2), removed earlier (Fig.11)

- Fasten the union on the delivery pipe (C) onto the steering rack, positioning it as shown in the figure and tightening it to a torque of 35 Nm (Fig. 11).
