Re: NHTSA Campaign Number 00E-031

This notice describes an **AMENDED** plan to the current remedy in place for the N600/N800 product recall.

Instructions to Replace the Refrigerator Cooling System

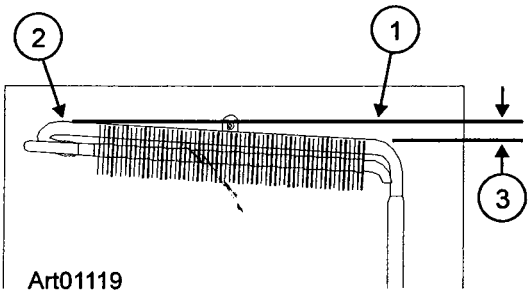
Art01119

- Do not tighten the screws completely at this time.
7. Make sure the condenser of the replacement cooling system has the correct slant (See Art01119).
 - Using a level, make sure that the top of the refrigerator is level from side-to-side.

- If the refrigerator is not level, put shims under the refrigerator until it is level.
 - Draw a level line [1] from the top left corner of the condenser [2] across the back of the refrigerator cabinet.

- Make sure that the right top corner of the condenser is the correct distance from the level line:
 - If the refrigerator has one door, the distance [3] must be between 5/8 inch min. and 1 inch max.

- If the refrigerator has two doors, the distance [3] must be between 3/4 inch min. and 1 1/4 inch max.
 - Raise or lower the top left corner of the condenser as necessary so the distance is correct.

- Make sure that the top left corner of the condenser is not higher than the top of the refrigerator cabinet.
 - Tighten all of the screws.
 8. Attach the thermistor to the fins inside the refrigerator.

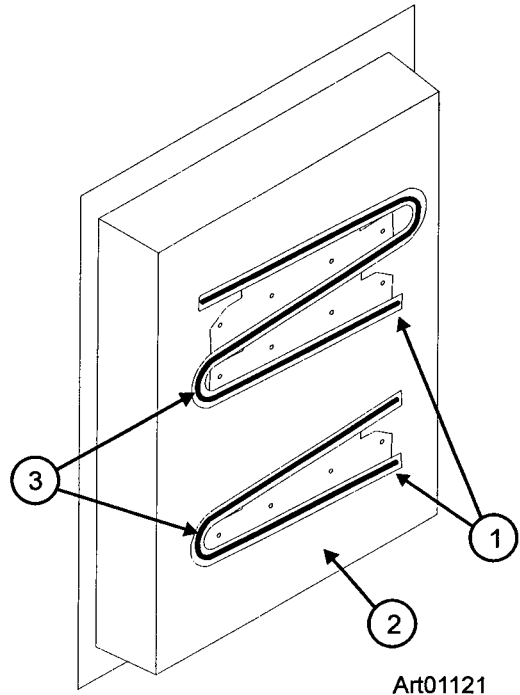
Art01121

1. Apply the transfer mastic to the replacement cooling unit (See Art01121):
 - Remove the tip from the caulking tube of transfer mastic that is marked "T".
 - Locate the evaporator tubes [1] on the front of the foam block [2] of the replacement cooling system.
 - Put a 1/2 inch bead of transfer mastic [3] on the evaporator tubes.
2. Apply the permagum sealant to the replacement cooling unit:

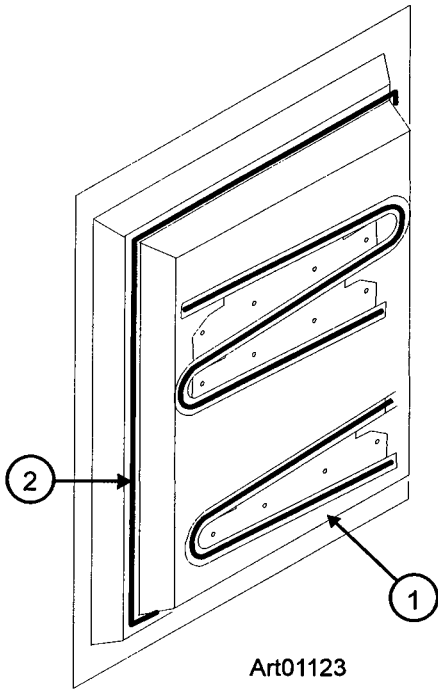
Art01123

- Remove the tip from the caulking tube of permagum sealant that is marked "P".
- Put a 1/2 inch bead of permagum sealant [2] around the edge of the foam block [1] of the replacement cooling system (See Art01123).
 - Put the 1/2 inch bead of permagum sealant in the flat area of the step.
- Put a 1/2 inch bead of permagum sealant around the cooling system opening [1] in the back of the refrigerator cabinet (See Art01124):
 - Put the 1/2 inch bead of permagum sealant [2] in the flat area of the step.

NOTE: Correct application of the permagum sealant prevents air leakage into the refrigerator. This reduces frost build up inside the refrigerator which improves the cooling performance of the refrigerator.

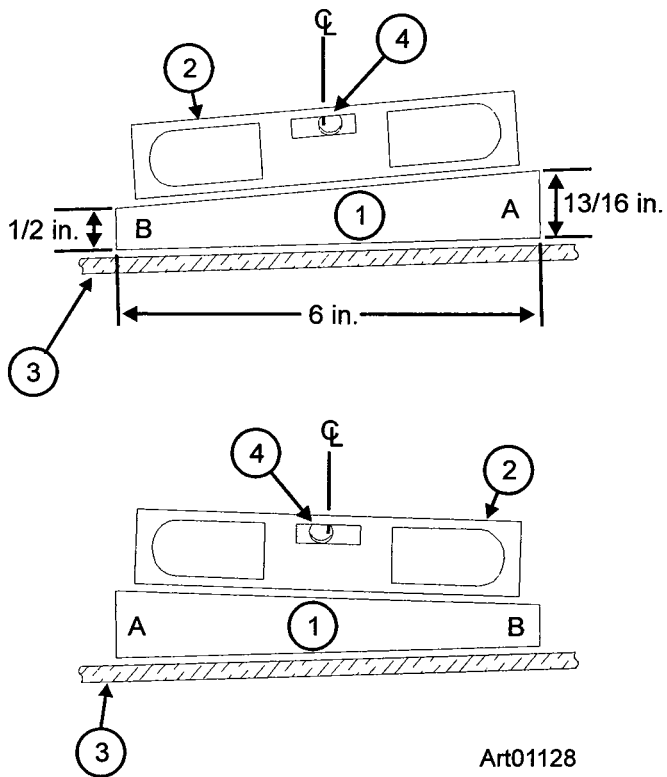
Art01128

Put the wooden block and level on a flat surface in the refrigerator [3] (glass shelf, etc.) so the ends point toward the sides of the refrigerator. Most of the bubble [4] of the level must be to the "A" side of the center line. Turn the wooden block and level end for end. Most of the bubble of the level again must be to the "A" side of the center line.

If most of the bubble of the level is to the "B" side of the center line in either direction, the refrigerator is more than 3° off level side-to-side.

This is a handy tool to make sure the refrigerator is within 3° off level side-to-side (See Art01128). Make a wooden block [1] that is exactly to the dimensions shown. The thickness of the is not important, but the top and bottom surfaces of the wooden block must be flat and smooth. Use an accurate torpedo type level [2].
