SERVICE PROCEDURE

G-05523-R1
February 2006

**SUBJECT: SAFETY RECALL (U.S., EXPORT)
ENGINE GROUND CABLE on certain 7000 and 8000
Series Models built 3/1/2003 thru 7/28/2005 with
Caterpillar® Engines**

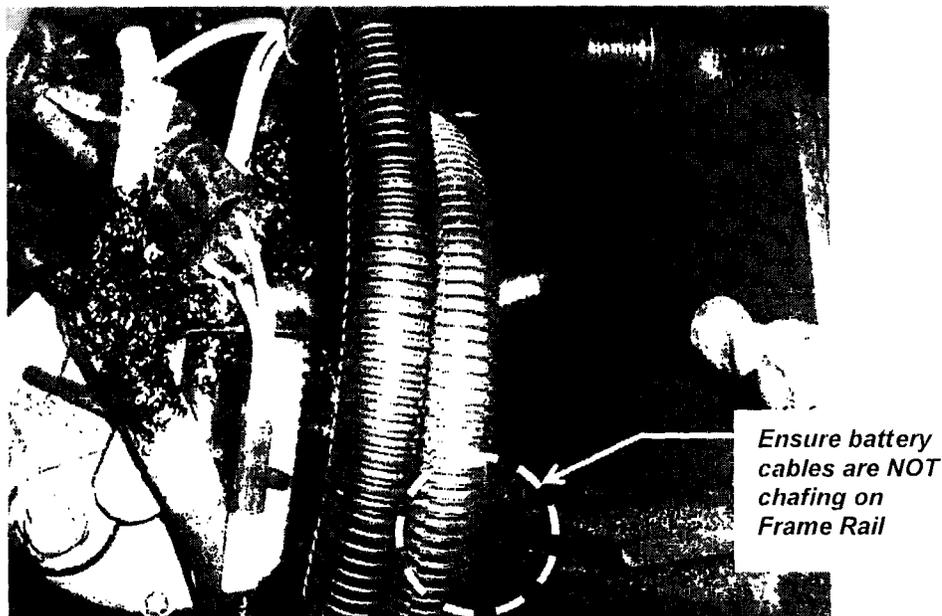
**Figure 3 – Battery Cables to frame rail rub
(Cummins engine shown, however condition may also exist on CAT engines)**

- Regardless of whether or not the saddle clamp was installed, please perform this final inspection on **all** vehicles to ensure the electrical cables are properly routed.
- Please inspect the starter electrical cable routing for rubbing or chafing in the following areas:
 - Battery Cables to frame rail.
 - Battery Cables to FRAME ground cable.
 - Battery Cables to ENGINE BLOCK ground cable .
 - Battery Cables to starter case, starter terminal studs or other starter components and wiring.
 - Battery Positive Cable to BATTERY ground cable.
 - Battery Positive Cable to FUEL FILTER housing.
- It may be necessary to loosen and/or remove a battery cable to re-orient it.
- It may also be necessary to loosen/replace routing/clipping points (p-clamps, extension clips, etc...) to facilitate a no-rub condition.
- See figures below for a representation of rub conditions that require remedied.

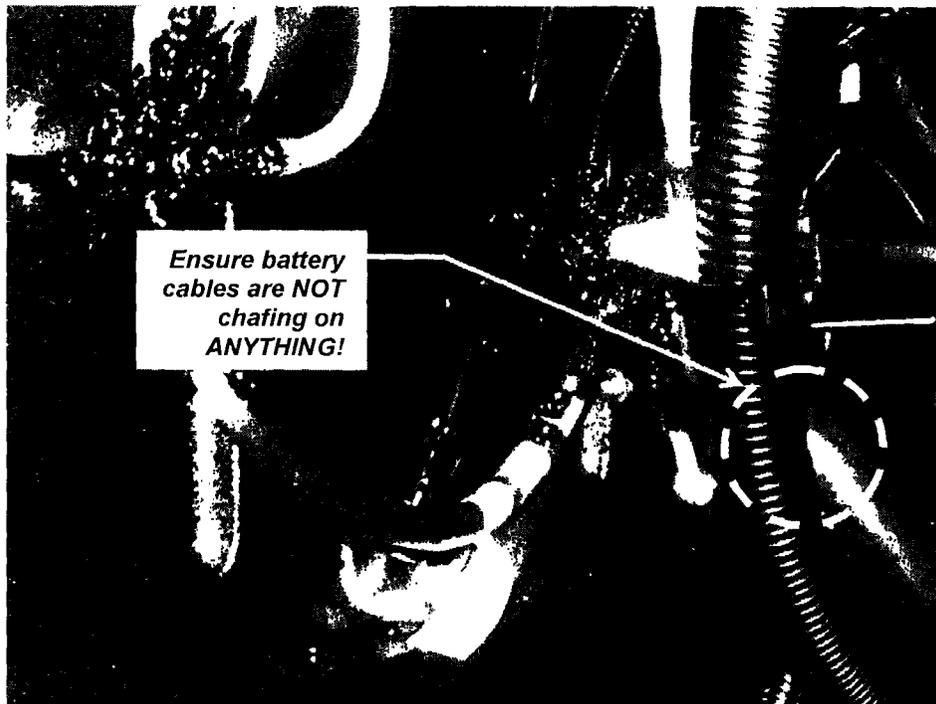
Figure 3d – Battery POSITIVE cables to Battery GROUND cables (Cummins engine shown, however condition may also exist on CAT engines)

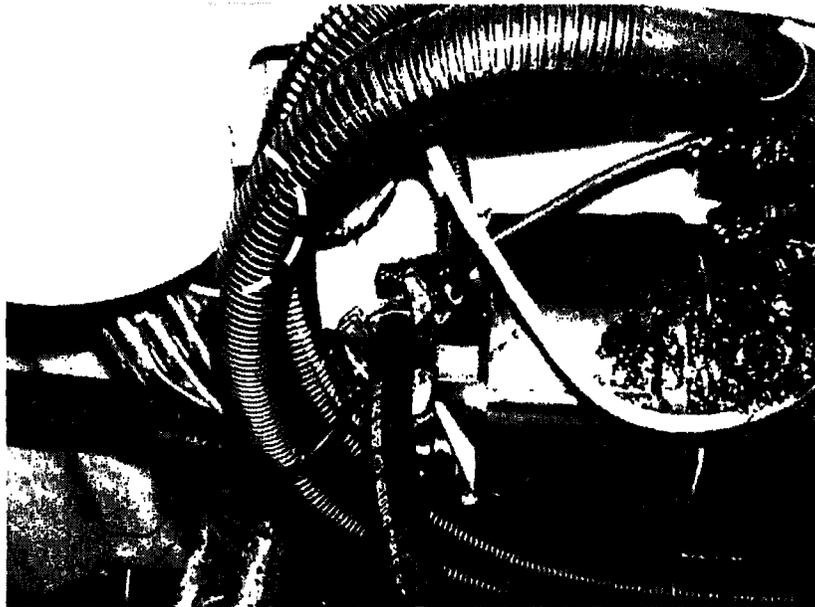
Figure 3e – Battery POSITIVE cables Rubbing on Fuel Filter housing

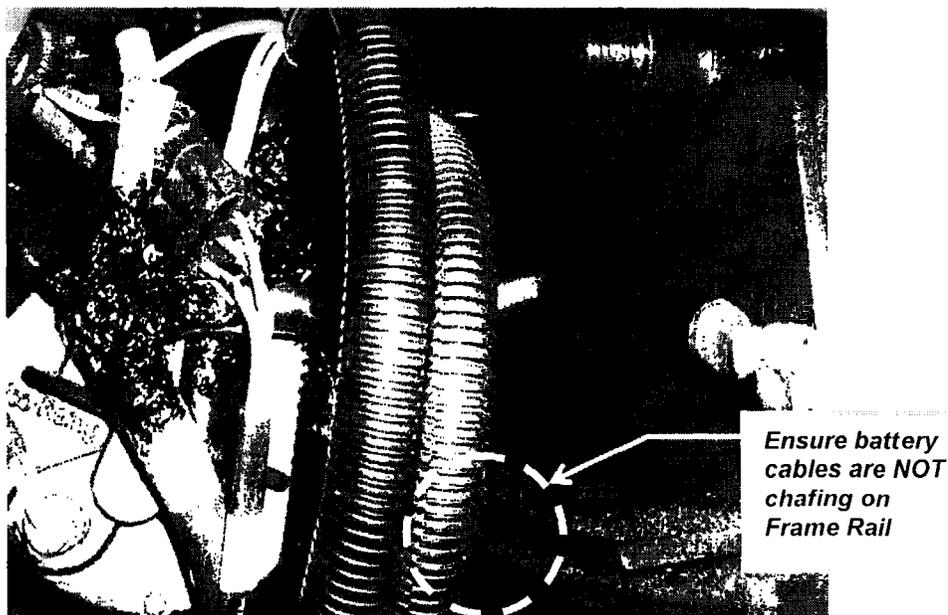
**Figure 3 – Battery Cables to frame rail rub
(Cummins engine shown, however condition may also exist on CAT engines)**

- Regardless of whether or not the saddle clamp was installed, please perform this final inspection on **all** vehicles to ensure the electrical cables are properly routed.
- Please inspect the starter electrical cable routing for rubbing or chafing in the following areas:
 - Battery Cables to frame rail.
 - Battery Cables to FRAME ground cable.
 - Battery Cables to ENGINE BLOCK ground cable .
 - Battery Cables to starter case, starter terminal studs or other starter components and wiring.
 - Battery Positive Cable to BATTERY ground cable.
 - Battery Positive Cable to FUEL FILTER housing.
- It may be necessary to loosen and/or remove a battery cable to re-orient it.
- It may also be necessary to loosen/replace routing/clipping points (p-clamps, extension clips, etc...) to facilitate a no-rub condition.
- See figures below for a representation of rub conditions that require remedied.

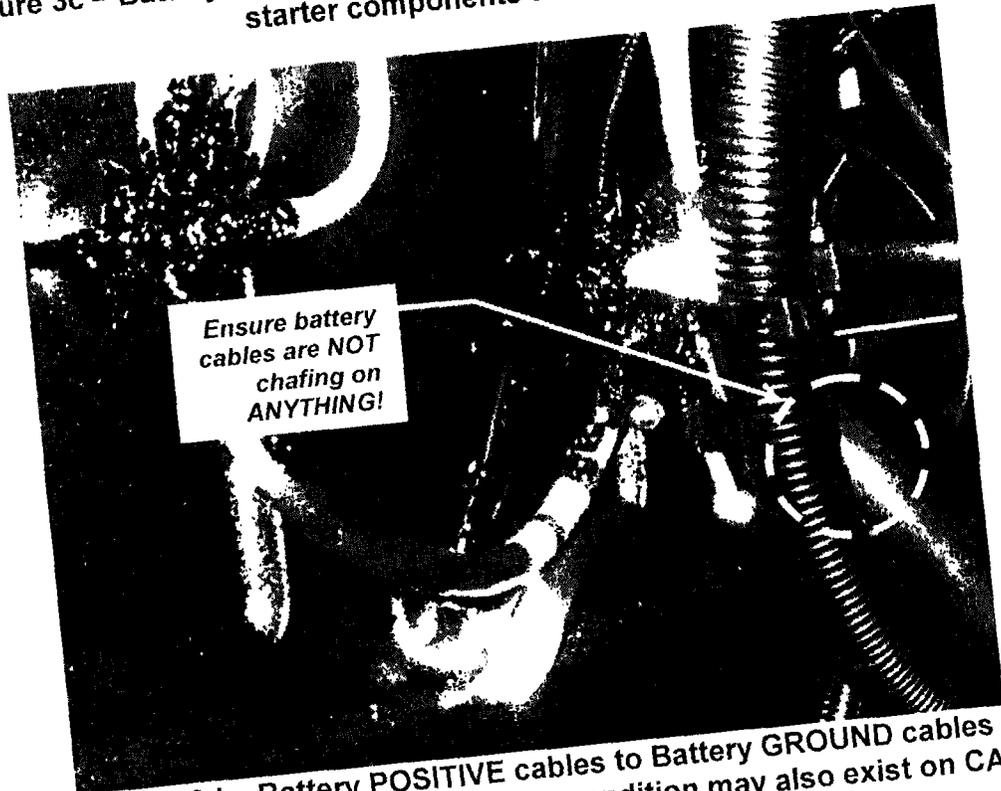
Figure 3d – Battery POSITIVE cables to Battery GROUND cables (Cummins engine shown, however condition may also exist on CAT engines)

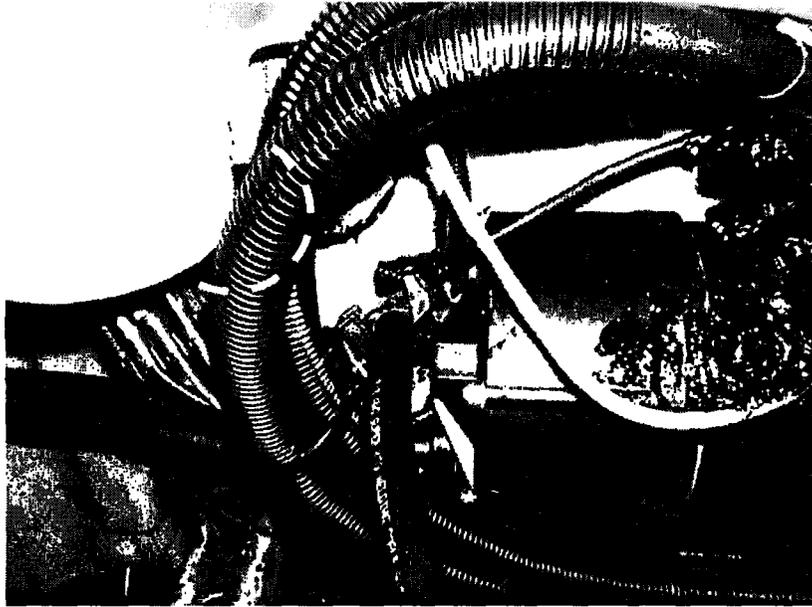
Figure 3e – Battery POSITIVE cables Rubbing on Fuel Filter housing
