# ***SERVICE PROCEDURE***

**G-06504  
July 2006**

**SUBJECT: SAFETY RECALL (U.S., EXPORT)  
FULL POWER PARK BRAKE SYSTEM on 1300 FBC,  
3300, CE and BE Models built 3/17/2004 thru  
5/15/2006 with Feature Codes 0004085 AND  
0004GAW**

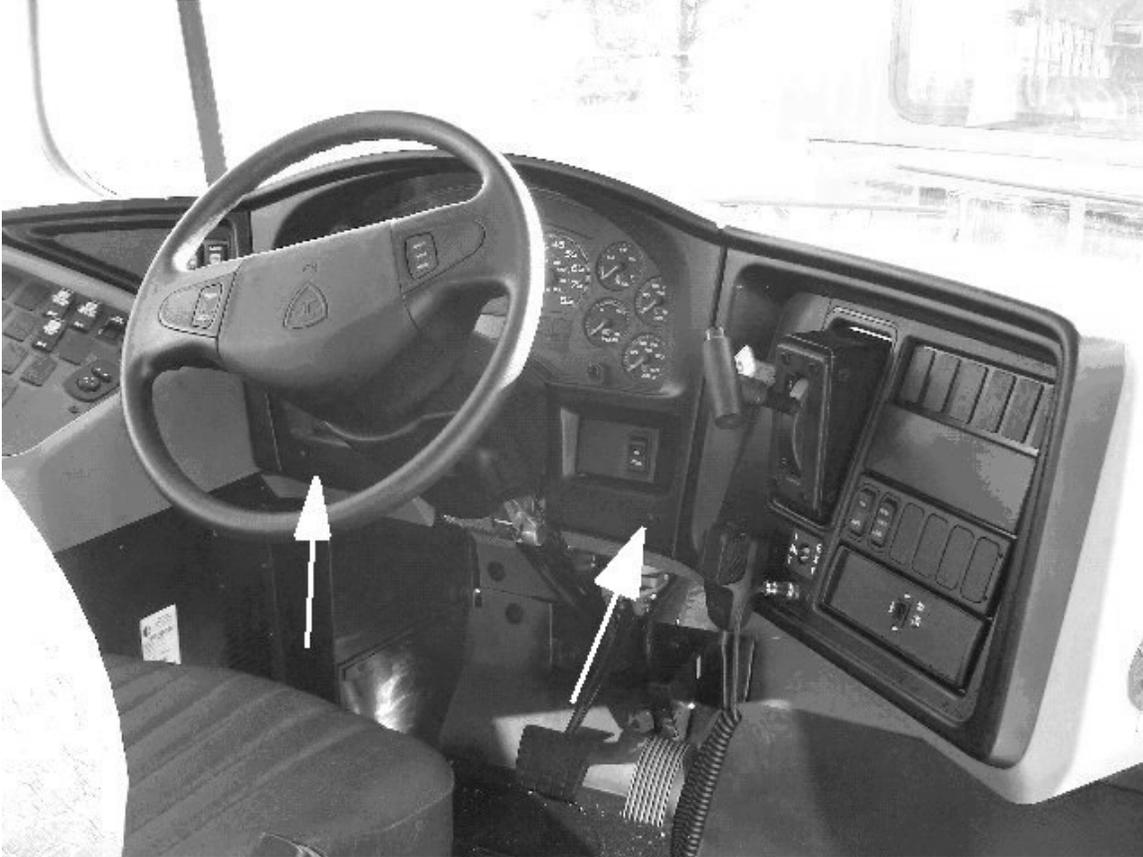
**Figure 1 - Panel Screws Located by Arrows**

1. Disconnect the negative battery cables and the negative engine/transmission control module feeds from the batteries.
2. Remove the center dash instrument surround by removing the two Phillips head screws (Figure 1) on the lower edge and pulling the panel outward at the top.

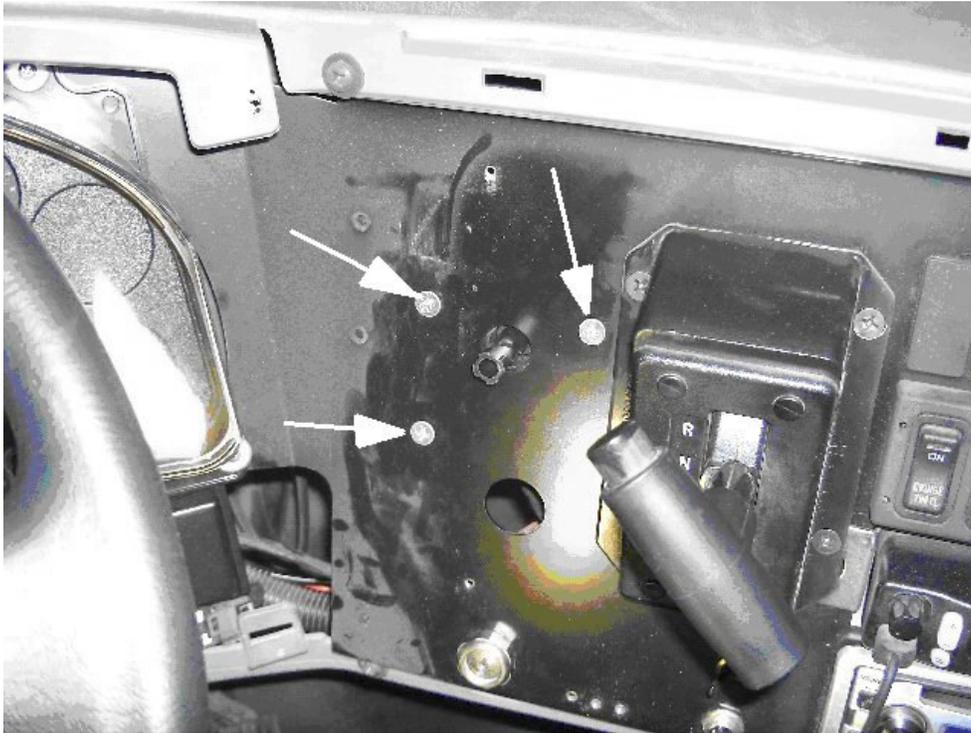
**Figure 2 - Parking Brake Switch Mounting Screws Shown by Arrows**

5. Remove the parking brake switch by removing the three Philips head screws (Figure 2) attaching it to the instrument panel.

- Install the new parking brake switch into the dash with the three Phillips head screws removed in Step 5 (Figure 2).

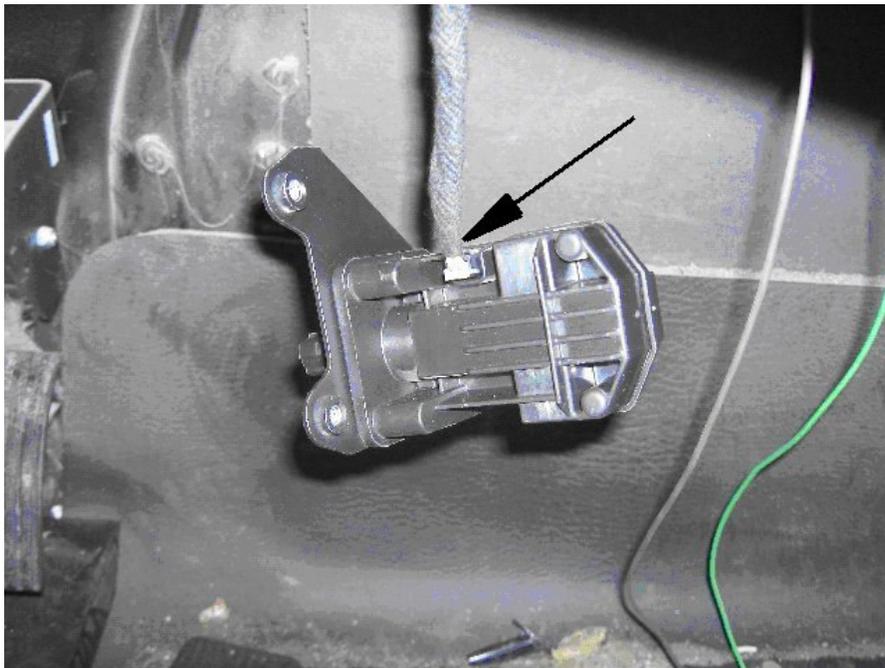
**Figure 3 - Cut Harness at Arrow**

6. Cut the harness feeding the switch right at the switch connector (Figure 3).

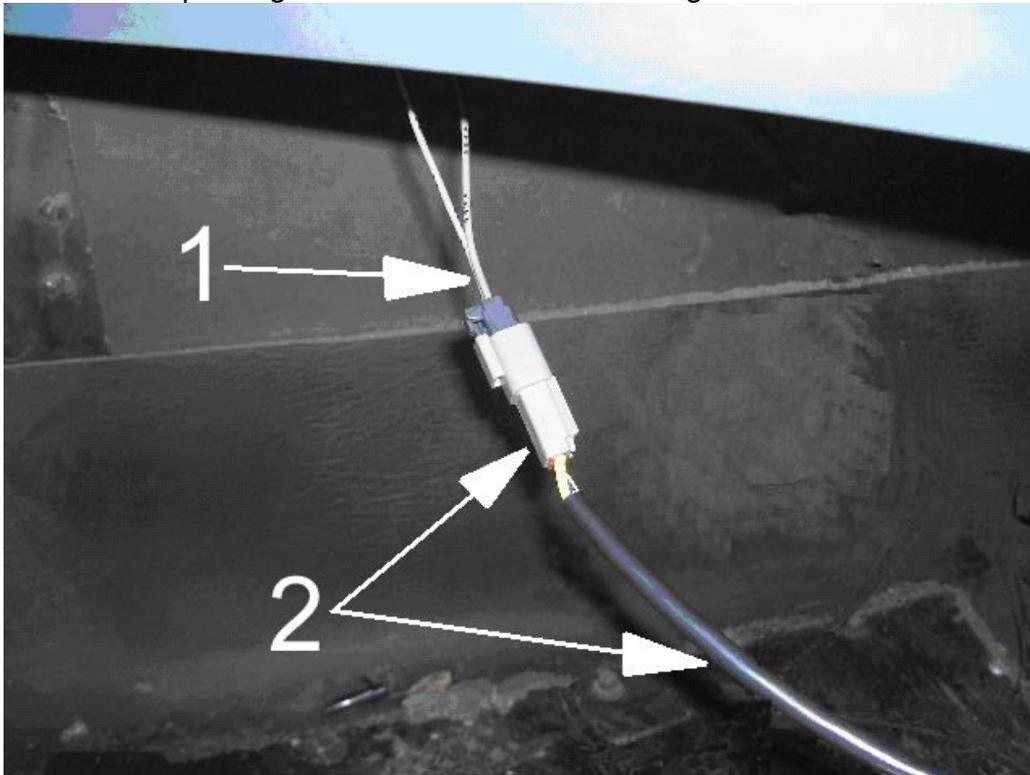
**Figure 4 - Connect New Pigtail to Connector**  
**1. Jumper Harness**  
**2. New Switch and Pigtail**

- Connect the new park brake switch jumper harness to the connector supplied with the new parking brake switch as shown in Figure 4.

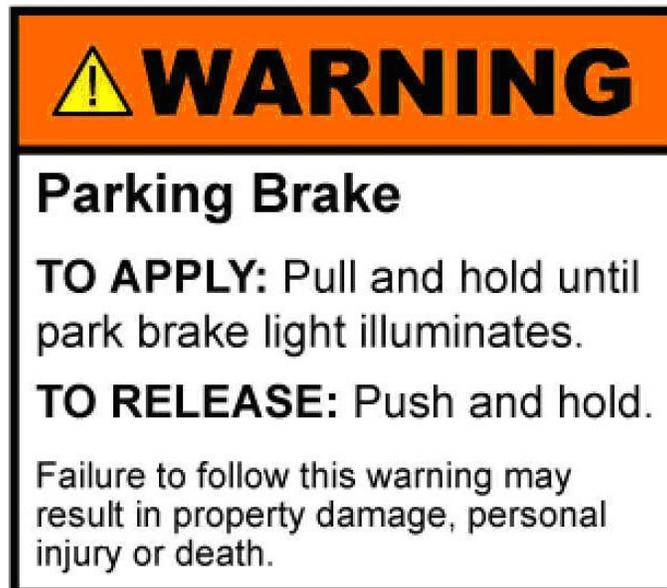
**Figure 5 - New Label**

11. Tie Strap the extra switch harness length behind the dash panel to prevent chafing and/or abrading while providing strain relief on the connector.
12. Re-install the right wing dash surround.
13. Re-install the center dash surround and install the two screws at the lower corners.
14. Re-install the parking brake switch knob previously removed.
15. Clean the area of the dash directly above the park brake knob with a mild degreaser such as rubbing alcohol. Allow dash to dry.
16. Apply one of the new parking brake label shown in Figure 5 to the dash panel immediately above the knob.

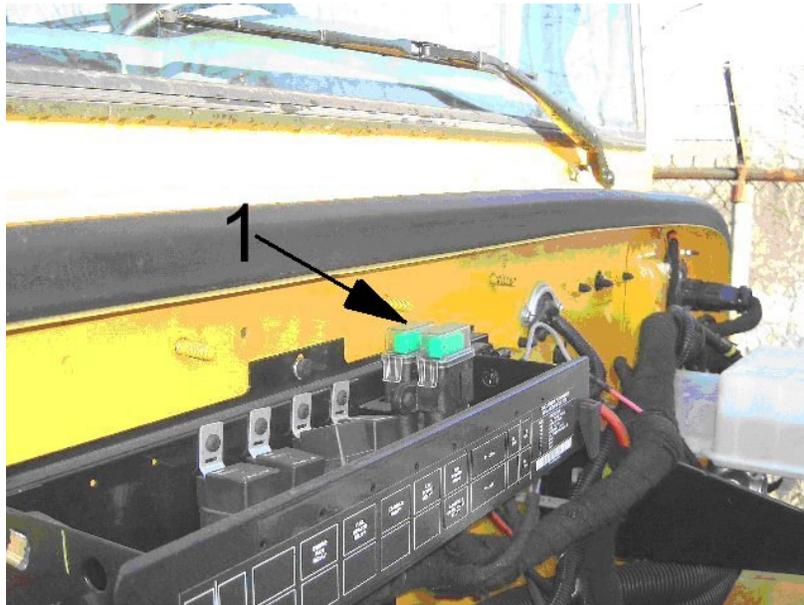
**Figure 6 - Remove Two 30 Amp Pump Fuses**

18. Locate and remove the two 30 amp pump fuses in the engine compartment located above the center of the engine bulkhead. Figure 6 shows the panel with the fuses under the clear plastic covers.

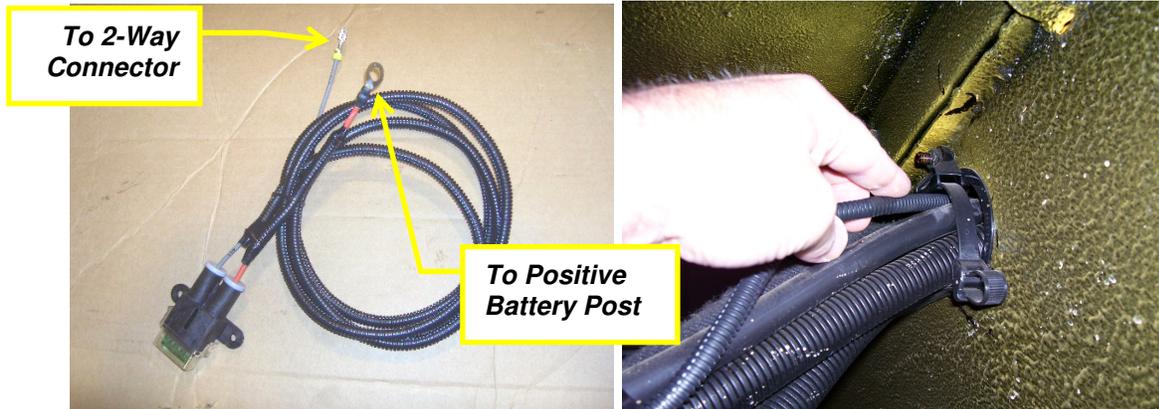
Figure 7 – New Fuse Harness (PN 2591029C1)

19. Refer to harness shown in Figure 7. Insert the single wire lead in conduit with terminal end for 2-way ECU connector from the inside of the battery box through the hole in the inboard side of the battery box.

NOTE: REMOVE FUSE FROM NEW FUSE HARNESS BEFORE....

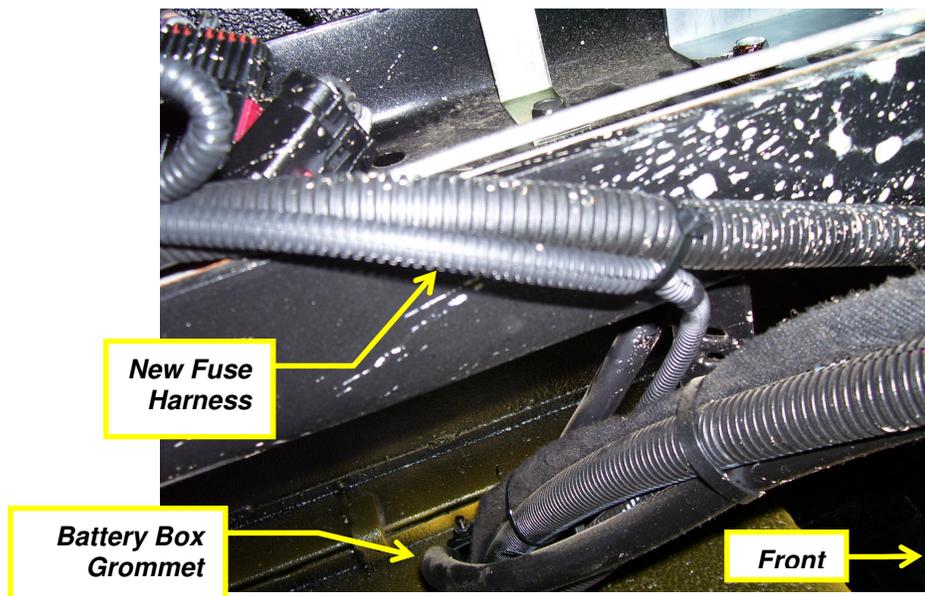
Figure 8

- Strap—lock new fuse harness to battery cables until just underneath the frame rail, then
- Strap—lock to the main chassis harness, following rearward to general location of the brake ECU.

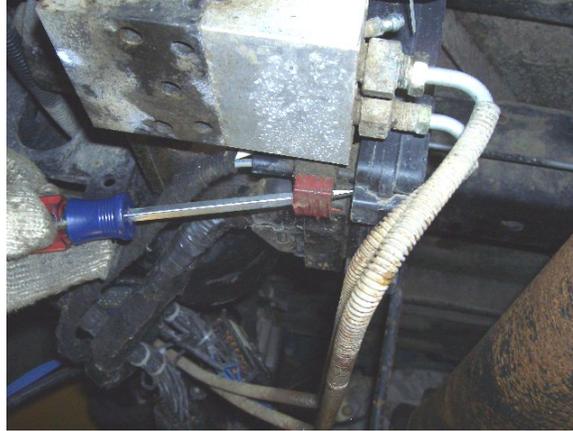
**Figure 9**

21. Release the red connector lock and pull out approximately 2 inches, until you feel the stop, and remove the 2-way connector (9510) at the brake ECU. See Figure 9.

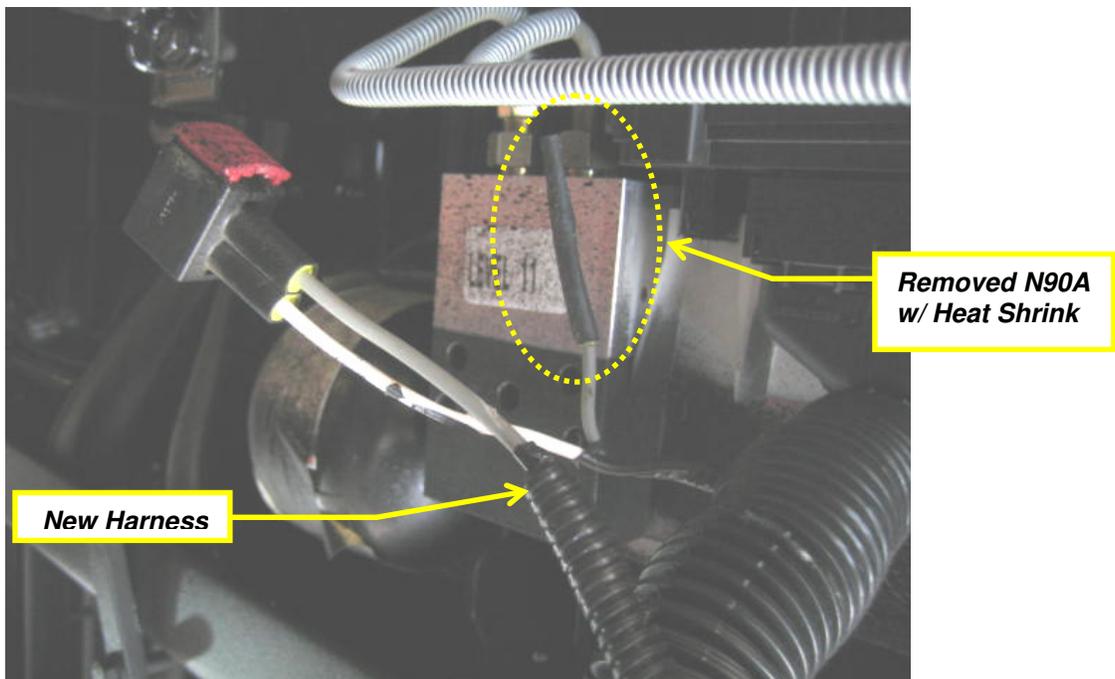
**Figure 10**

22. Remove circuit N90A (gray wire) from cavity 2 using terminal extraction tool (259268C91), remove terminal from end of wire and seal using remaining dual wall heat shrink. See figure 10.

23. Insert the terminal of new fuse harness into the empty cavity (2) of the 2-way connector. Ensure the terminal snaps into place and that the wire seal is properly seated into the connector body.

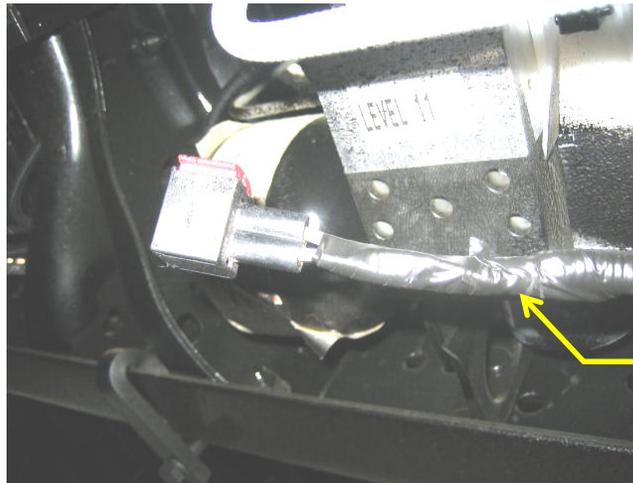
**Figure 11**

24. Use electrical tape to wrap unprotected and removed circuit as shown in Figure 11.

**Wrap all three (3) wires together.**

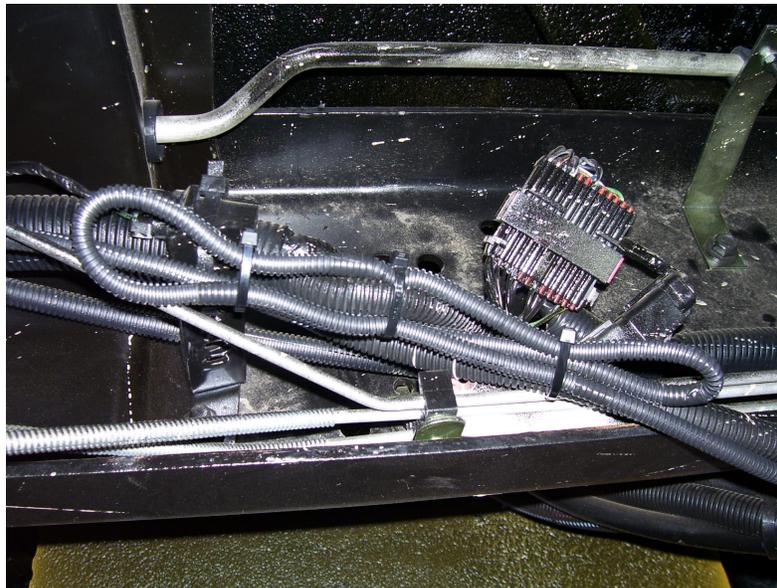
**Figure 12 – Excess Slack**

26. Strap-Lock the new fuse harness between the battery box and the ECU, eliminating any looseness or chafing.

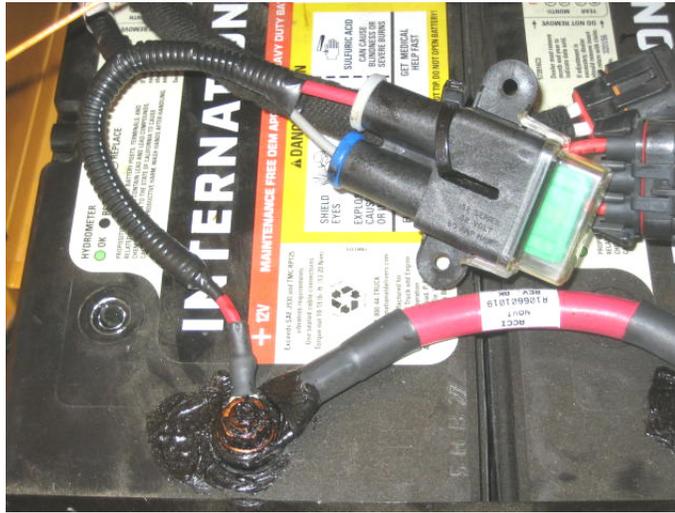
**Figure 13**

27. Route the wire and fuse holder in the battery box and connect the ring terminal to a positive battery post that is ***NOT being used for the starter B+ feed.***

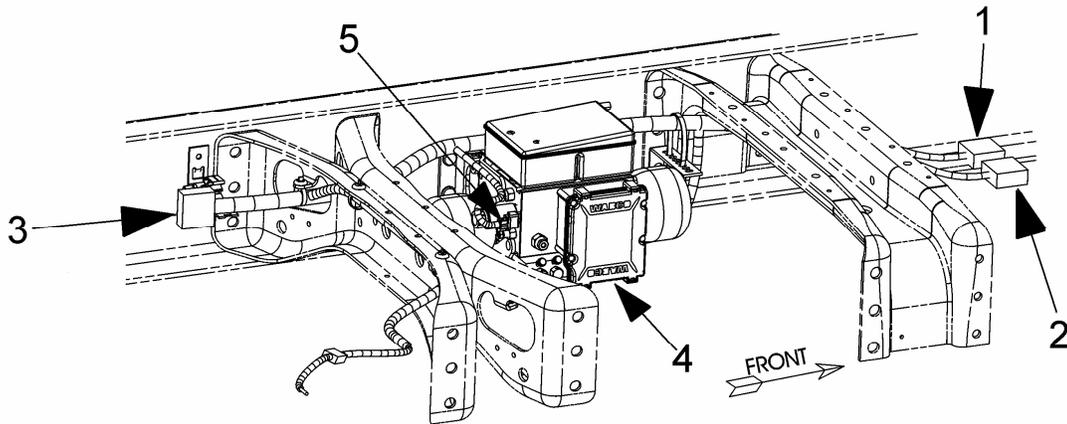
**Figure 14 - Connector locations**

33. Disconnect connectors labeled 1, 2 and 3 in Figure 14 and inspect for corrosion. Replace any corroded terminals.

38. Locate the ECU 31 pin connector labeled item 4 in Figure 14, release the red lock by inserting a screw driver into the end of the lock.
39. Inspect the connector for corrosion. Replace any corroded terminals.
40. Use low pressure air to remove any debris from the connector halves.
41. Make certain that all seals are in good condition and properly located.
42. Apply a light coat of dielectric grease to the connector terminals.
43. Prior to reconnecting adjust harness to provide a drip loop at the ECU to allow for connector strain relief while preventing water from wicking into the connector.

46. Locate the 2-pin supply valve connector labeled as 5 in Figure 14, remove the connector from the valve body.

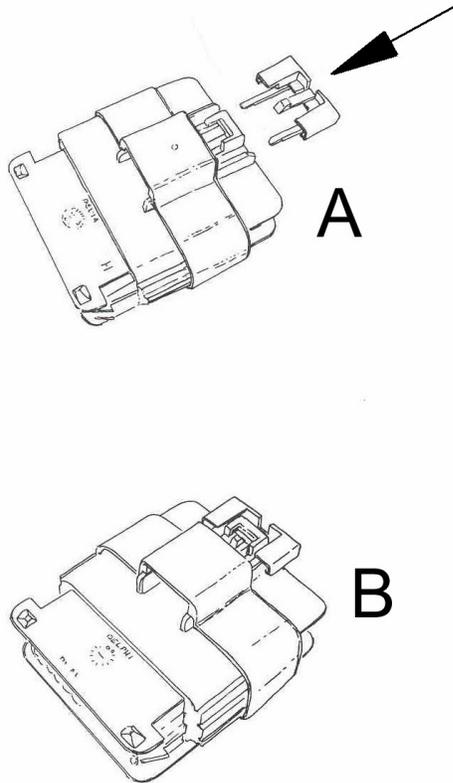
37. Reconnect the connector halves making sure they are properly mated and tight. Install the secondary locks as shown below in Figures 15, Item A and B on the 16-way connectors.

**Figure 15 - Install Secondary Lock into Connector**  
**A. Install Secondary Lock in Direction of Arrow**  
**B. Make Sure Lock is Fully Inserted into Connector**

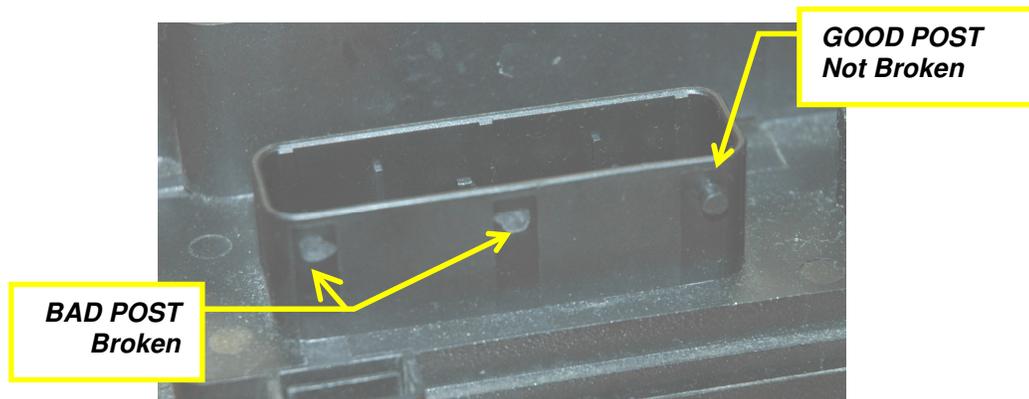
44. Inspect ECU for broken posts. If any posts are missing, contact Technical Services for further instructions.

**Figure 16 – 3 posts on each side – 6 total**

**ALL POSTS MUST BE PRESENT TO CONTINUE**

***NOTE: If ECU has broken posts, please call Technical Services @ 1-800-336-4500, select Option “4,” then option “1,” for further instructions.***

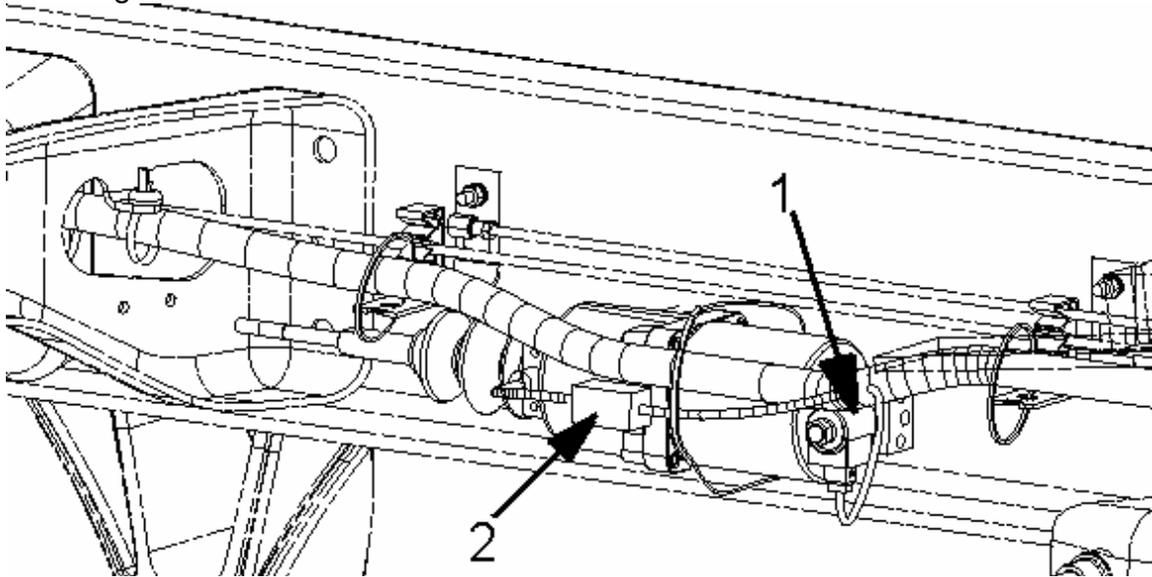
52. Locate the SAHR canister mounted rearward of the power unit as illustrated in Figure 17.

**Figure 17 - Spring Apply Hydraulic Release (SAHR) Canister**  
**1. 9778 Cut Off Valve**  
**2. 9777 Travel Sensor**

53. Disconnect the three pin Travel Sensor connector (9777), Figure 17, Item 2, and the two pin Cut-Off Valve connector (9778), Figure 17, Item 1, from the SAHR canister.

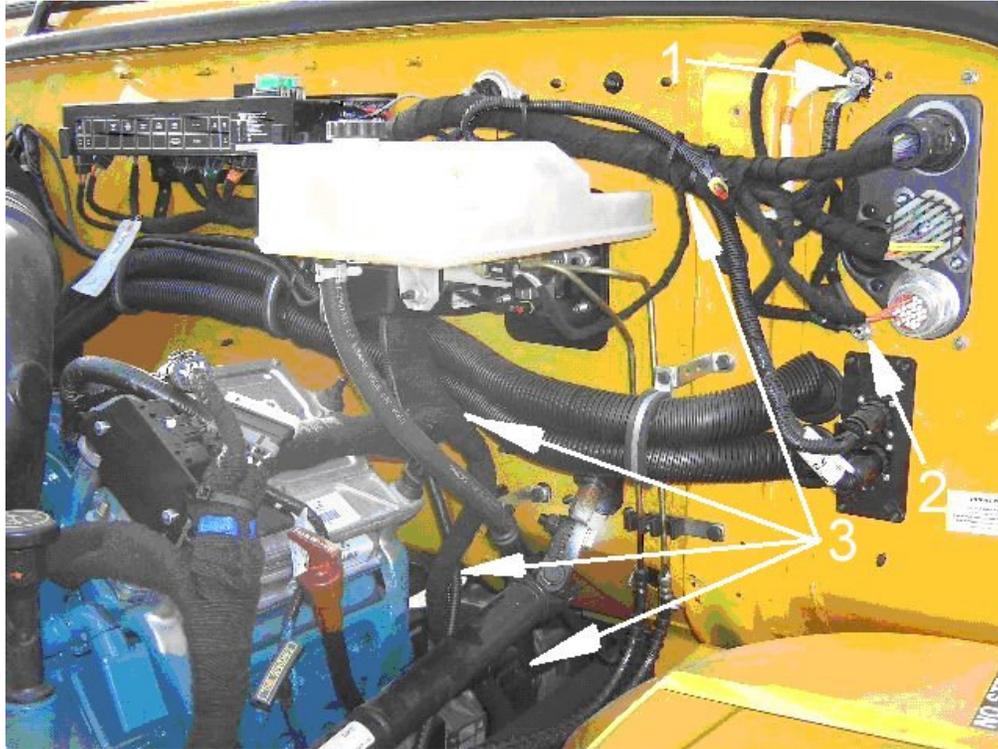
59. Follow the chassis harness from the bulkhead connectors to where it terminates in the two 16-way connectors (or the 14-way and 24-way) inside the drivers side frame rail and inspect for any areas where the harness may be rubbing and/or chafing against other harnesses and/or metal objects that may be wearing the insulation. See Figure 18, Item 3.

**Figure 18**  
**1. Ground Stud**  
**2. Ground Stud**  
**3. Areas Subject to Rubbing or Chafing**

60. Repair and reroute the harness to prevent further wearing of the insulation.

61. Locate and inspect the ground studs shown in Figure 18 (Items 1 and 2). Ensure paint is sufficiently removed from cowl at base of ground stud for proper electrical connection.

70. Locate the two ground studs on the driver's side of the engine bulkhead shown in Figure 18.

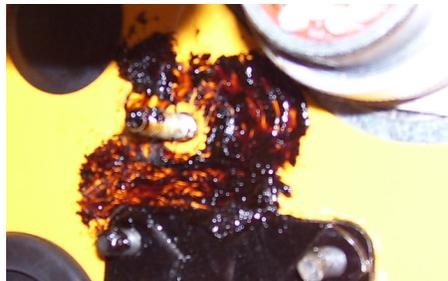
**Figure 18a – Yellow Paint at Base of Ground Stud (Bad)**

**NOTE:** When re-attaching ground studs, ensure stud nuts are tight and that there is sufficient grafo grease on the studs and eyelets to protect the connections from corrosion.

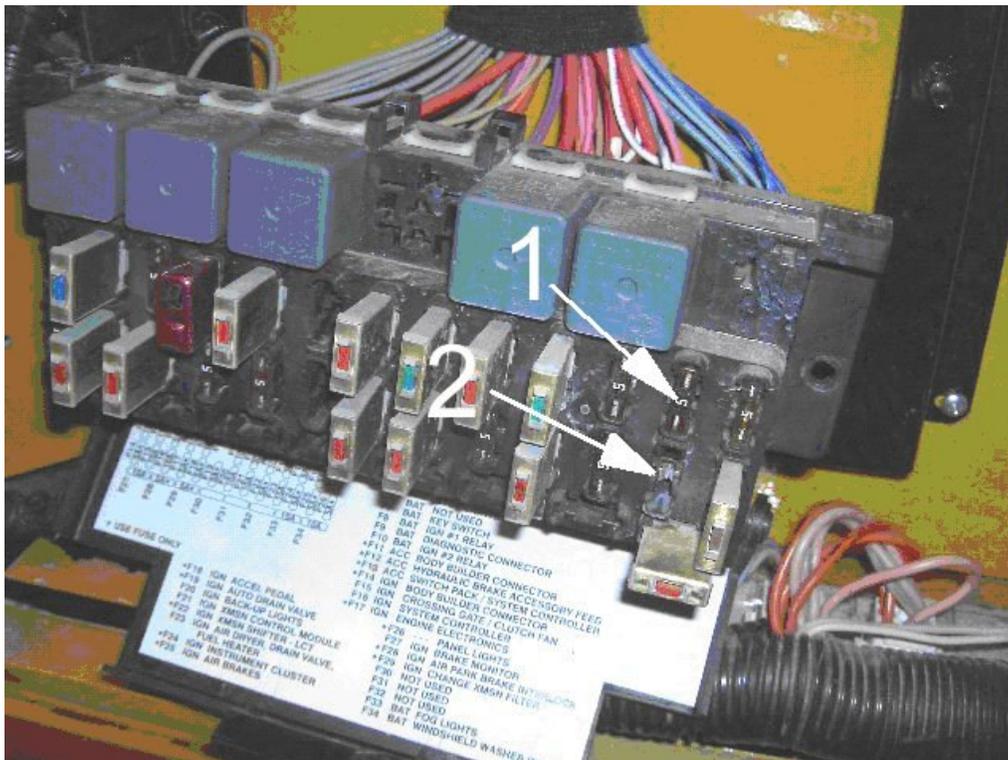
**Figure 19 - Chassis Fuse Block**

65. In the chassis fuse block (left side of panel) verify that there is a 5amp fuse in location F12 and that location F25 is empty as shown in Figure 19.

- 1. Fuse Block Location F12 with 5 Amp Fuse**
- 2. Fuse Block Location F25 (Empty)**

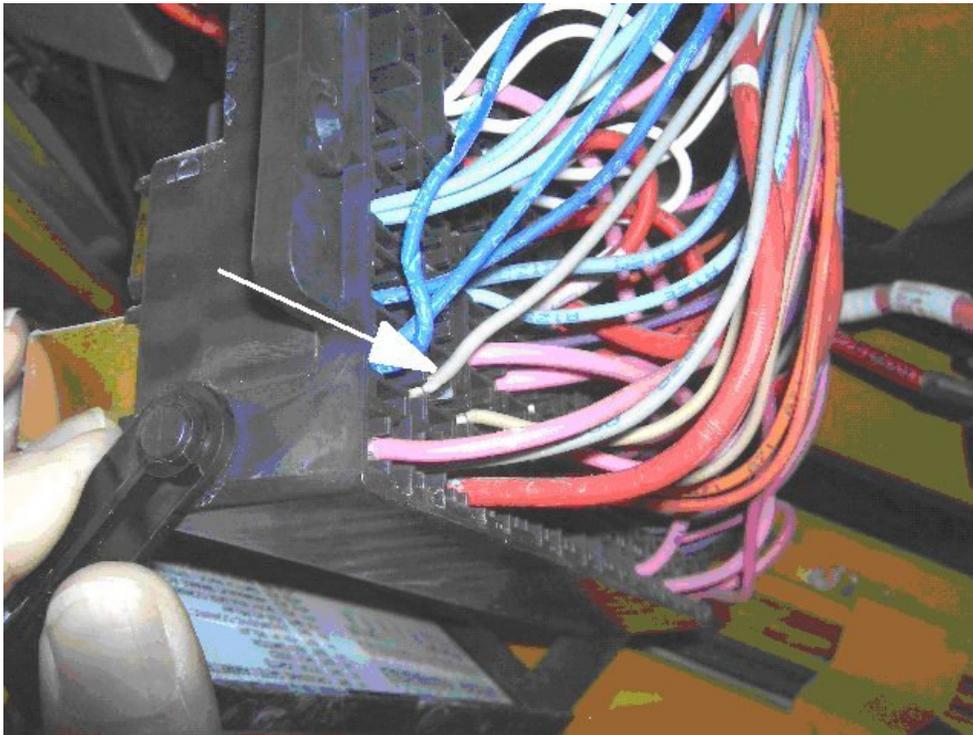
67. From the backside of the fuse block move circuit A90E (gray wire) from cavity F12-B to F25-B. Figure 20 shows circuit A90E after it was moved to F25-B.

**Figure 20 - Circuit A90E Shown in Cavity F25-B (Arrow)**

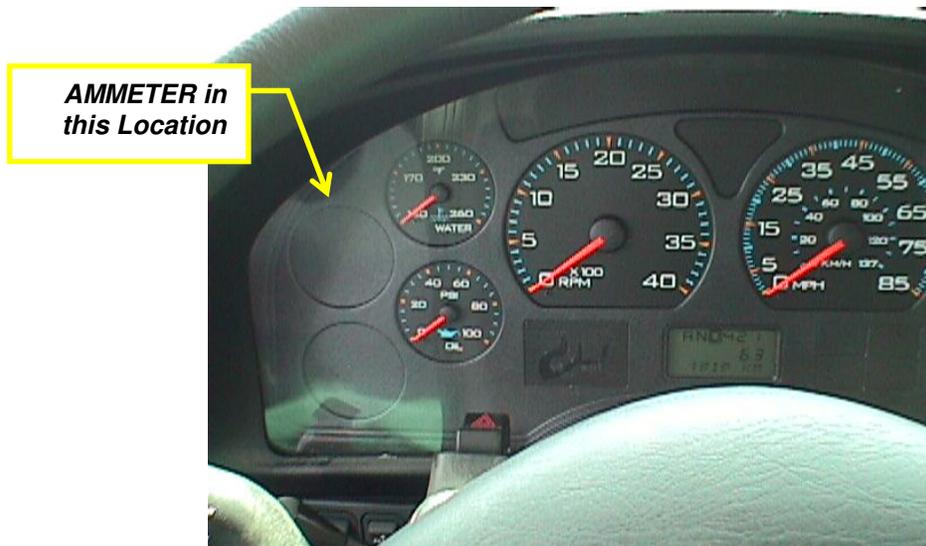
76. Before performing the Wabco Brake ECU re-flash, determine if vehicle's gauge cluster contains an ammeter.

**Figure 21 – This example does *not* have an ammeter**

77. If a vehicle is equipped with an ammeter, please remove its fuse (F4) from the chassis fuse block before continuing with this procedure.

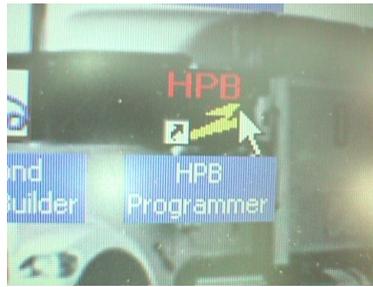
Figure 22

79. Select and run the *HPB Programmer*.

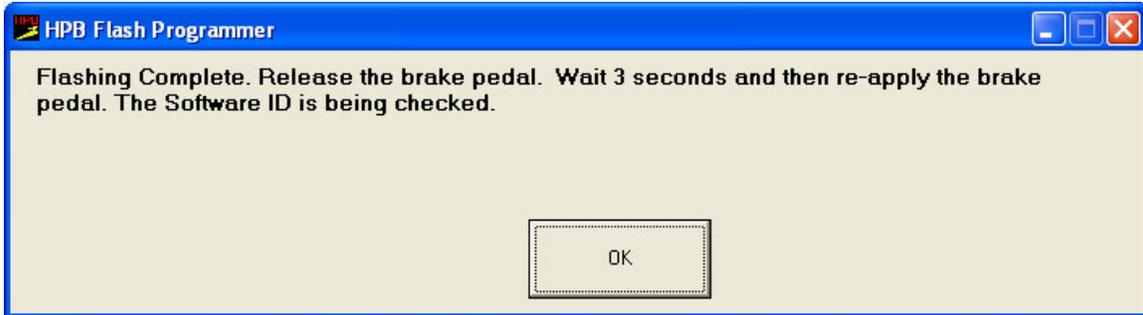
Figure 27

84. When the re-flash is complete, the following screen is displayed.
- Release the brake pedal.
  - Wait three (3) seconds.
  - Re-apply brake pedal.

85. Ensure the Software ID is: **HEAB0007**.
