TECHNICAL SERVICE BULLETIN

Victory Motorcycle

Bulletin Number: V-06-04
Model Years: 2004 & 2005

SUBJECT: Shift Lever Shaft Weld Failure

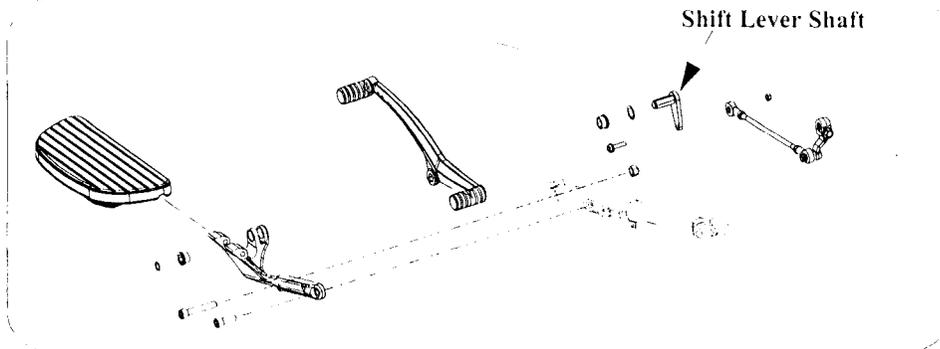
The welded joint on the shift lever shaft may fail, causing the shift pedal to become inoperable. The inability of an operator to shift gears increases the risk of a crash.

1. Contact owners of delivered units immediately and make arrangements to perform this warranty repair.
2. Replace the shift shaft lever shaft on all affected vehicles in your inventory following procedure outlined on page 3. DO NOT operate or sell an affected vehicle until this bulletin has been completed.
3. File a warranty claim for affected units immediately after completion of this bulletin. Follow warranty claim filing procedures on page 2.

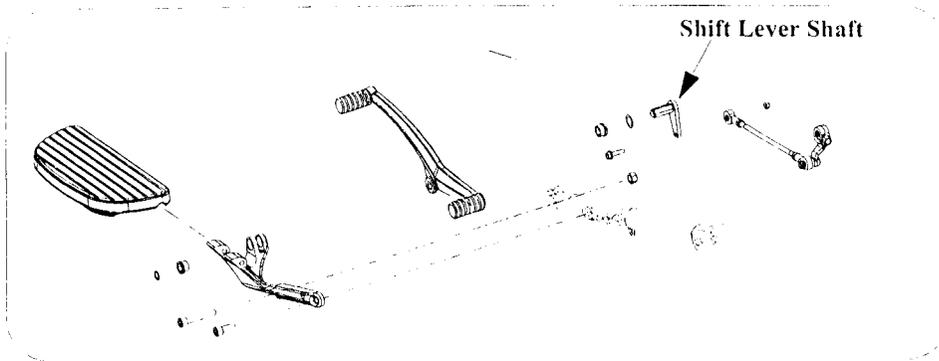
The welded joint on the shift lever shaft may fail, causing the shift pedal to become inoperable. The inability of an operator to shift gears increases the risk of a crash.

1. Contact owners of delivered units immediately and make arrangements to perform this warranty repair.
2. Replace the shift shaft lever shaft on all affected vehicles in your inventory following procedure outlined on page 3. DO NOT operate or sell an affected vehicle until this bulletin has been completed.
3. File a warranty claim for affected units immediately after completion of this bulletin. Follow warranty claim filing procedures on page 2.
