06V-456
(9 pages)

SUBJECT: Campaign #103 –TV STRAP BOLTS

INSTRUCTIONS TO PERFORM CAMPAIGN 103 TELEVISION STRAP BOLTS

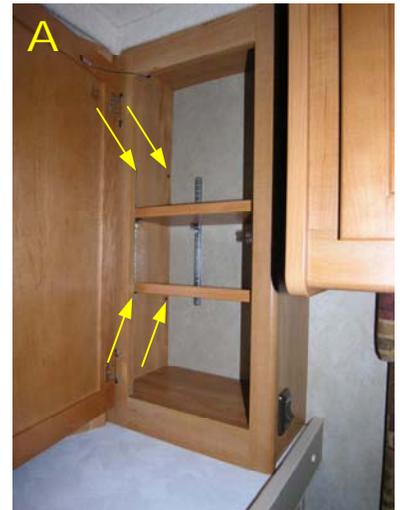
1. Remove the shelves in the cabinet to the right of the television. Unscrew the left side panel in the cabinet. (Photo A)

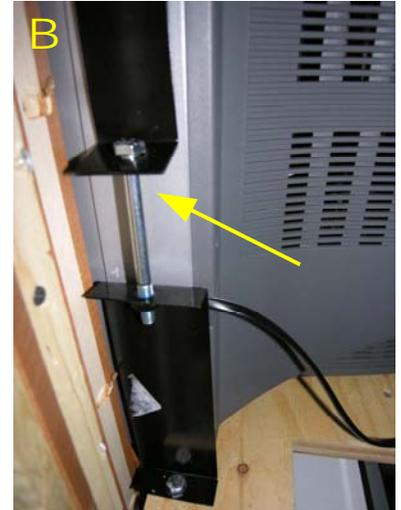
2. Inspect the bolt holding the straps together on the right side of the television. You may want to use a mirror and flashlight to easily see the bolt. (Photo B)
 - a. If this bolt has blue thread lock compound, you may stop. You will not need to perform the campaign. Reassemble the cabinet and submit for inspection only.
 - b. If this bolt does not have blue thread lock compound, you will need to replace all three bolts securing the strap. Continue to Step 3.

4. Remove the bolt holding the straps together on the right side of the television. (Photo B)
5. Remove the television from the cabinet and set aside.
6. Make note of which hole the strap is bolted to on the left side. There are two attachment locations. Remove both straps from the cabinet.

14. Fasten the straps together with the new 4" bolt. (Photo B)
 - a. Hold the lower strap so it will not turn and cause harm to the television casing.
 - b. While tightening the bolt, ensure the strap is tight, but not to the point of causing damage to the television.

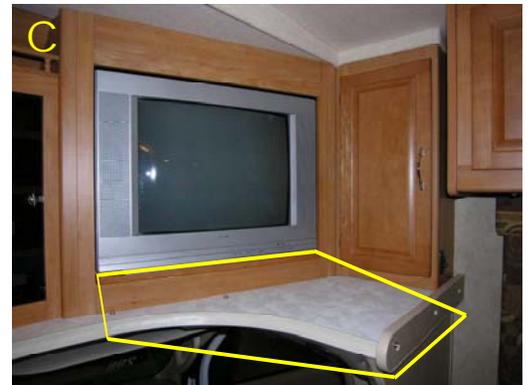
3. Protect the bottom edge of the television cabinet and surrounding areas with masking tape and carpet squares, or equivalent. (Photo C)

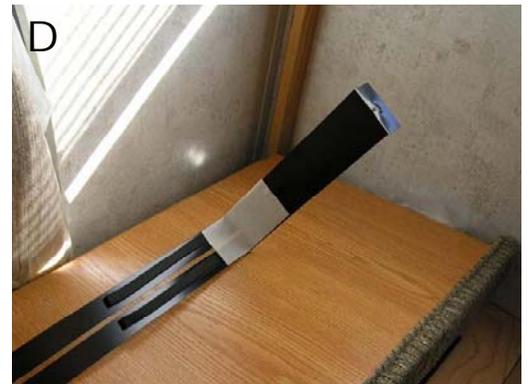
7. Cut the 12" piece of adhesive into two 6" pieces. Remove paper from one side and place adhesive in the corners of the strap. If there is foam tape in the way, cut away the interfering sections. A typical strap has been shown in the picture. (Photo D)
8. Reinstall the right, shorter portion, of the strap with the new 3" bolt. Tighten this bolt all the way down.

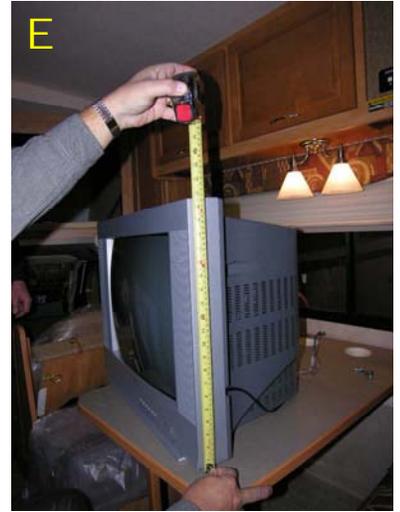
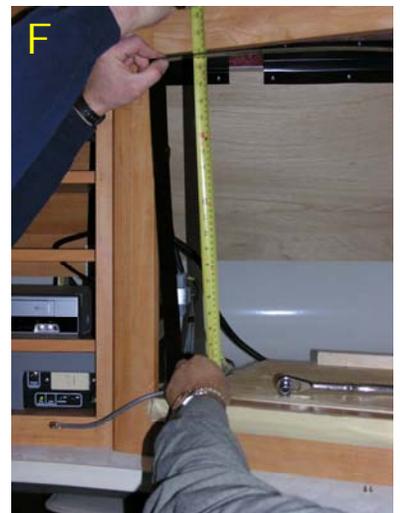
9. Measure the television from the base to the top to ensure proper height for the left strap. (Photo E)
10. Reinstall the left side of the strap with the new 3" bolt. Position it so the top inside corner of the strap is the same height as the television. (Photo F) Make sure to bolt it through the original hole to ensure proper fit.
