Subject: 07066 Product Safety Recall  
Air Compressor Does Not Build Air Pressure

Models: 2007 Chevrolet Kodiak, T-Series  
2007 GMC TopKick, T-Series  
2007 Isuzu F-Series, H Series 7500/8500 Series  
with 7.8L Diesel Engine (RPO LG4/LF8) and Air Brakes (RPO JE4)

# Recall Bulletin

**SUBJECT:** Air Compressor Does Not Build Air Pressure

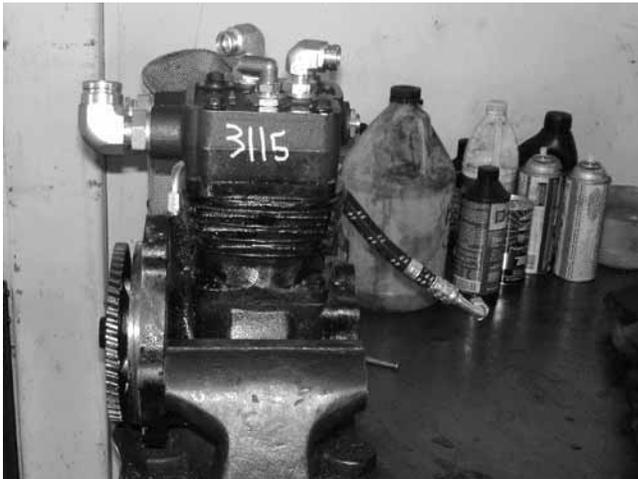
1966484

11. Remove the power steering pump. Refer to *Power Steering Pump Replacement* in SI.
12. Remove the air compressor inlet hose at the air compressor.
13. Remove the air compressor water inlet hose at the air compressor.
14. Remove the air compressor water outlet hose at the air compressor.
15. Remove the air compressor oil inlet hose at the engine block.
16. Remove the air compressor.
  - 16.1 Support the air compressor.
  - 16.2 Remove the air compressor mounting stud nuts.
  - 16.3 Remove the air compressor from the vehicle.

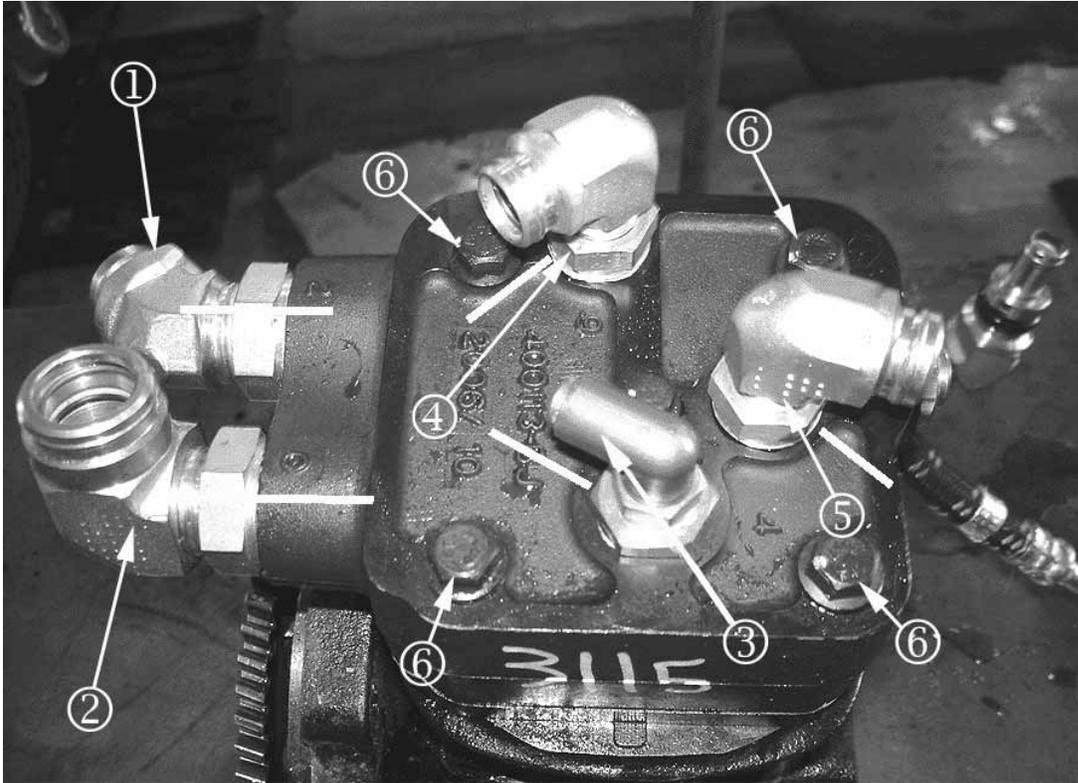
1966476

- (1) Air Discharge
- (2) Air Supply
- (3) Control 1/4 PTC Tube
- (4) Coolant
- (5) Coolant
- (6) Head Bolts

- 18. Note the location and orientation of the fittings on the cylinder head. Mark the location and orientation of the cylinder head fittings with a white marker. Mark both the fitting and the cylinder head. Transfer of these marks and fittings to the new cylinder head is required.
- 19. Loosen the locking nut of the coolant fitting closest to the engine and rotate the fitting counterclockwise to access the top left head bolt.
- 20. Loosen and remove the four head bolts.
- 21. Note the orientation of the cylinder head ports to the engine. Remove the cylinder head/reed plate assembly from the cylinder block. If necessary, insert a lever arm between the reed plate and cylinder block.

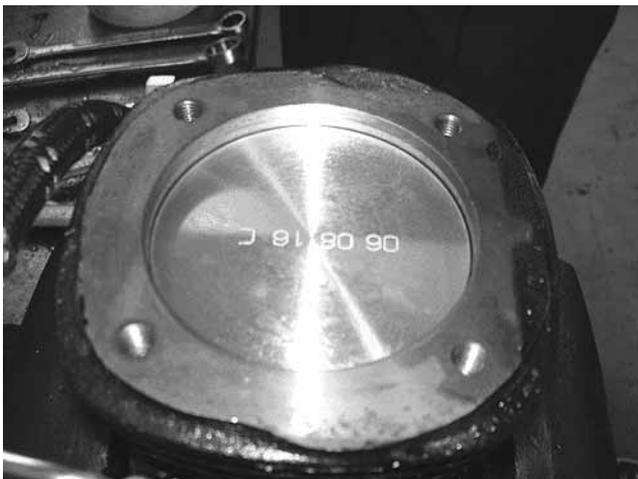
1966480

22. Inspect the cylinder bore and piston for damage or debris. Replace the air compressor if the bore and/or the piston are damaged. The piston and bore in the illustration are not damaged. Refer to *Conditions Requiring Compressor Replacement* illustration in this bulletin.
23. Remove the gasket on top of the cylinder block and discard. If necessary, scrape the gasket from the cylinder block. Use special care to not damage the top of the cylinder block.
24. Loosen and remove the coolant port fittings from the old cylinder head.

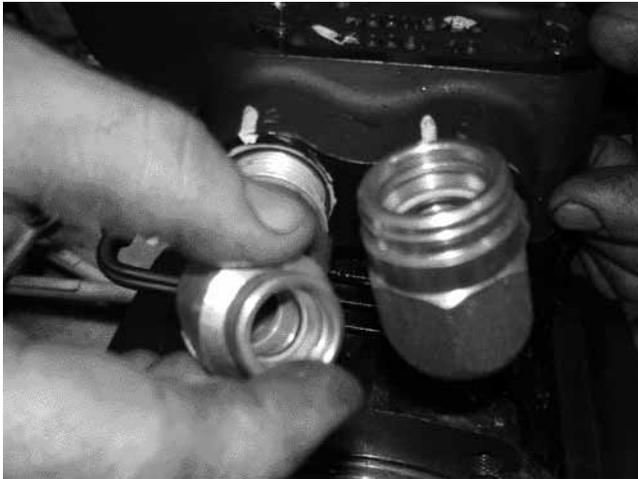
1966473

25. Loosen and remove the air discharge fitting from the old cylinder head.
26. Loosen and remove the air supply fitting from the old cylinder head.
27. Hold the control cap with a 24 mm wrench. Loosen the 90 degree P-T-C control fitting from the old cylinder head.
28. Loosen and remove the safety valve from the old cylinder head.

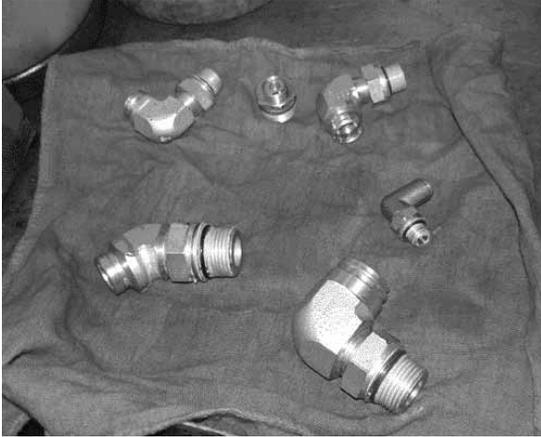
19666481

30. Retrieve the new cylinder head assembly.

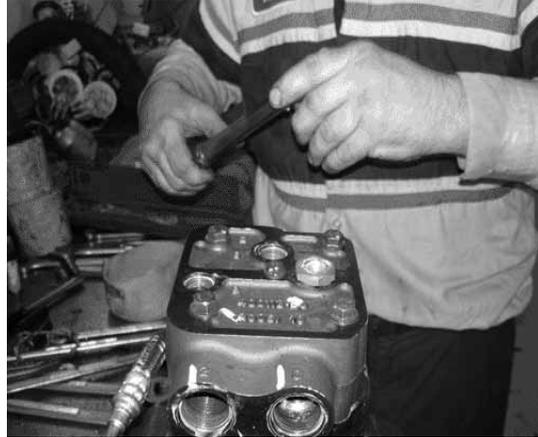
1966483

31. Install the fittings from the old cylinder head to the new cylinder head. Transfer the fitting and orientation markings created in Step 18 to the new cylinder head. Tighten the fittings.

- Coolant fitting to 50-60 N·m (37-44 lb-ft)
  - Air discharge & air supply fittings to 130-151 N·m (96-111 lb-ft)
  - Control fitting to 20-26 N·m (15-19 lb-ft)
  - Safety valve fitting to 58-65 N·m (43-48 lb-ft)
32. Install the cylinder head onto the air compressor.
- 32.1 Ensure that the cylinder bore, piston, and the top of the cylinder block are clean and dry.
- 32.2 Oil the threads of the head bolts with 15W40 engine oil.
- 32.3 Install two head bolts into the new cylinder head assembly.
- 32.4 Install the cylinder head gasket onto the two head bolts until it is flush with the reed plate.

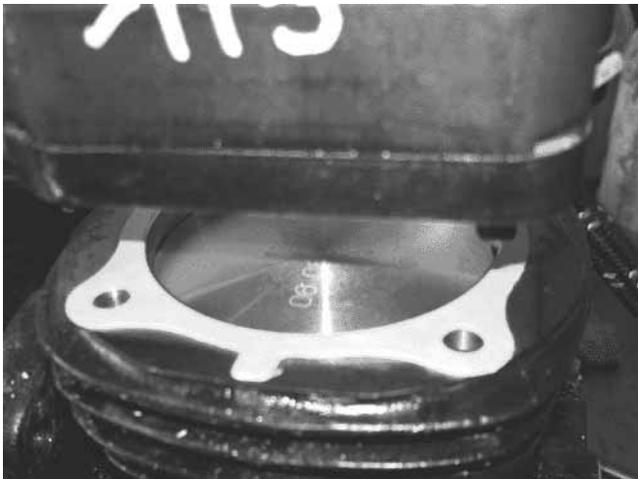
1966475

- 32.5 While holding the gasket against the cylinder head assembly and the two bolts against the cylinder head, orient the cylinder head/head gasket assembly onto the

cylinder block as the original. Align the two head bolts in the thread holes of the cylinder block.

- 32.6 Hand-tighten the two head bolts.
  - 32.7 Install the two remaining head bolts and hand-tighten them.
  - 32.8 Torque the four head bolts to 34-40 N·m (25-30 lb ft) in a cross pattern.
  - 32.9 Torque the center head bolt to 13-16 N·m (10-12 lb ft).
  - 32.10 Rotate the coolant fitting closest to the engine to the proper location,  $38 \pm 5$  degrees
  - 32.11 Tighten the coolant fitting nut to 50-60 N·m (37-44 lb ft).
  - 32.12 Reconnect the air and coolant S-T-C lines to the appropriate cylinder head fittings.
33. Install the air compressor. Tighten the bolts.

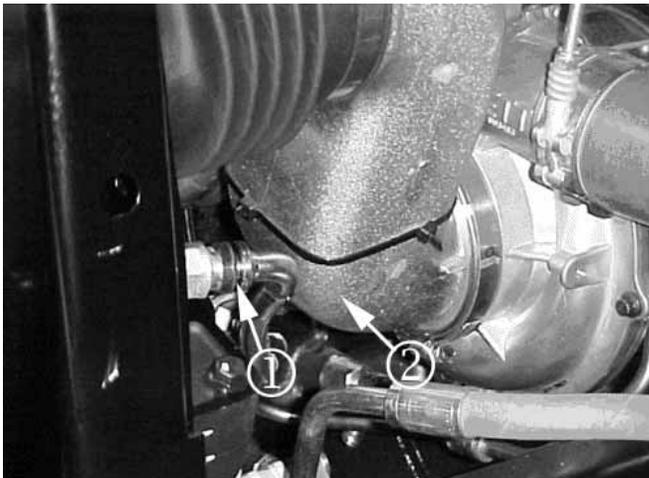
1966478

**Important:** Refer to the illustration below if the vehicle is a tilt cab model equipped with RPO LF8 engine. The LF8 engine CAC duct restricts compressor water inlet fitting accessibility. For ease of installation, the water inlet hose should be connected to the fitting before the compressor is positioned on its mounting studs.

- (1) Water Inlet Fitting
- (2) Charge Air Cooler Duct (CAC)

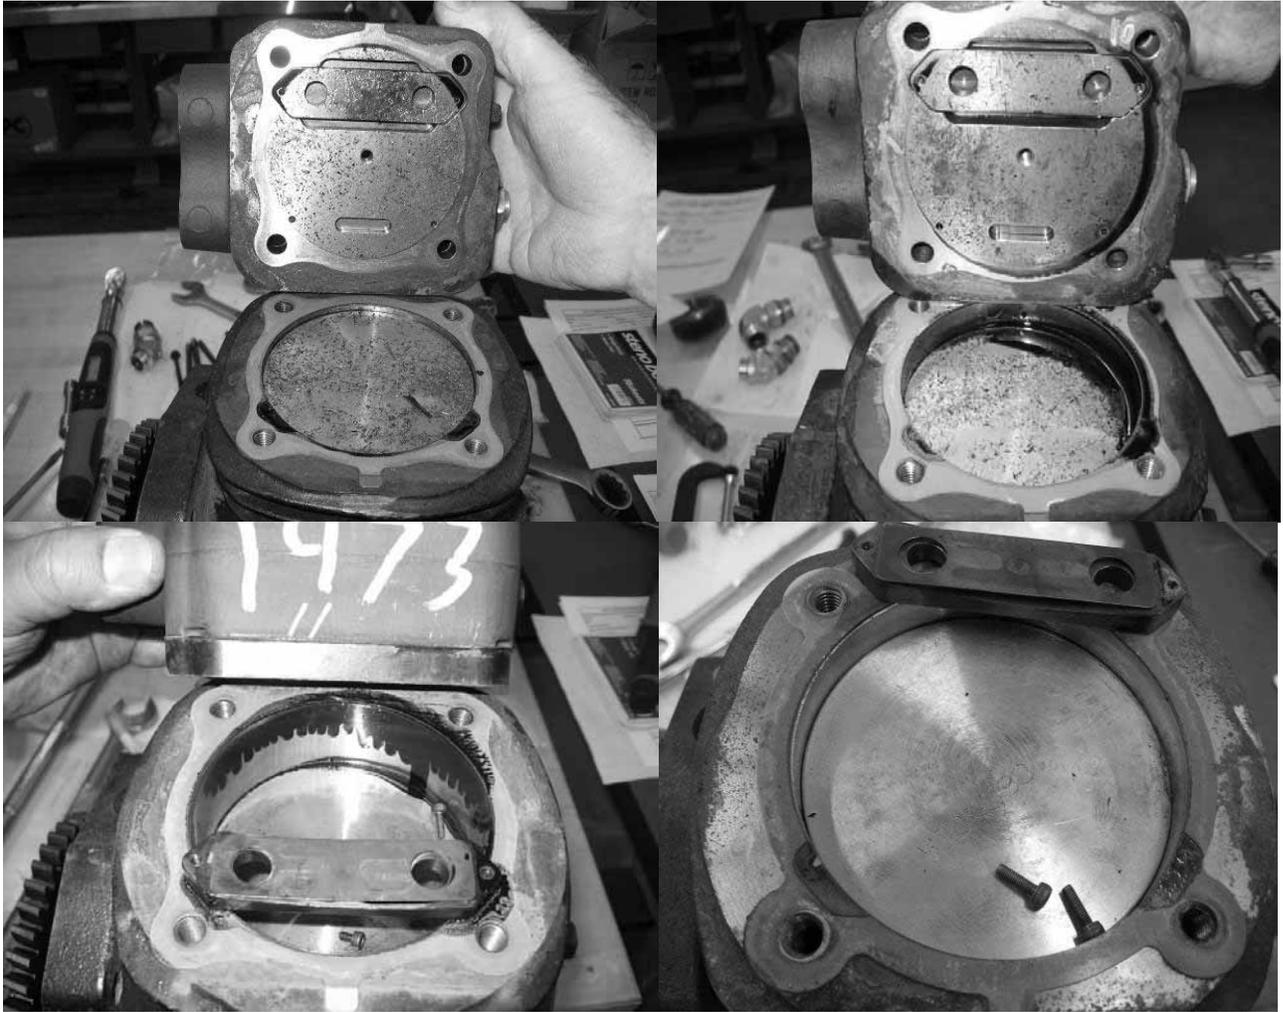
1966486

## Conditions Requiring Compressor Replacement

1. Refer to the text and illustrations above to determine if the air compressor must be replaced. Do not install a new cylinder head on an air compressor with a damaged piston or cylinder. If the piston or cylinder is damaged, the whole air compressor must be replaced. Inspect the piston and cylinder for the following conditions:
  - Loose parts and/or bolts, nuts, washers lying on top of the piston.
  - Ground-up metal debris deposited on top of the piston and/or pitting of the piston top and/or underside of the reed valve plate.
  - Ground-up metal debris deposited on top of the piston and/or visible score marks on the cylinder wall.

Do **not** replace the whole air compressor **unless** there is damage to the piston and/or cylinder bore of the air compressor. Refer to *Conditions Requiring Compressor Replacement* in this bulletin.
