Service Bulletin

SAFETY RECALL

2001-2012 GL1800/A Secondary Master Cylinder Inspection/Replacement

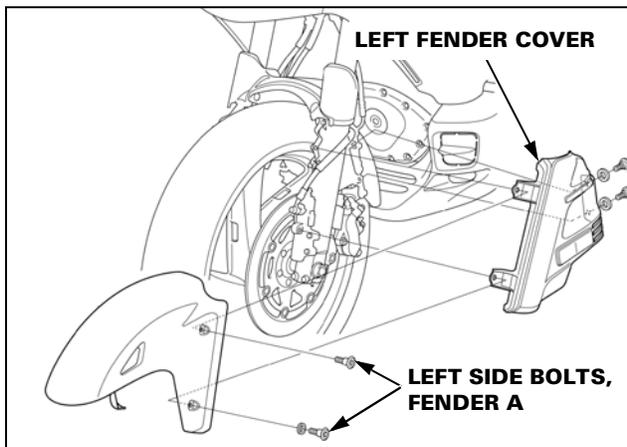
1. Remove the mounting bolts from the left side of front fender A and then remove the left fender cover as shown.

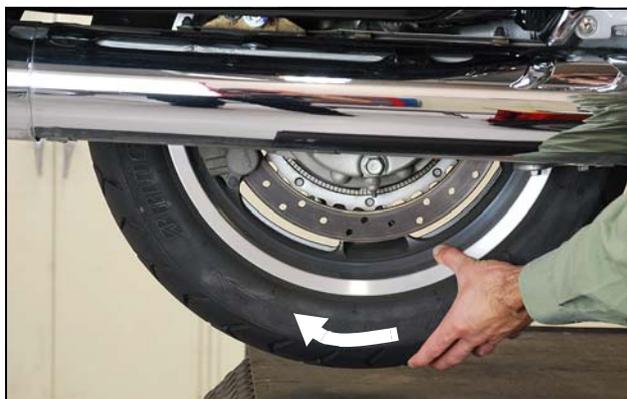
2. With the motorcycle on its centerstand, rotate the rear wheel with your hand and note the amount of drag on the rear wheel. This will be a reference point for Step 10.

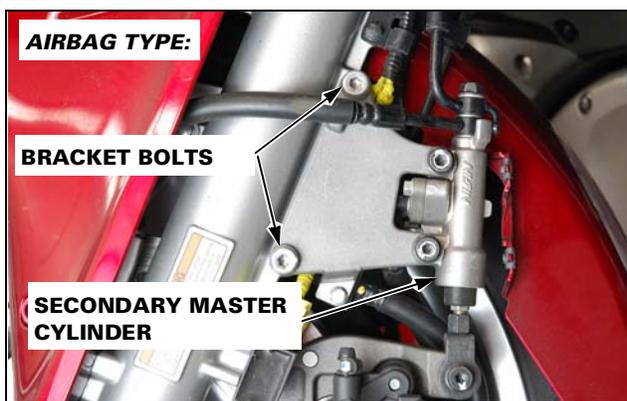
- 3A. *Airbag type only*, for all other types go to Step 4: Loosen both bracket bolts as shown.

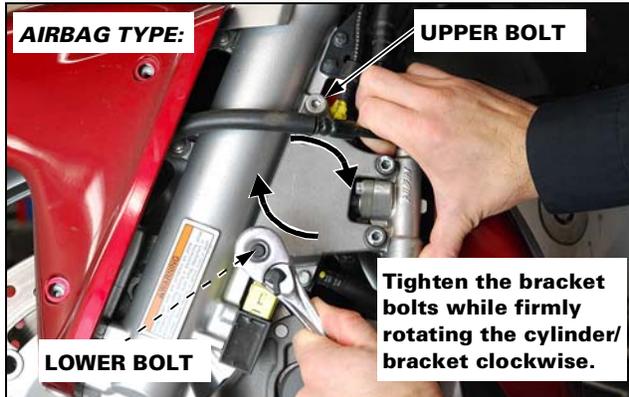
3B. *Airbag type only*; for all other types go to Step 4: Grasp the secondary master cylinder with one hand as shown and firmly rotate the cylinder and bracket in a *clockwise* direction.

While firmly holding the secondary master cylinder and bracket in this position, tighten both mounting bracket bolts.

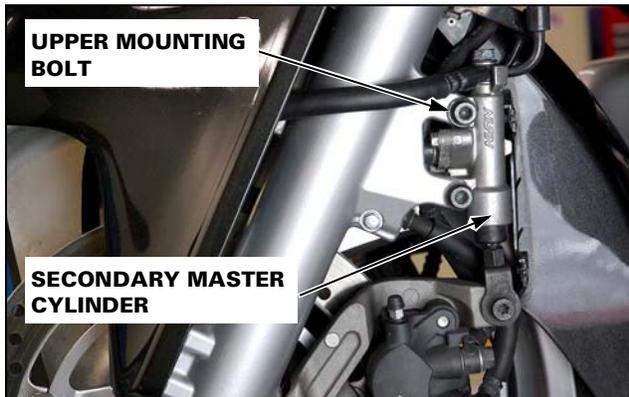
4. Remove the upper secondary master cylinder mounting bolt only.

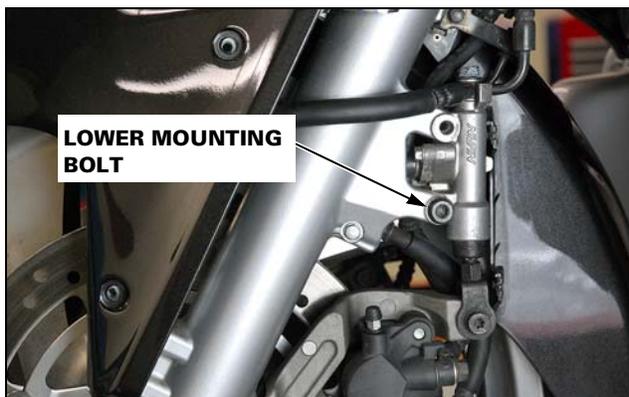
5. Loosen the lower secondary master cylinder mounting bolt by 90 degrees only.

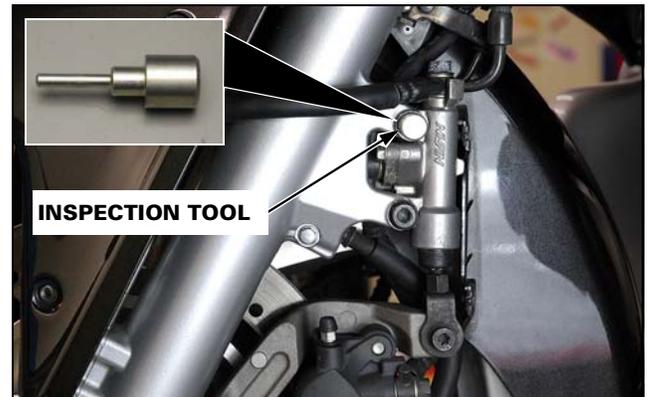
6. Insert the inspection tool into the upper secondary master cylinder bolt hole until it is fully seated, as shown.

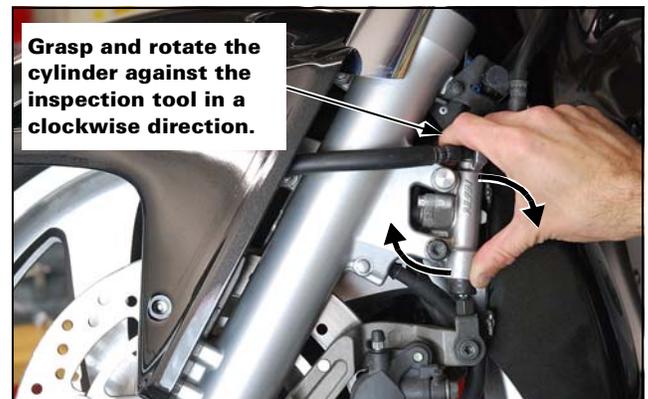
7. Grasp the secondary master cylinder with one hand as shown and firmly rotate the cylinder in a *clockwise* direction.

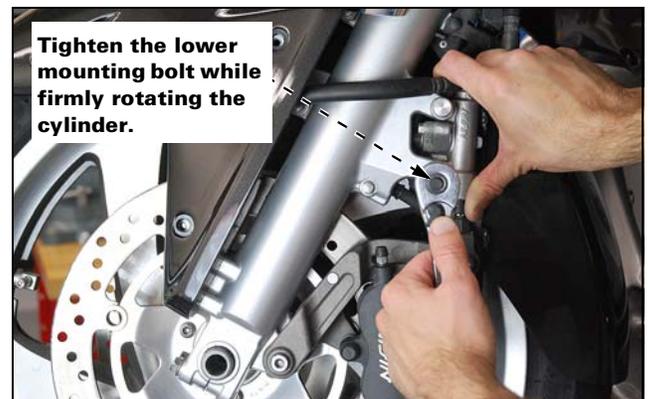
8. While firmly holding the secondary master cylinder in this position, tighten the lower cylinder mounting bolt as shown.

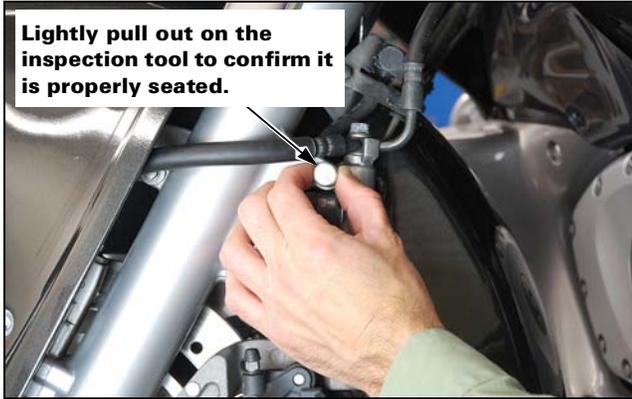
9. Grasp the inspection tool and check the tension by pulling lightly on the tool as shown. The tool should not slip out. If the inspection tool slips out, loosen the lower bolt, repeat Step 8 and re-check the tension.

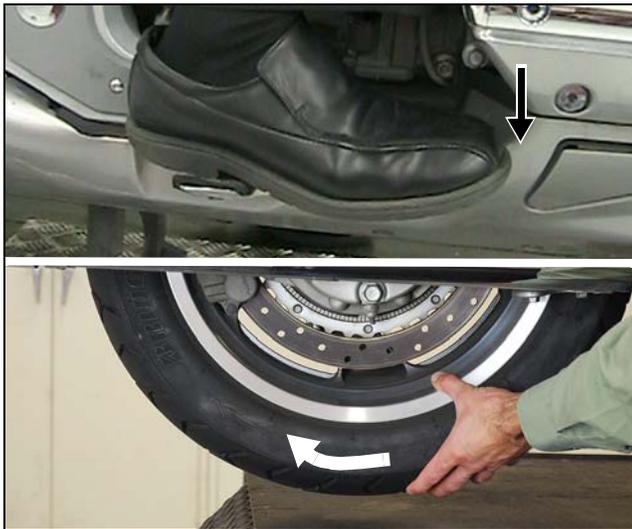
10. Firmly depress and slowly release the brake pedal five times, then release the brake pedal and immediately try to rotate the rear wheel as shown.

- If the rear wheel rotates freely, the secondary master cylinder is OK. Proceed to Step 11.
- If the rear wheel is locked (does not rotate), the secondary master cylinder must be replaced. Proceed to the REPAIR PROCEDURE section of this bulletin.
- If the wheel is not locked, but feels like it has more drag than noted in Step 2, check the drag as shown with a spring scale (T/N: SAMIN12MRP). The rear wheel drag should be no more than:
50 N (5.1 kgf, 11.2 lbf)

If the wheel drag is greater than specified, the secondary master cylinder must be replaced. Proceed to the REPAIR PROCEDURE section of this bulletin.

If the wheel drag is less than specified, the secondary master cylinder is OK; proceed to Step 11.

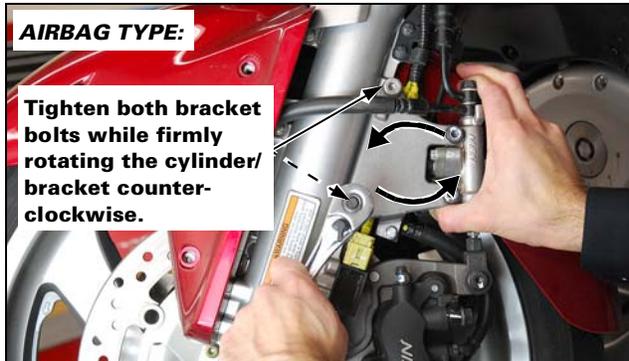
12. *Airbag type only:* If the secondary master cylinder passed the inspection, loosen both secondary master cylinder bracket bolts.

Grasp the secondary master cylinder with one hand as shown and firmly rotate the cylinder/bracket in a *counter-clockwise* direction and tighten the bolts to the specified torque.

TORQUE: 30 N·m (3.1 kgf·m, 22 lbf·ft)

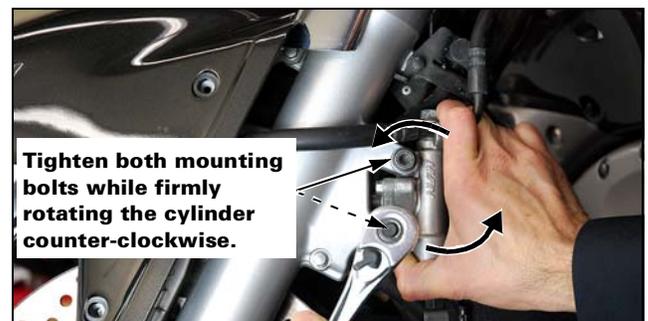
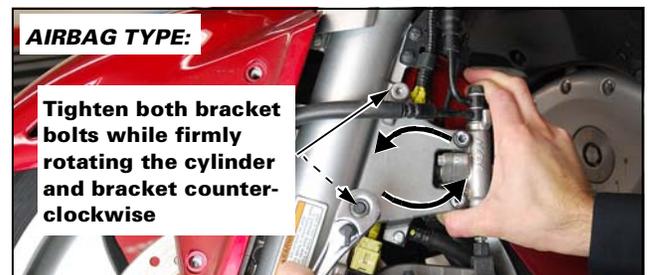
2. Using the procedures in the appropriate Service Manual, install the updated secondary master cylinder set as identified in the PARTS INFORMATION section of this bulletin. To ensure the optimum operating angle for the secondary master cylinder, grasp it (and bracket) with one hand as shown and firmly rotate the cylinder in a *counter-clockwise* direction when tightening the bolts to the specified torque during installation.

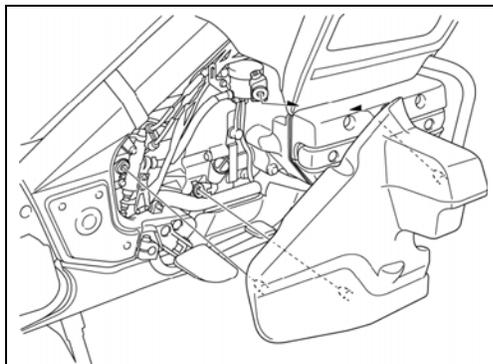
1. Remove the right engine side cover.

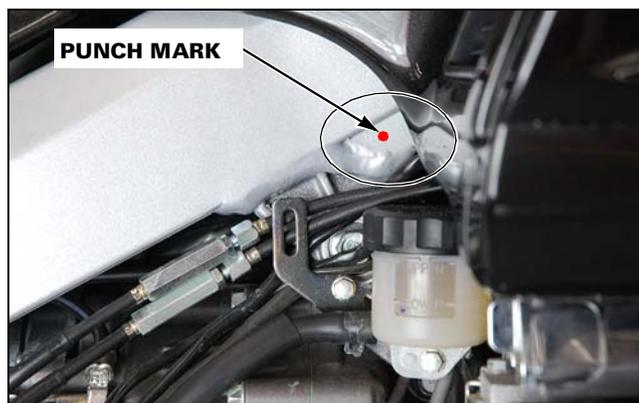
2. Apply a punch mark to the right frame spar, just above the rear master cylinder reservoir. See the following photo for placement.
