ITB12-020

VOLUNTARY SAFETY RECALL CAMPAIGN 2003 – 2004 INFINITI M45 FUEL GAUGE

CAMPAIGN ID#: R1208**NHTSA #:** 12V-088**APPLIED VEHICLES:** 2003 – 2004 M45 (Y34)**NOTE: Use Service Comm to confirm campaign eligibility.**

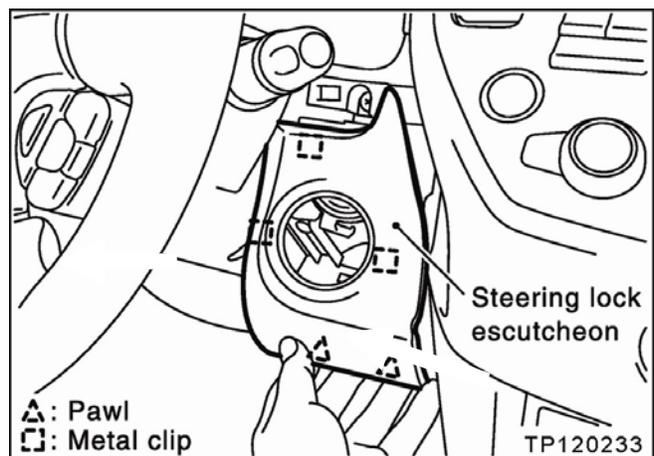
Figure 1

6. Remove the steering lock escutcheon.
 - Pull back to disconnect (snap loose) the clips.
 - Use a plastic trim tool as needed.

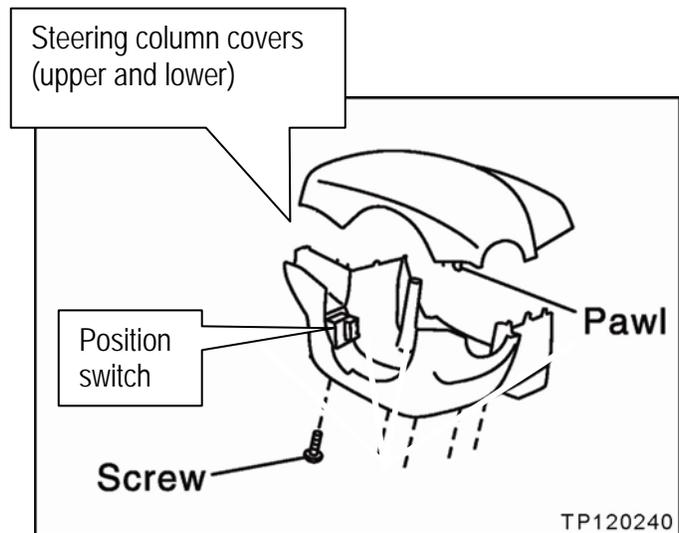
Figure 2

7. Remove the steering column covers.
 - a. Remove the 5 attaching screws.
 - b. Disconnect the electrical connector from the steering position switch (tilt / telescoping switch).
 - c. Remove the covers.

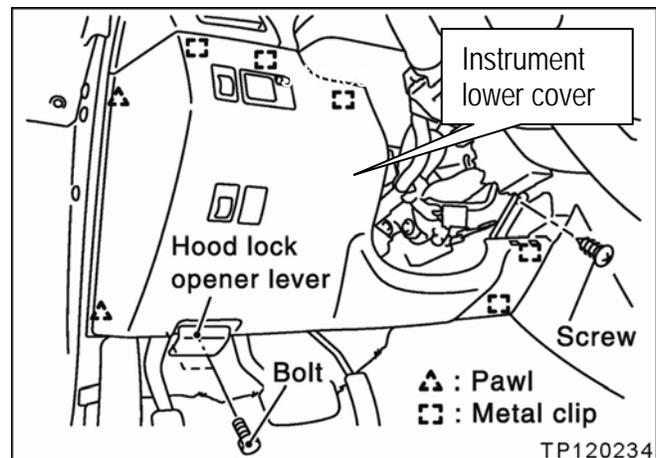
Figure 3

8. Remove the instrument lower cover.
 - a. Remove the bolts for the hood lock opener lever, and remove the lever from the cover.
 - b. Remove the attaching screws.
 - c. Pull back to disconnect (snap loose) the clips.
 - Use a plastic trim tool as needed.
 - d. Disconnect the electrical connectors.

NOTE: If preferred, the electrical connectors can be left connected and the lower cover left hanging below the steering column. This condition will allow access to the cluster lid screws.

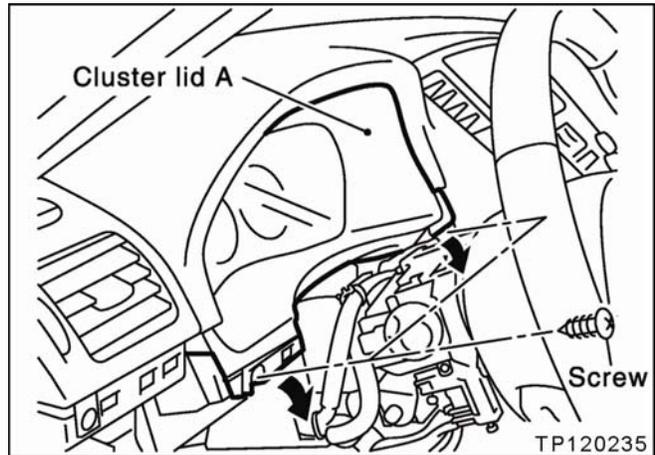
Figure 4

9. Remove cluster lid A (see Figures 4 and 5).

a. Remove 2 attaching screws.

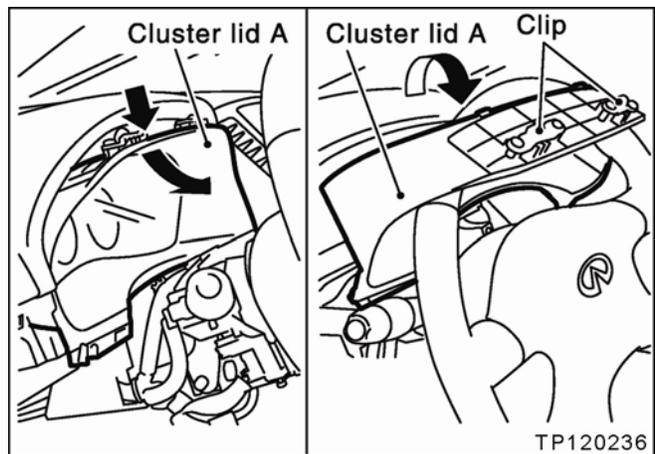
Figure 5

b. Pull down on the upper part of cluster lid A to unsnap the clips.

- Use a plastic trim tool as needed.

c. Pull back on cluster lid A to remove it.

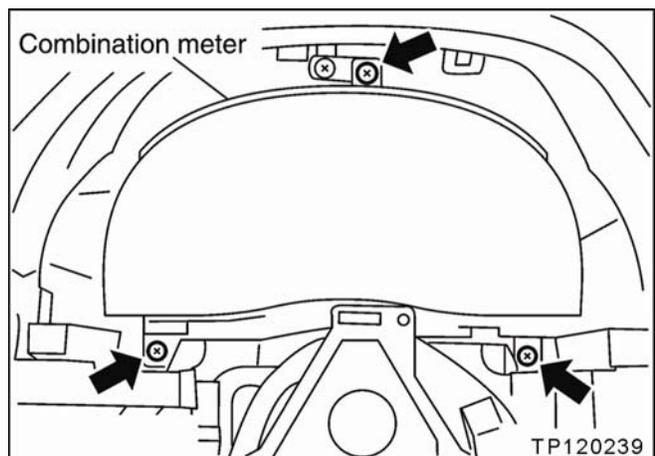
Figure 6

10. Remove the combination meter (see Figures 6 – 9).

a. Remove 3 attaching screws.

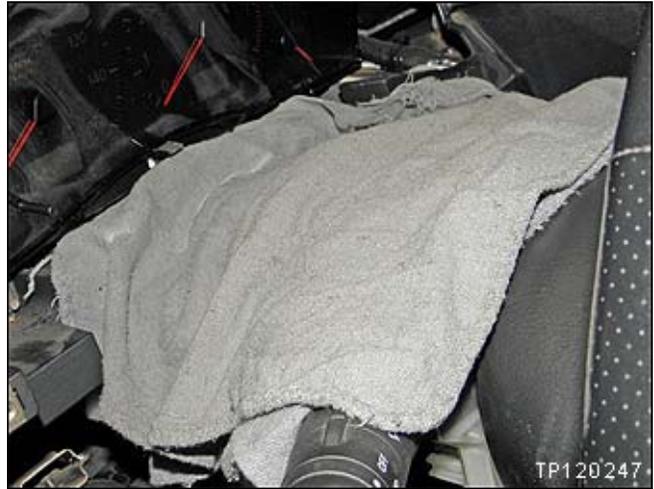
Figure 7

CAUTION: Use protective cloth as needed to protect meter lens from being scratched.

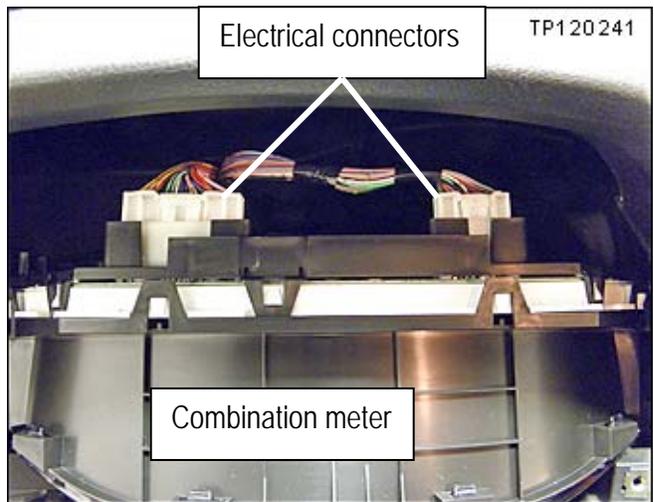
Figure 8

- b. Pull the combination meter rearward (toward the driver).
- c. Turn the combination meter so it is facing down.
- d. Disconnect the electrical connectors.

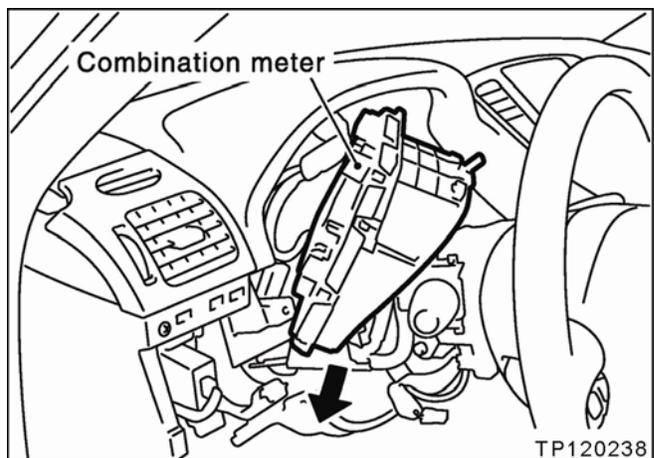
Figure 9

- e. Remove the combination meter to the left side of the steering wheel.
- f. Place the combination meter in a working area that is covered with protective cloth.

CAUTION: Use protective cloth as needed to protect meter lens from being scratched.

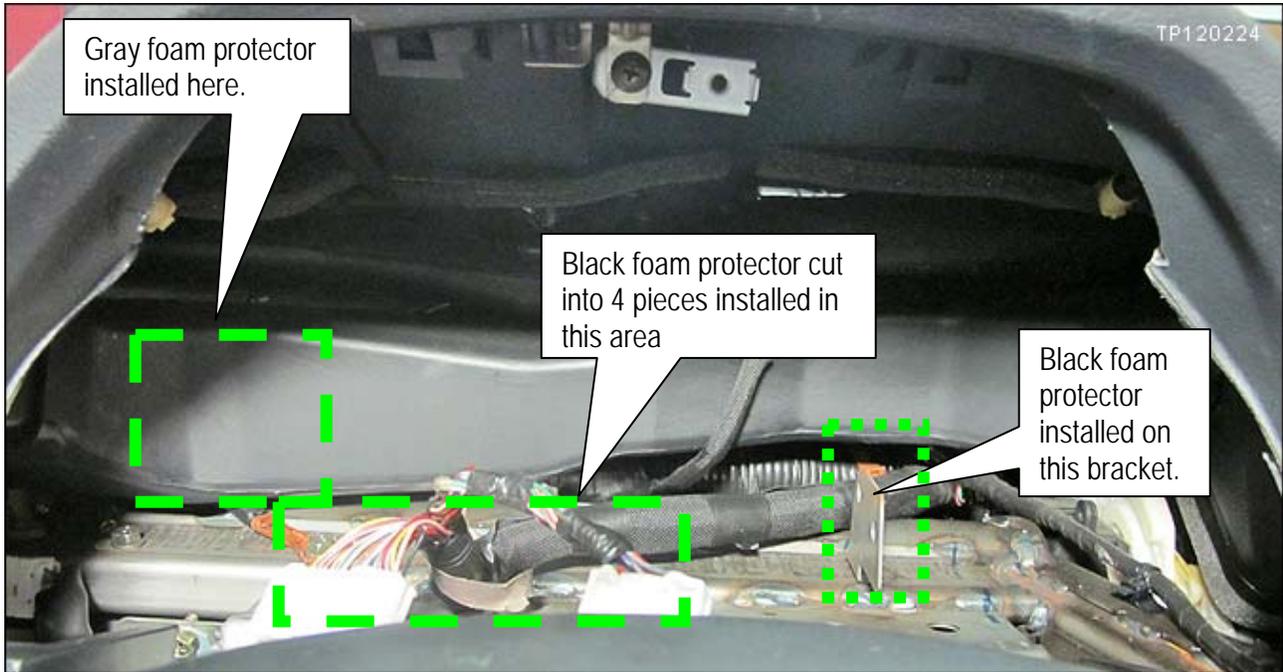
- In the next four steps you will be installing 3 foam protectors included in the sub-amplifier repair kit.
- Use Figure 10 as a location reference for these protectors.
- One of the 2" x 4" black foam protectors will be cut into 4 pieces.

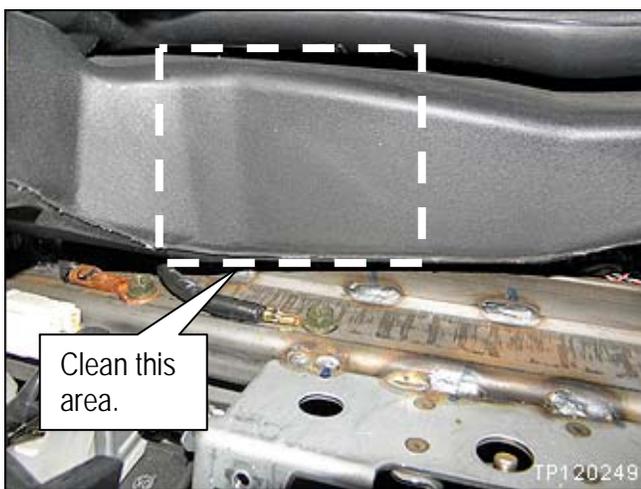
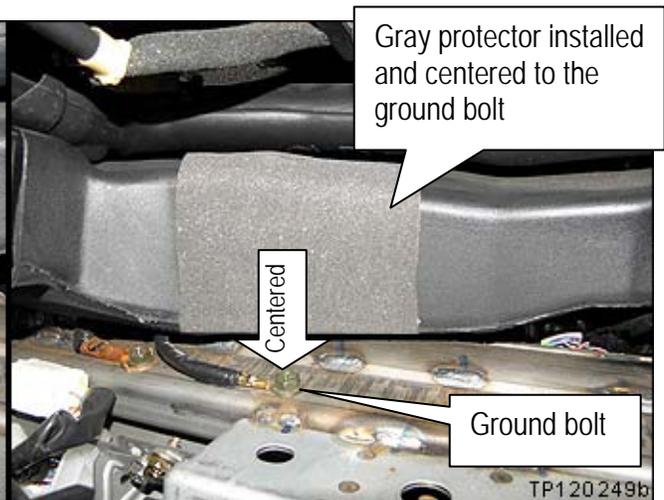
11. Install the gray foam protector as shown in Figures 11a and 11b):

- a. Clean the air duct in the area where the protector will be attached.
- b. Attach the protector so the center of the protector is aligned with the ground bolt (see Figure 11b).

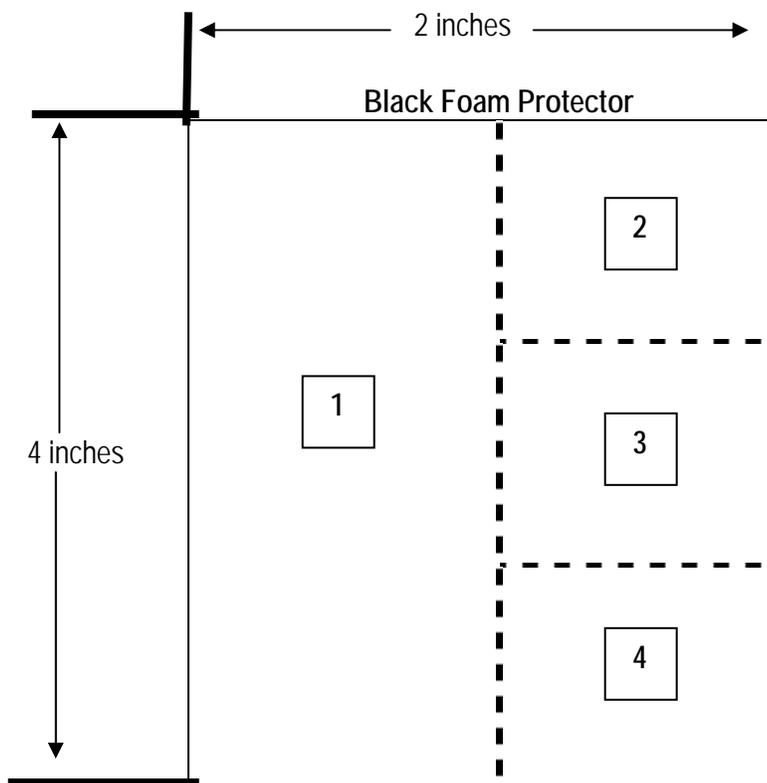
Figure 12

12. Cut one of the 2" x 4" black foam protector into 4 pieces as shown in Figure 12.

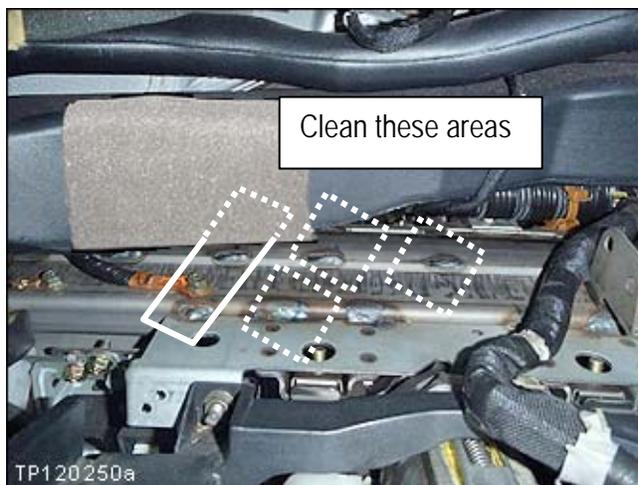
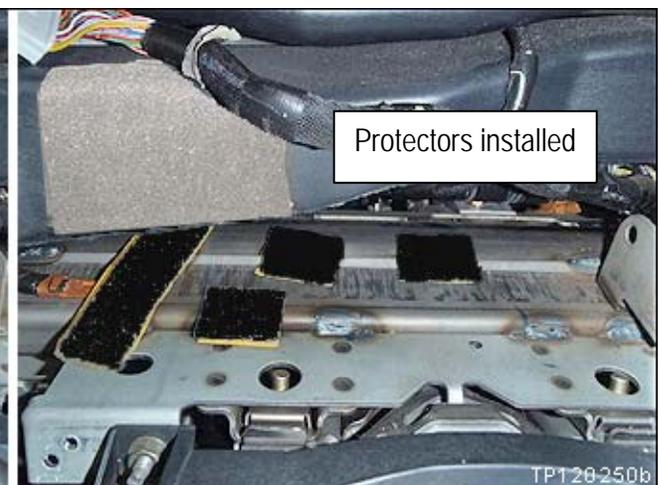
13. Install the 4 foam protector pieces in the locations shown in Figures 13a and 13b:

- a. Clean the areas where the protectors will be applied (see Figure 13a).
- b. Attach the protectors as shown in Figure 13b.

NOTE: Protectors should cover weld spots and bolt head.

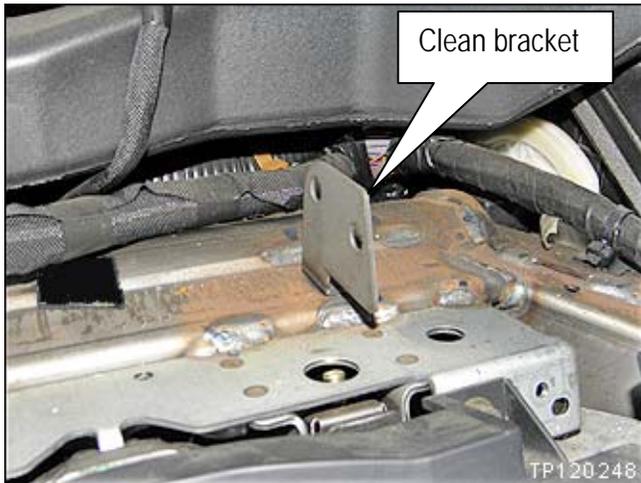
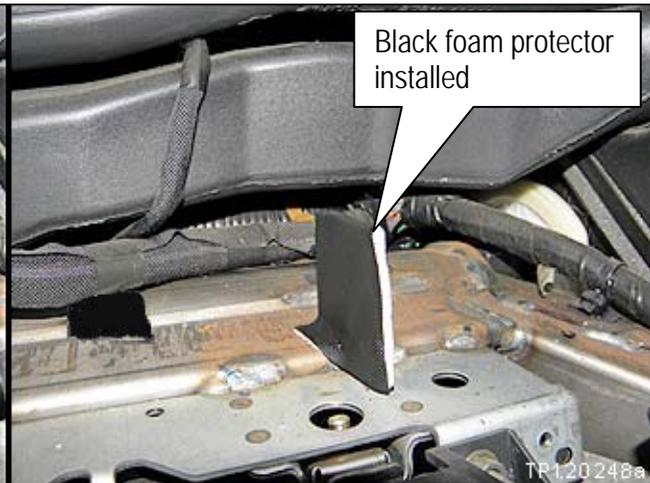
14. Install black foam protector as shown in Figures 14a and 14b):

- a. Clean both sides of the bracket shown in Figure 14a.
- b. Attach the protector (fold it over the bracket) so it completely covers both side of the bracket as shown in Figure 14b.

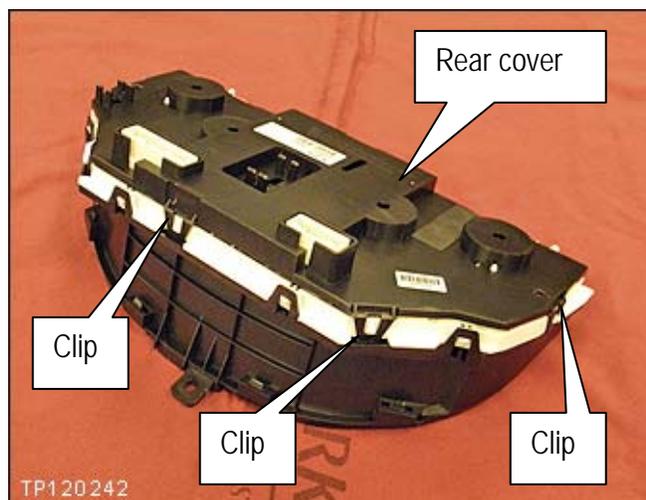
Figure 15

- a. Remove the rear cover from the combination meter.
 - Use a small flat blade screw driver to disconnect 8 clips from around the edges of the cover.
 - Only 3 of the clips are shown in Figure 15. There are a total of 8 clips.

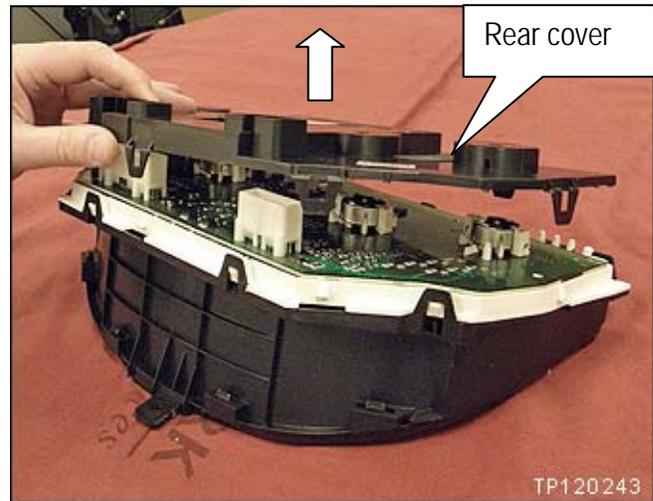
Figure 16

- b. With the clips disconnected, remove the rear cover.

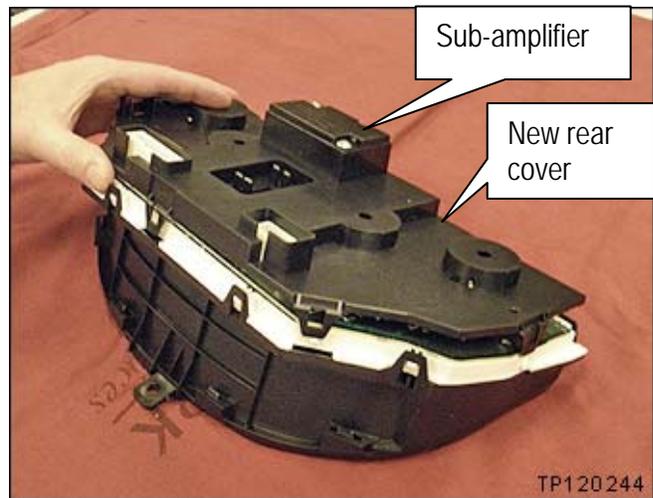
Figure 17

- c. Install the new rear cover (which includes the sub-amplifier).
- Make sure the 8 clips around the edge of the cover are snapped in place.

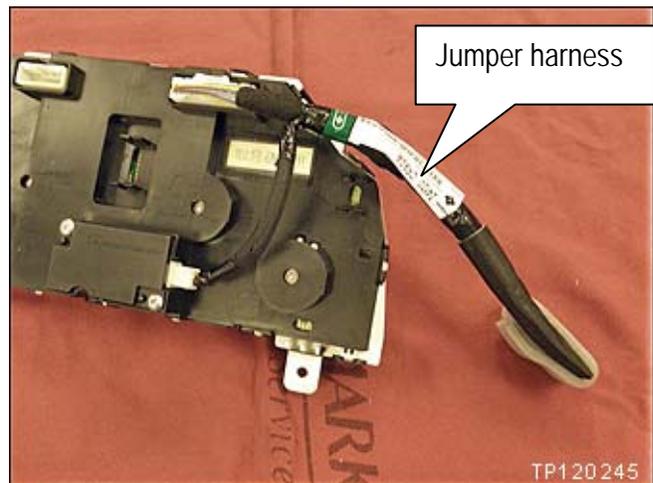
Figure 18

16. Attach the jumper harness to the sub-amplifier and the back of the combination meter as shown.

NOTE: The jumper harness is included in the sub-amplifier repair kit.

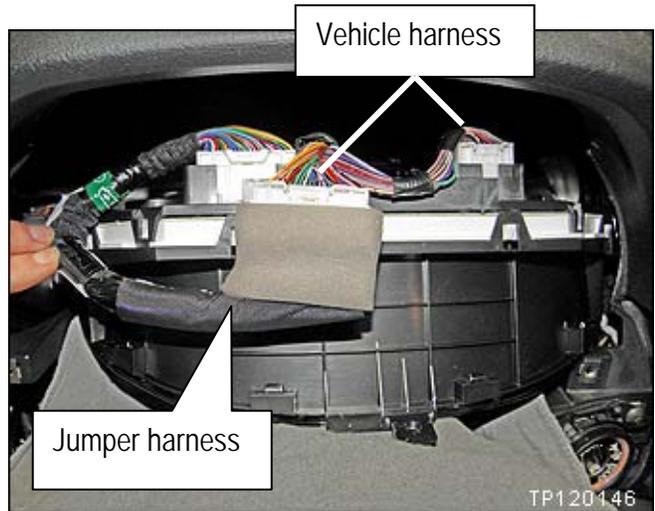
Figure 19

17. Reinstall the combination meter.

- Attach the vehicle harness to the jumper harness and the back of the combination meter as shown.
