Safety Defect and Noncompliance Report Guide for Equipment
PART 573 Defect and Noncompliance Report

Generic name of the item: Rear of Car Bike Rack System

Model: SpareTime

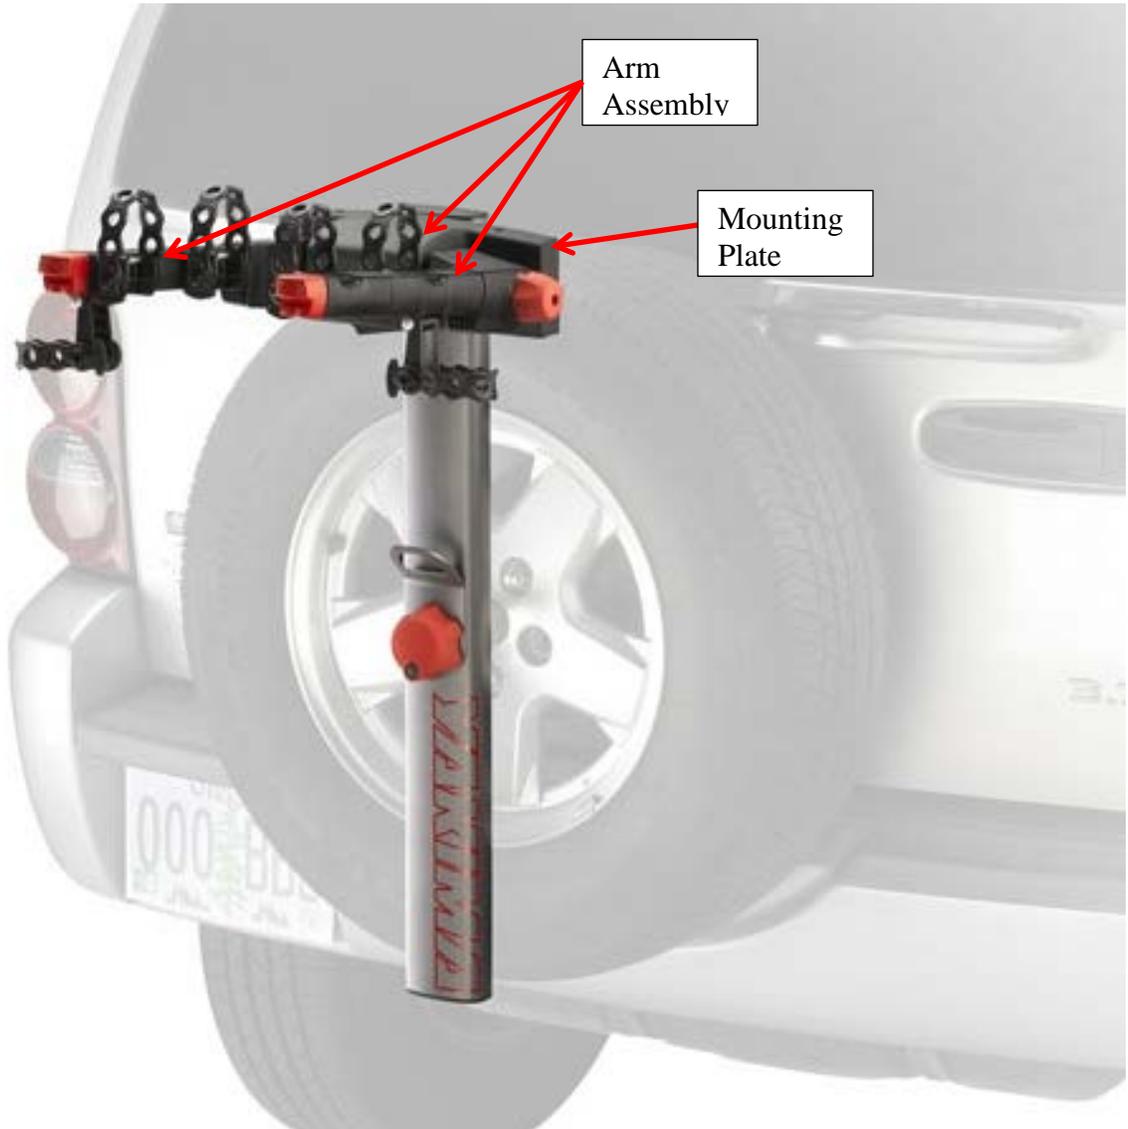
Function: Provides bike carrying capability for vehicles that have a rear mounted spare tire system.

The equipment impacted attaches to spare tire mounting bolts on the rear of a vehicle in applications similar to the one pictured above. When viewed from the back side of the product (i.e., the side facing the rear of the vehicle) there is a silver looking mounting plate containing six threaded inserts used to attach the arm assembly to the mast assembly. These bolts allow for positioning the arm assembly in a right, center or left orientation depending on the position of the spare tire holder on the applicable vehicle. Any SpareTime product containing bolts that are not identified with a head marking (See “Bad Bolt” picture below), need to be replaced with a one that has markings (See “Good Bolt” picture below).

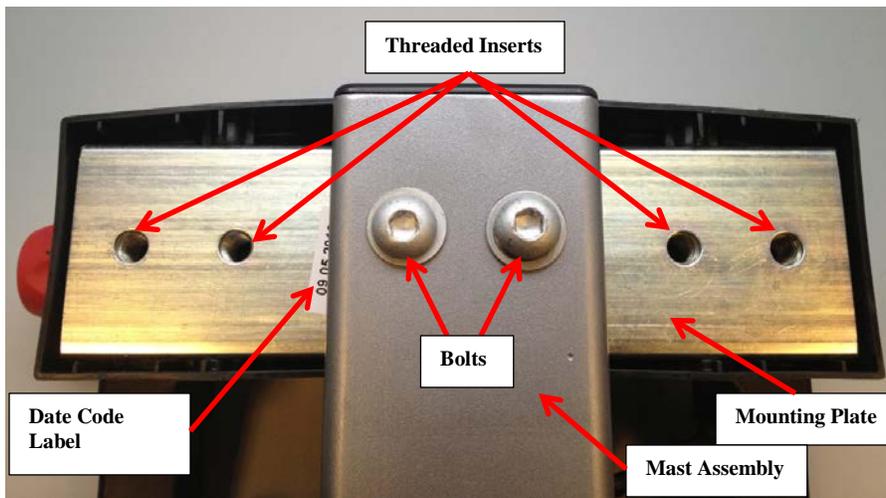
Back of Product View

Good Bolt

Bad Bolt

Remedy: As directed in the Consumer Letter to be issued concurrent with this report, owners of suspect SpareTime products can contact Yakima to obtain replacement bolts to be sent to them via mail. The bolt application in the product is designed to be consumer serviceable. The consumer will be sent two bolts inside a bubble line manila envelope with brief instructions on what to do when they receive it. Until the consumer receives and installs the replacement bolts, the product should not be used.

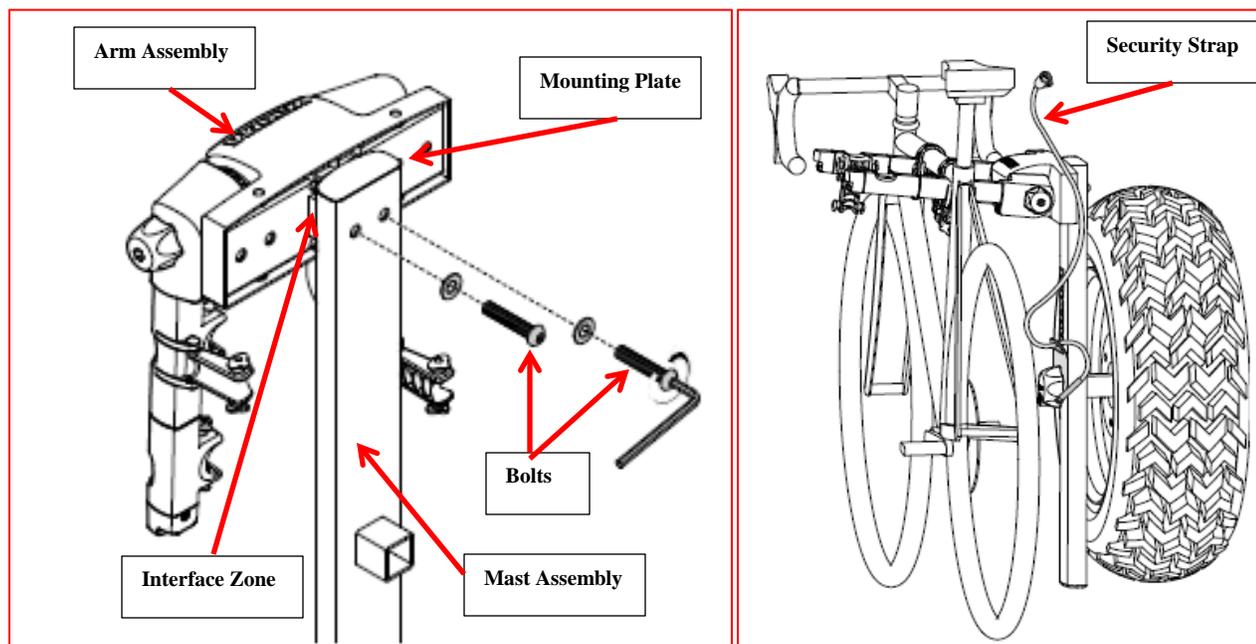
There are two bolts that secure the SpareTime arm assembly to the mast assembly. These bolts are the primary part of the bike rack system that keeps the arm assembly and related bike load attached to the vehicle. There is also a secondary security cable, that if used as required by the product instructions, will keep the arm assembly and load tied to the vehicle.

Based on consumer reports (two) and actual testing conducted by Yakima, the strength of material used to manufacture the bolts did not meet the requirements for an M12X1.75X65 MM, Button Head Bolt per ISO 7380 Grade 10.9. As a result, the bolts have been seen to break between the interface zone between the face of the mast and the back of the mount plate

The cause for the defect is due to the bolt material being too soft (32 to 39 Rockwell C). Test bolts were far below the requirement indicated and a lower quality material was used to manufacture them. When tested, the bolts did not exhibit the necessary tensile strength or hardness that correlates to M12X1.75X65 MM, Button Head Bolt per ISO 7380 Grade 10.9. When a soft bolt is used in the SpareTime application, product motion induced by terrain and vehicle speed eventually causes them to crack.

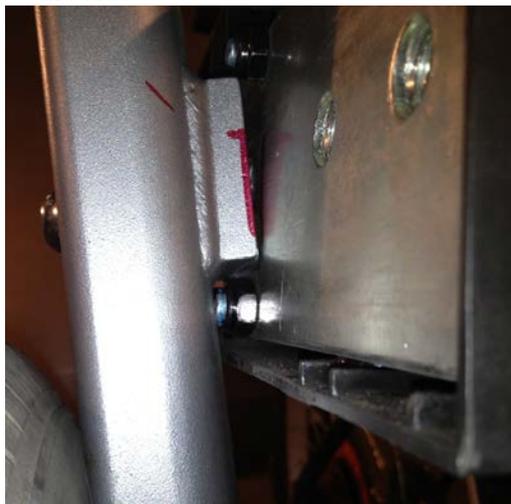
- (a) a wedge shaped area between the mast and the mounting plate would be noticeable when viewed from the side

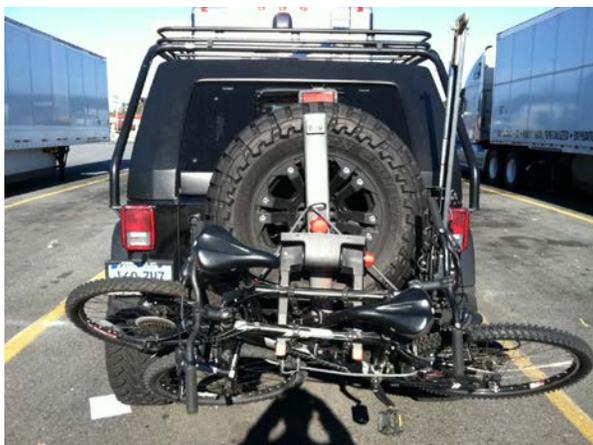
CONSUMER 1

18 November 2012 - The first report of a failure experienced by a consumer was received (See Picture 2). The consumer followed the product instructions and had the security cable installed. This prevented separated arm assembly and related load from being ejected.

Based upon the above two consumer reports, Yakima became concerned that something was going on with the bolts (See below consumer pictures). Subsequent hardness analysis on bolt remnants found much lower than expected values. In addition, bolts in stock at the manufacturing facility as well as with units pulled from US distribution were inspected and tested. The were found to exhibit the same low hardness values.

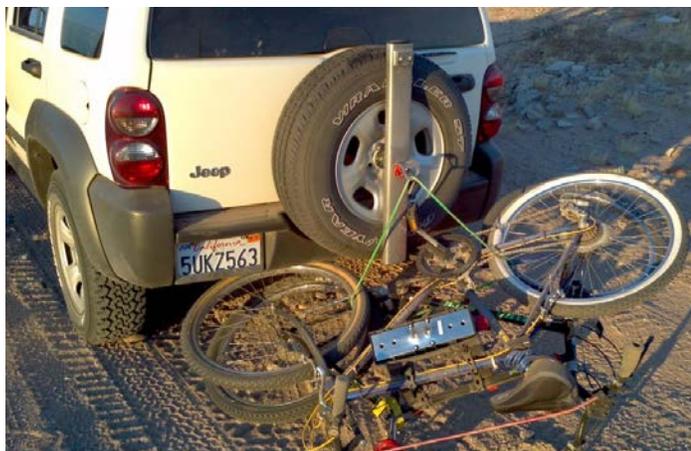
CONSUMER 2

14 January 2013 - A second consumer experienced failure of their SpareTime product (See Picture 3). In this instance the consumer did not have the security cable installed but did have their own bungee cords installed. This prevented the separated arm assembly and related load from being ejected.

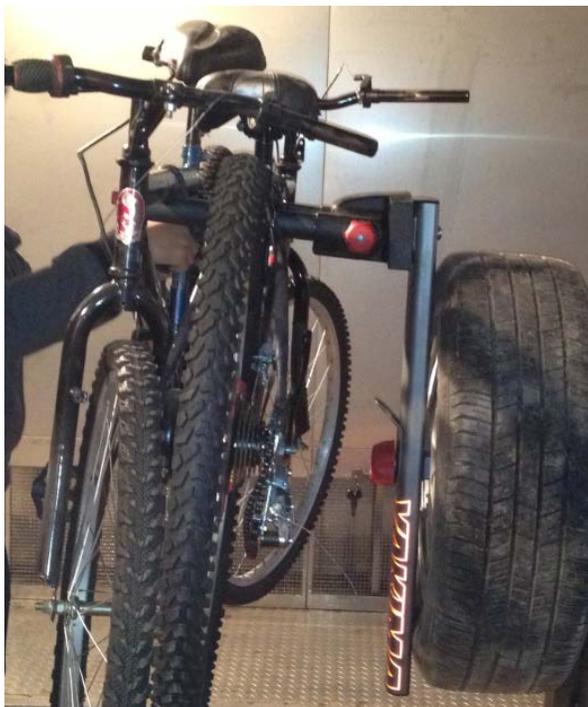
LABORATORY TESTING

To facilitate understanding the risk, Yakima conducted laboratory testing at our Nanjing, China environmentally controlled shaker facility. This testing validated the problem and demonstrated that the bolts would fail. In the lab setting, Yakima saw predictable and repeatable failure results around 2.5 hours into the test cycle. This testing timeframe cannot be directly correlated to actual product performance in the field since test parameters represent extreme conditions (temperature as well as severe terrain) and are compressed into short intervals. However, the results are indicative that bolts will fail in actual use over time. The timeframe required to see such failures by consumers will depend a lot on the type of road surfaces that their vehicle encounters as well as driving habits of the consumer as well as how long and often they keep the product installed with a load on it.

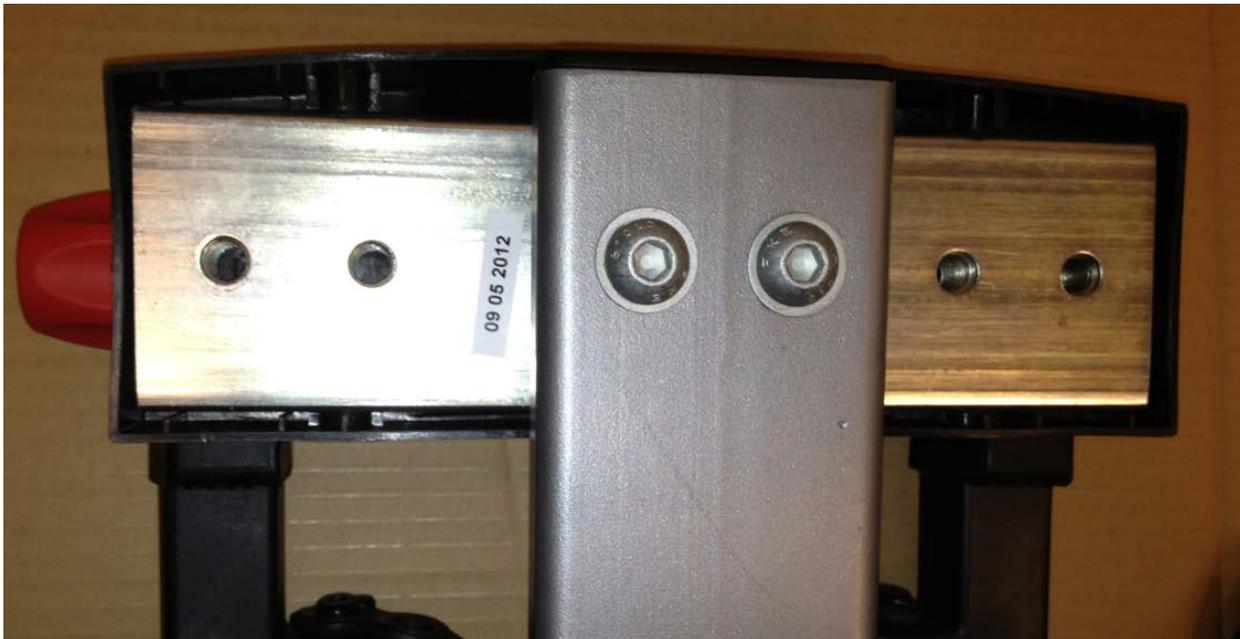
Recall Condition: Any SpareTime product with a manufacturing date code between 1 November 2011 and 30 October 2012. The date code (white printed label) can be found on the mounting plate. Format will be:

XX XX XXXX (Month Day Year)

Example: 5 September 2012 would look like 09 05 2012 (See below picture for typical location and appearance of the date code.
