# Recall Campaign

NHTSA#: 13V-071

Inspect breaker gap for minimum 3/8" gap. Repair if gap is less than 3/8"

**2013 Autumn Ridge Travel Trailers**

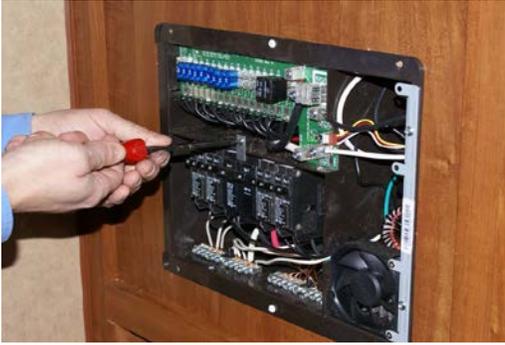
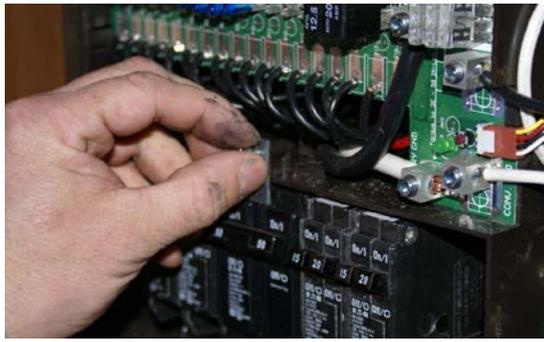
1. Make sure all power to the unit is turned off.
2. Remove the center screw along with the (4) exterior screws so the breakers can be removed.

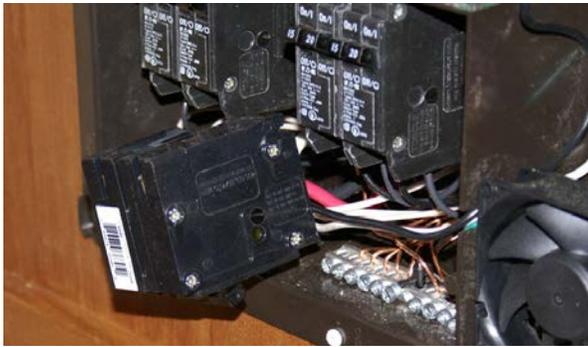
3. Pull the breaker out of the load center panel.

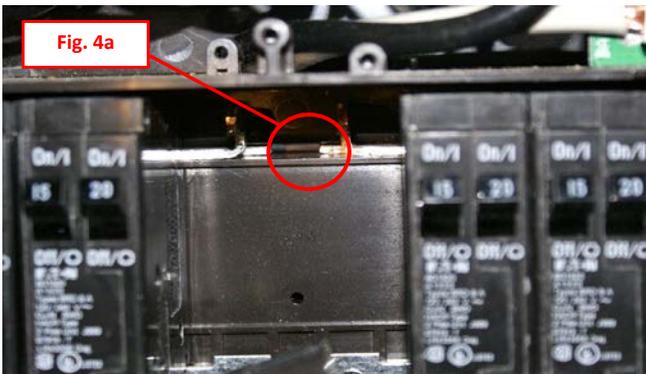
4. Using a screwdriver or similar tool that is 3/8" wide, measure the gap between the breaker plates (**Fig 4a**). The minimum gap should be 3/8". If the gap is 3/8" or more, return the breaker and screws to the original position, and there is no additional repair required. If the gap is less than 3/8" proceed to step 5.

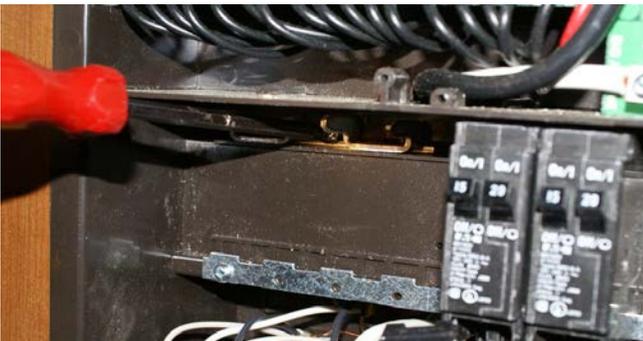
5. Remove the remaining breakers. Remove the screw holding the breaker plate. Remove the plate.

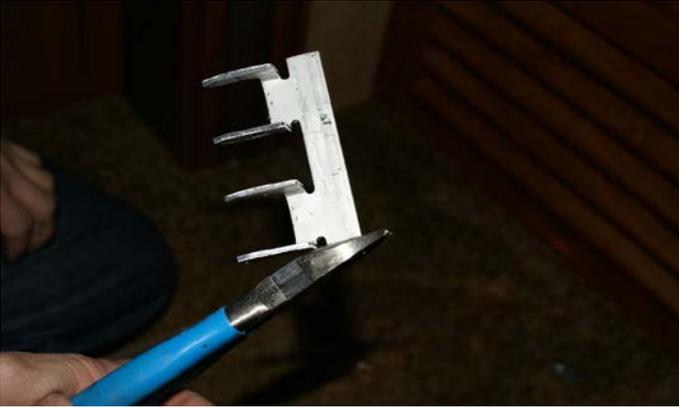
- Using a tin snips or similar tool, trim the end of the breaker plate. NOTE: Be sure to trim the end of the plate that is in the center of the load center where the gap is measured.

- Re-install the trimmed plate and re-measure the gap. If the gap is still less than  $\frac{3}{8}$ " , remove the plate and trim off more. If the gap is  $\frac{3}{8}$ " or more, reassemble the load center.
