April 2013

Safety Recall N07 / NHTSA 13V-118 Seat Wiring Harness Connectors

2011-2012 (LC) Dodge Challenger
(LD) Dodge Charger
(LX) Chrysler 300

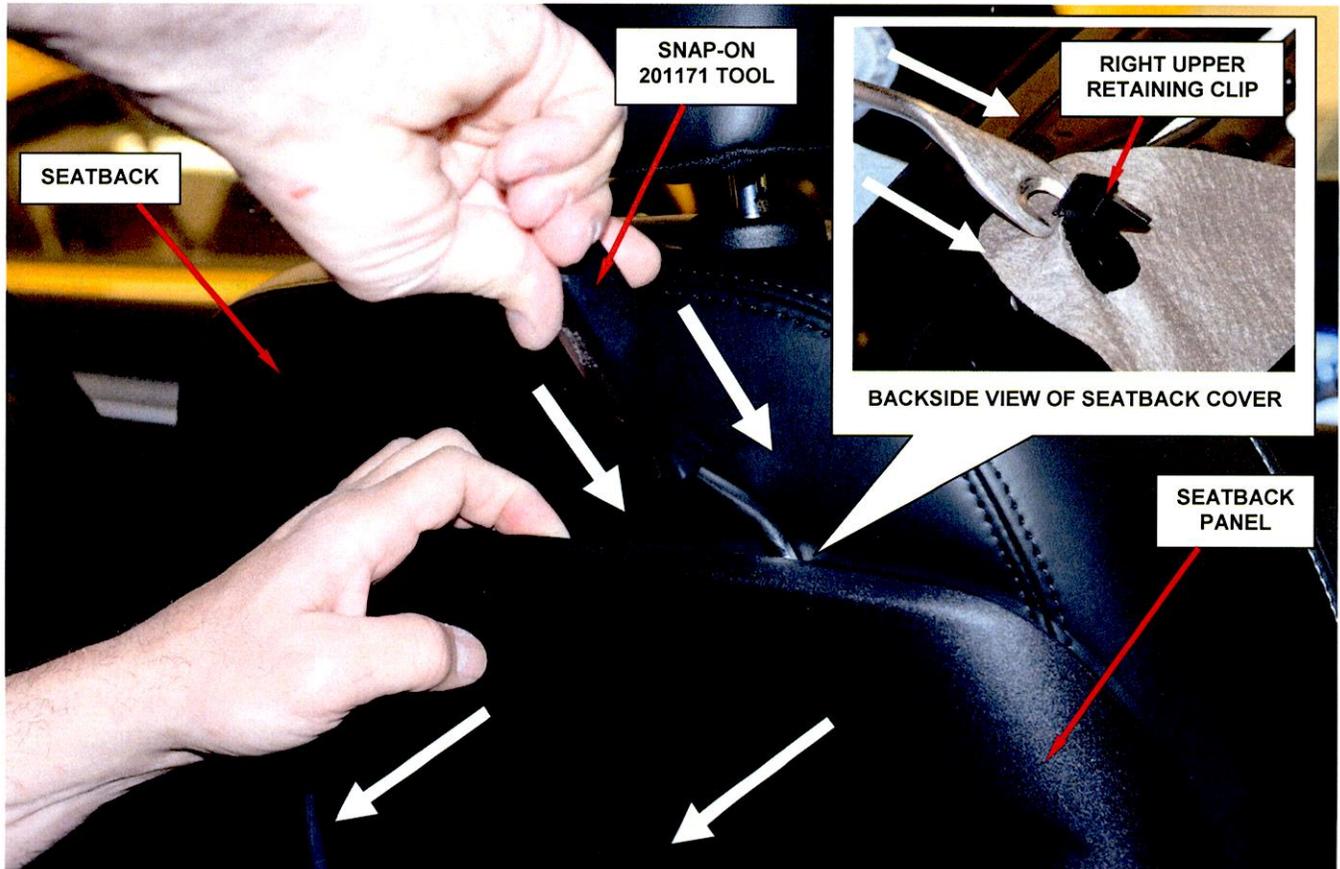
Figure 1 – Disengage the Two Upper Retaining Clips

1. Move the front seats to the full forward position.
2. Open the trunk to access the battery.
3. Disconnect the negative battery cable at the battery.
4. Disconnect the two straps that hold the lower seat cover to the seat on both front seats.
5. Remove both seatback covers from the front seats using the following procedure:
 - a. Insert a Snap-on 201171 tool, or equivalent, at the top of the seatback panel and push down on the upper retaining clips to disengage the two clips while pulling outward slightly on the top of the seatback panel (Figure 1).

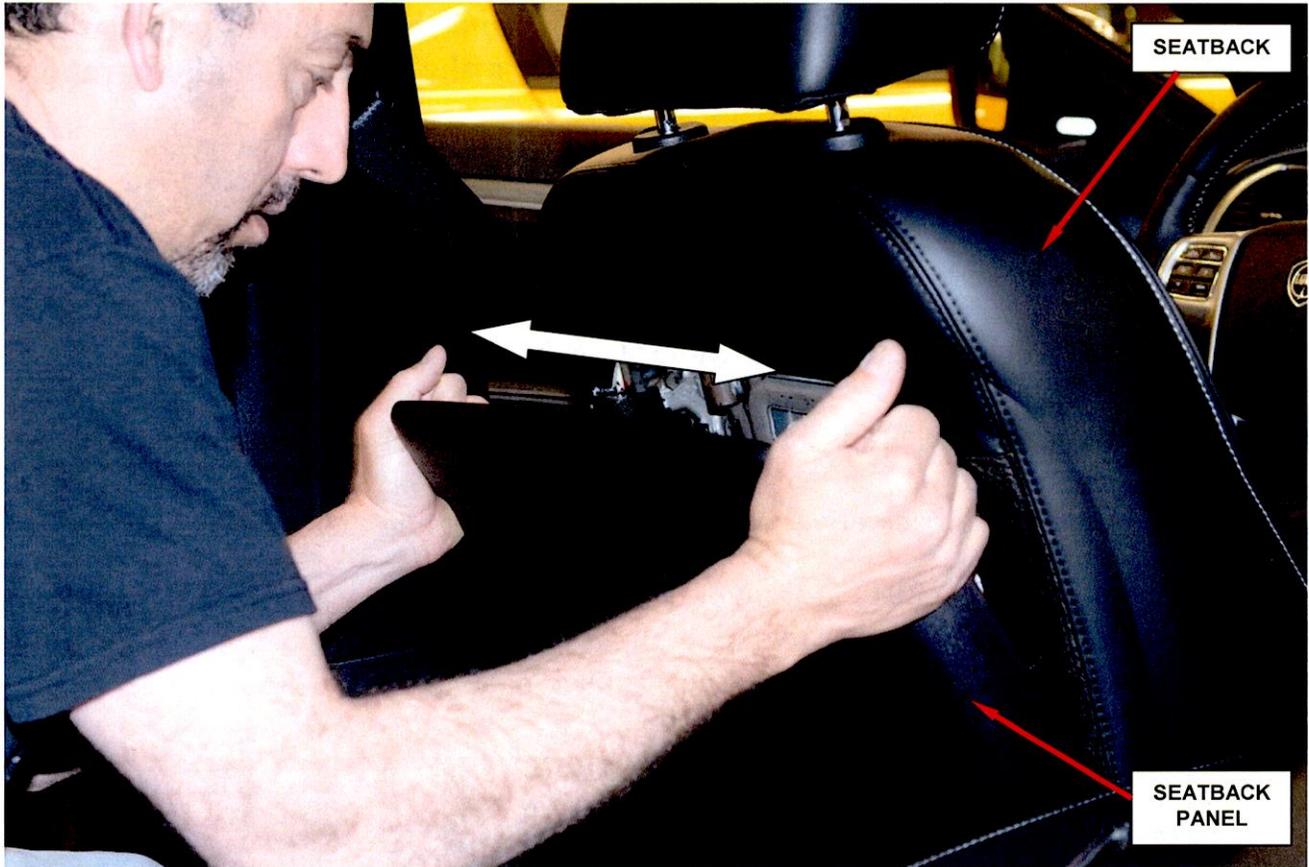
Figure 2 – Wiggle Seatback Panel Right and Left While Pulling Rearward

- b. Once the two upper retaining clips are disengaged, wiggle the seatback panel right and left, while pulling the seatback panel away from the seatback, to disengage the side clips (Figure 2).

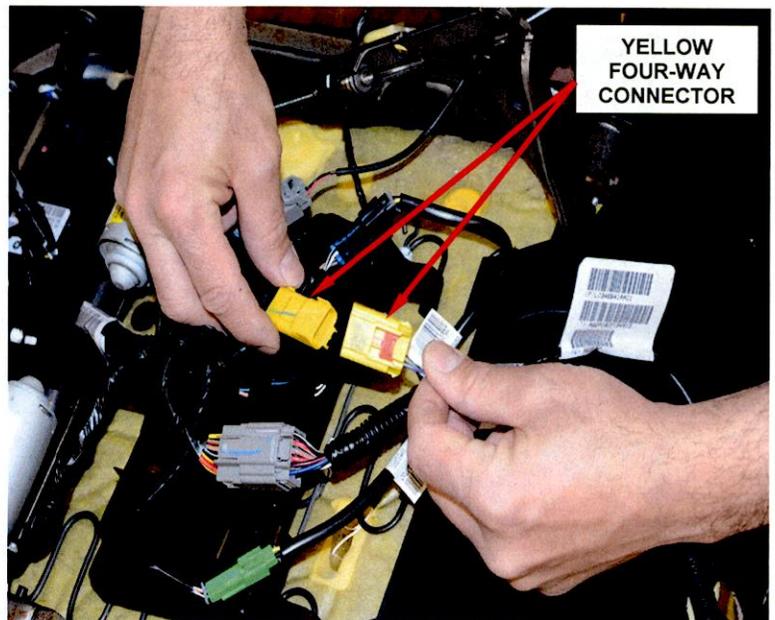
Figure 3 – Disconnect Yellow Four-Way Connector

6. Disconnect the yellow four-way wiring connector from the seat cushion wiring harness (Figure 3).

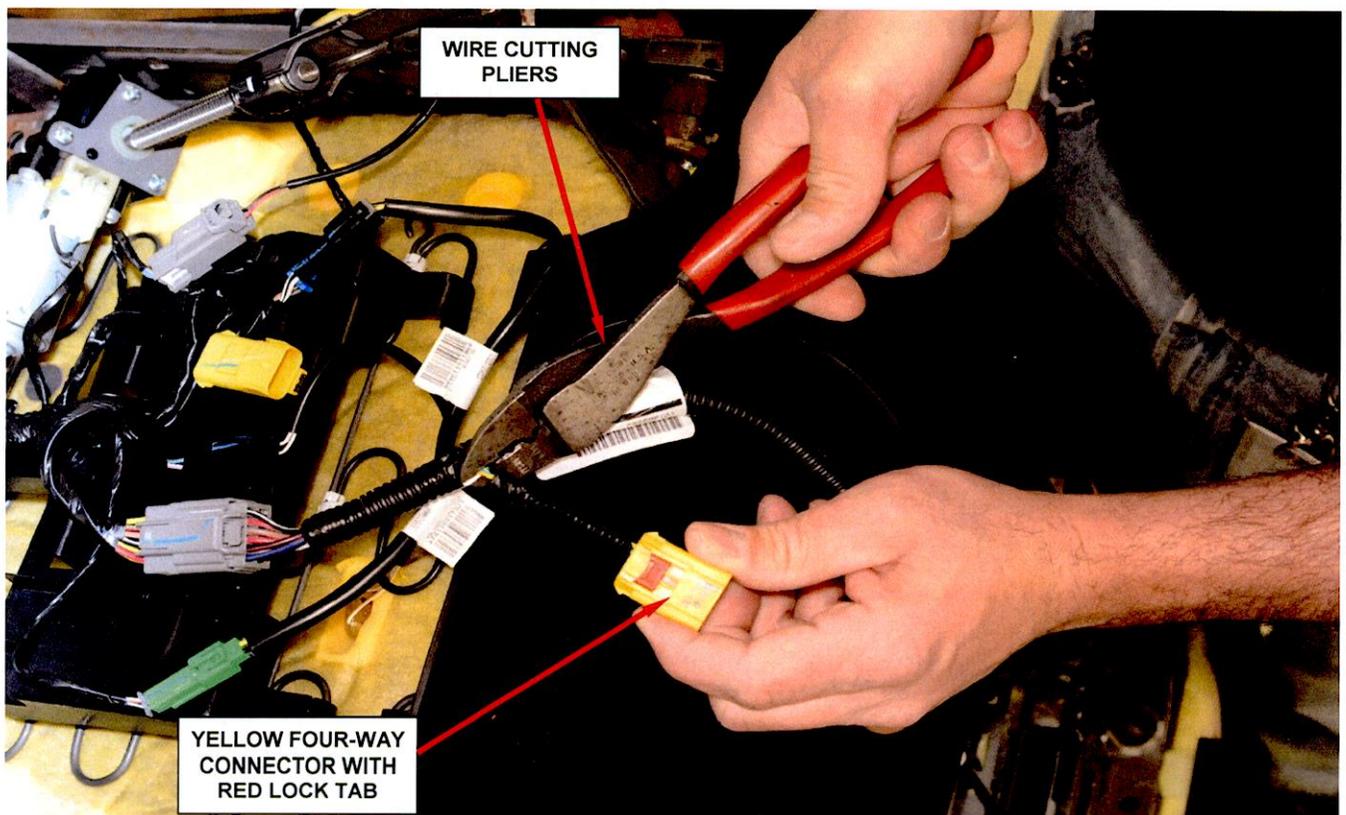
Figure 4 – Cut Off and Discard Yellow Four-Way Wiring Harness Side Connector (Except Challenger Right Side Front Seat)

7. For all models except Challenger right side front seat, cut off and discard the original wiring harness side four-way yellow electrical connector (Figure 4).

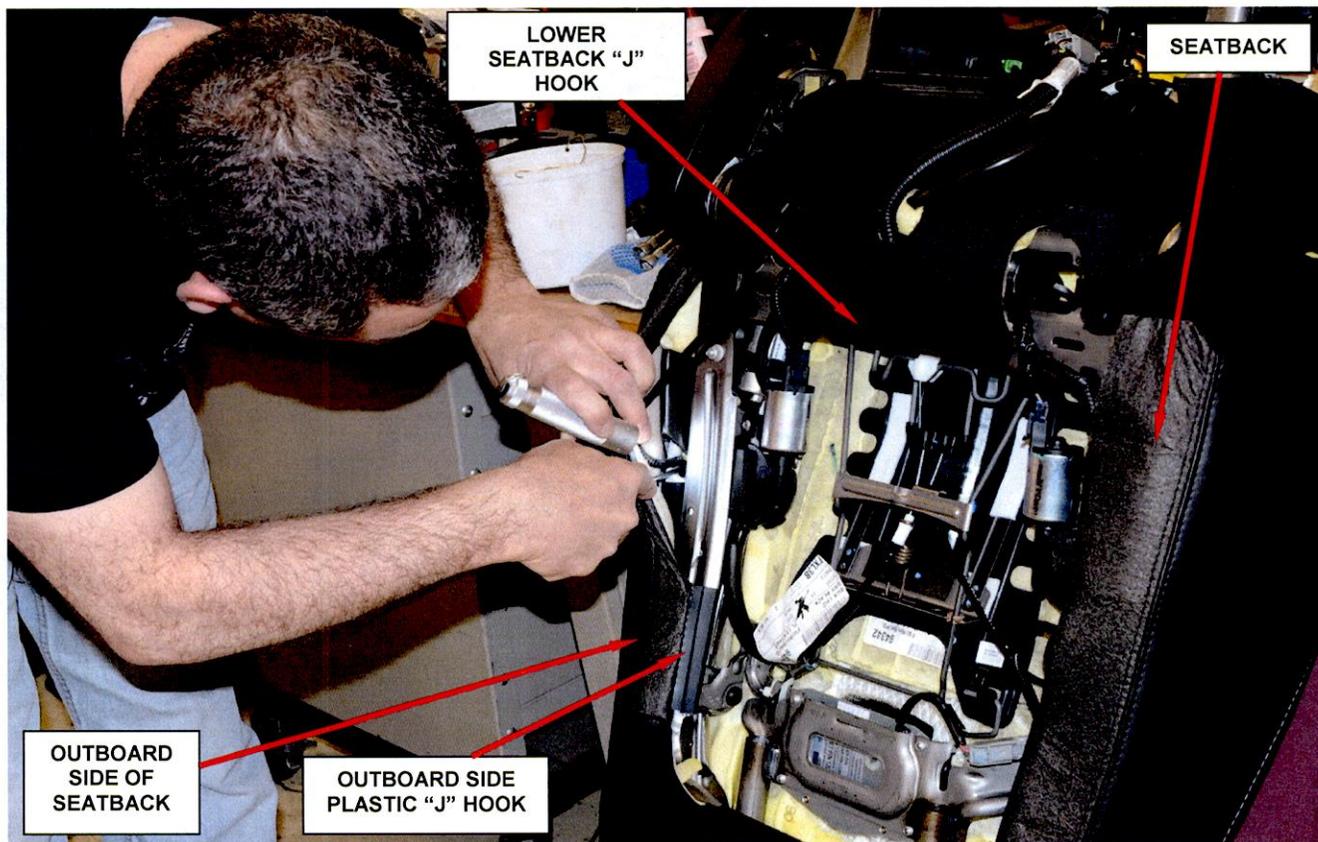
Figure 5 – Disconnect Yellow Squib Wiring at Airbag Module

8. Disconnect the outboard side seatback plastic “J” hooks to gain access to the airbag module squib connector (Figure 5).

9. Disconnect the lower seatback plastic “J” hook (Figure 5).

10. Disconnect the yellow squib connector at the airbag module (Figure 5).

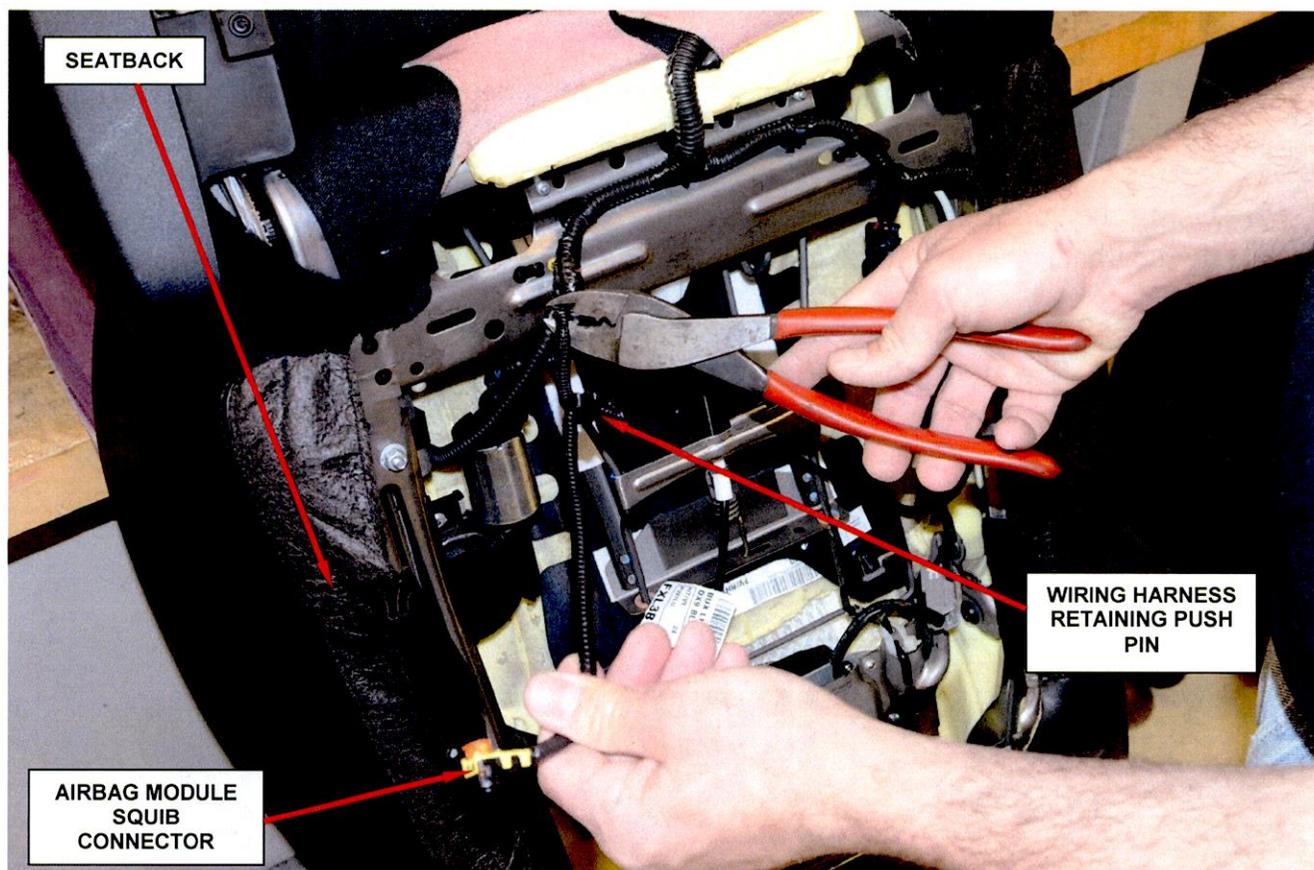
**Figure 6 – Cut Off Original Airbag Module Wiring
(Except Challenger Right Side Front Seat)**

11. Disconnect the airbag wiring harness retaining push pin(s) at the seat frame.
12. **For all models except Challenger right side front seat**, cut off and discard the original airbag module wiring (Figure 6).
13. **For Challenger right side front seat only**, remove and discard the original airbag module wiring harness.
14. Connect the new squib connector from the overlay harness to the airbag module. Be sure to engage the red connector lock.

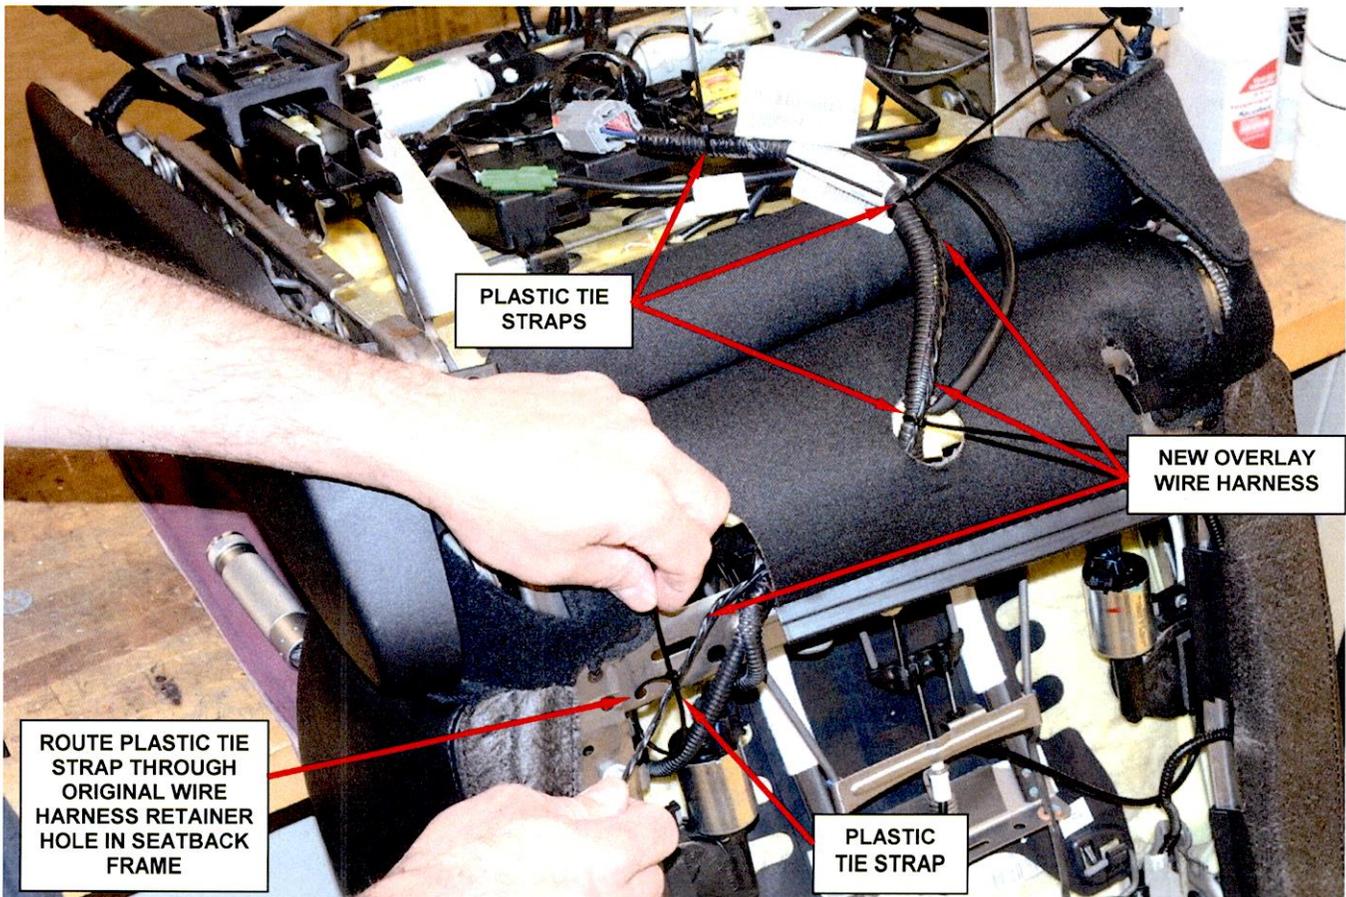
Figure 7 – Route and Tie Strap Overlay Wire Harness to the Original Wiring Harness (Except Challenger Right Side Front Seat)

- 15. Route the new airbag module overlay wire harness along the seatback (Figure 7).
- 16. Connect the new yellow four-way wiring connector to the seat cushion wiring harness. Be sure to engage the red connector lock.
- 17. Using the supplied tie straps, secure the airbag module overlay wire harness to the seatback frame and original wiring harness.
