Reference: NHTSA Identification Number 13V-124

Dealer Service Instructions for:

Safety Recall N21 / NHTSA 13V-124 Rear Brake Calipers

2013 (PF) Dodge Dart

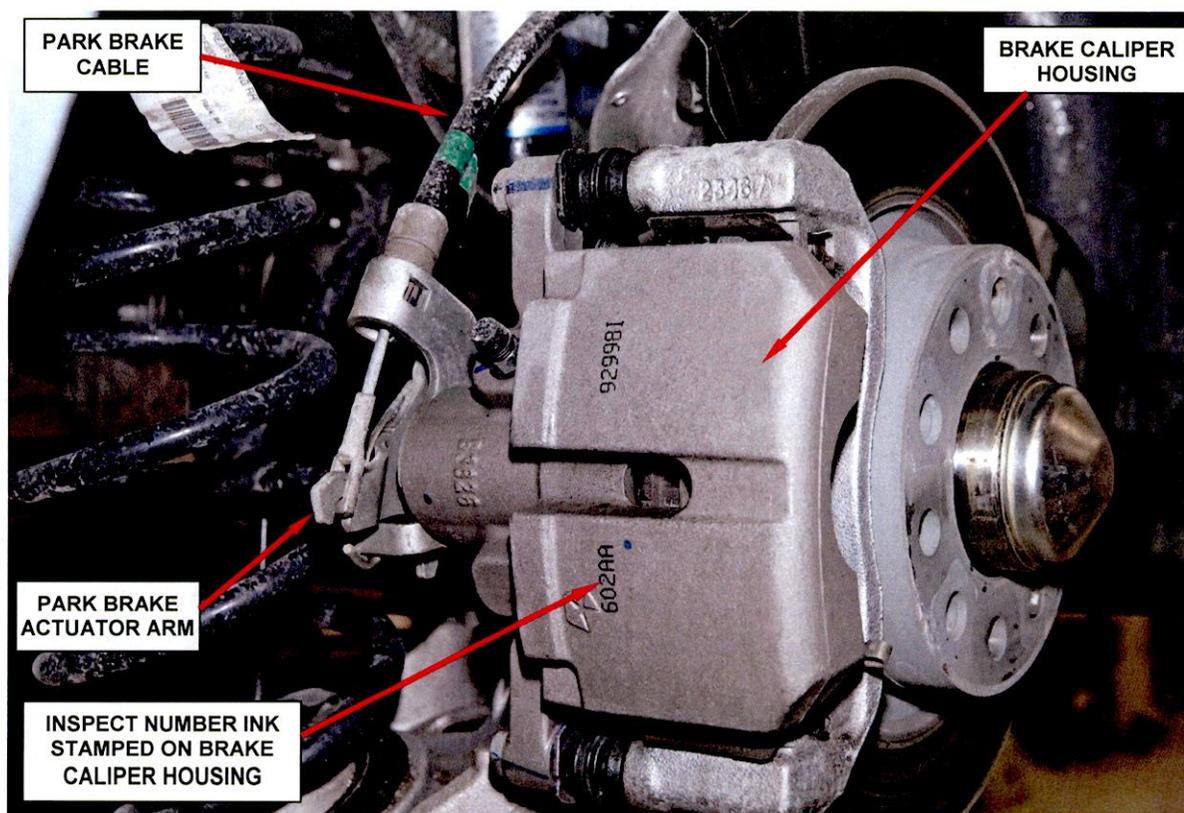
**Figure 1 – Inspect Part Number on Brake Caliper Housing
(right side shown)**

1. Lift the vehicle on an appropriate hoist.
2. Remove and save both rear wheels.
3. Inspect the rear brake caliper housing part numbers:
 - If the part number ink stamped on the rear brake caliper housing is **602AA** on the right side and **603AA** on the left side, brake caliper replacement is not required (Figure 1). Install the rear wheels onto the vehicle and tighten the lug nuts to 90 ft. lbs. (122 N·m). Then return the vehicle to the customer.
 - If the part number ink stamped on either of the rear brake caliper housing is **100AD** or **101AD**, replace that brake caliper. Continue to **Section B: Inspect Park Brake Cable, Wheel, and Tire**.
 - If the part number ink stamped on either of the rear brake caliper housings is missing or not readable, replace that brake caliper. Continue to **Section B: Inspect Park Brake Cable, Wheel, and Tire**.

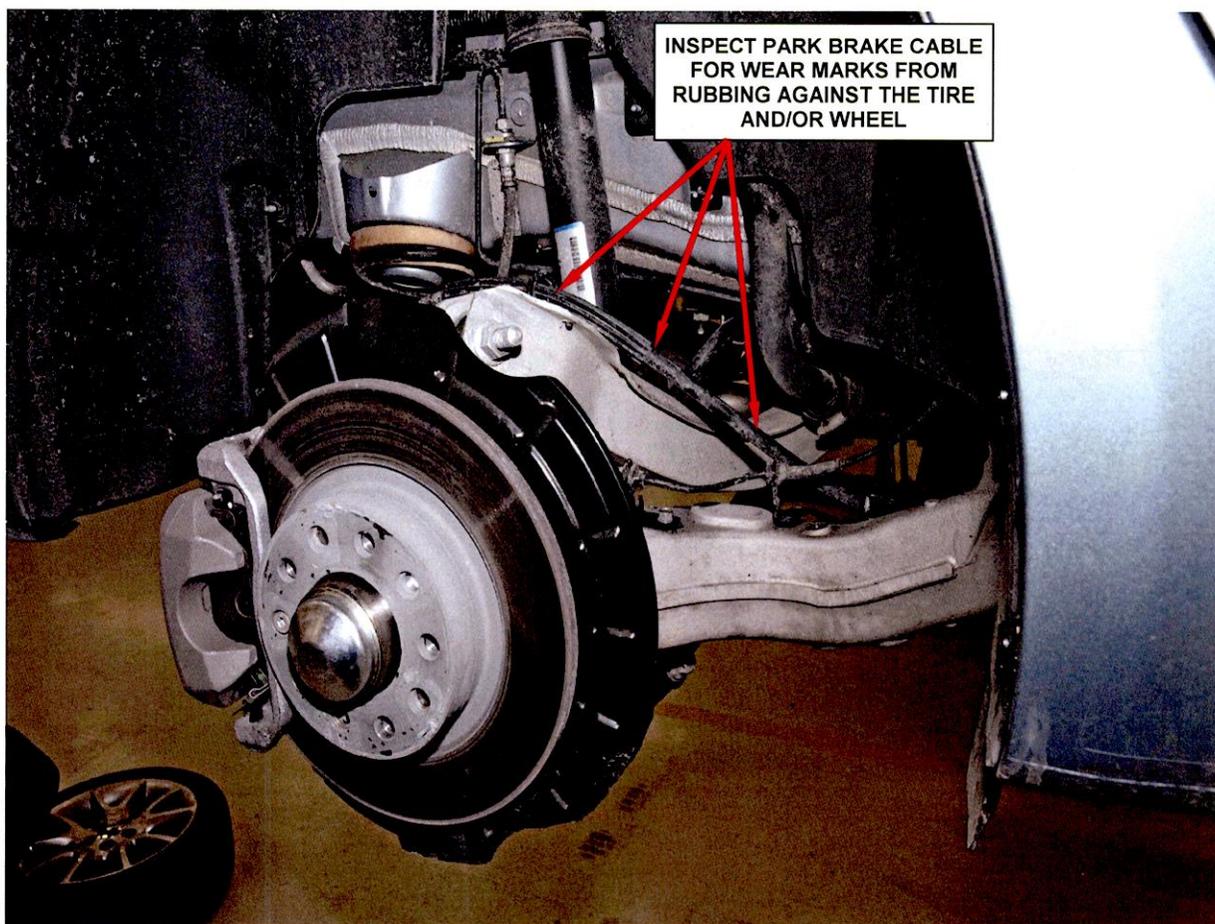
Figure 2 – Inspect the Park Brake Cable for Signs of Rubbing Against the Wheel and/or Tire Sidewall (right side shown)

1. Inspect both park brake cables for indications that they were rubbing against the wheel and/or tire:
 - If there are no rub marks (Figure 2) on the park brake cables, continue to **Section E. Replace Brake Caliper(s)**.
 - If there are rub marks on the park brake cable(s), continue with Step 2 of this inspection.

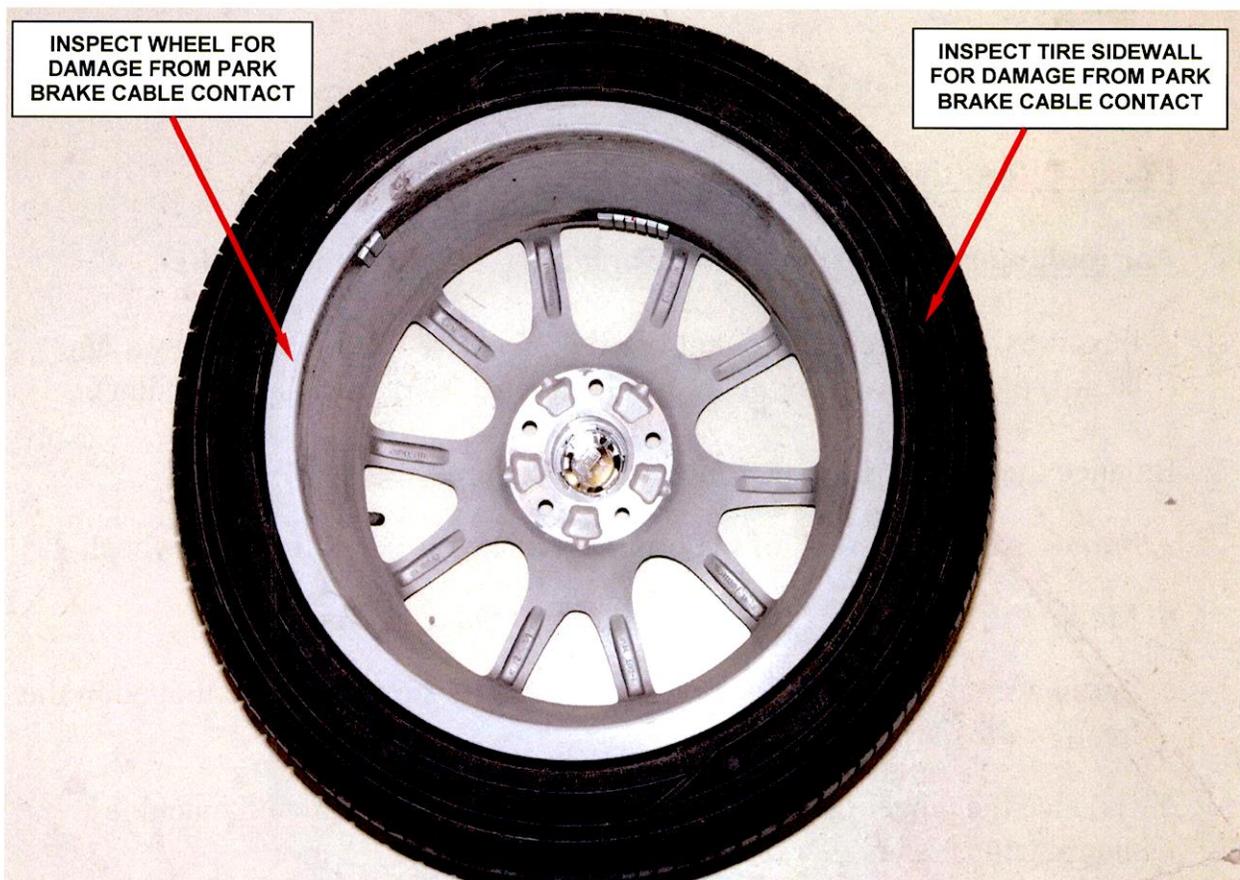
Figure 3 – Inspect the Wheel and Tire Sidewall for Damage

2. Inspect the inner sidewall of the tire and wheel for damage from rubbing against the park brake cable (Figure 3):
 - If there is no damage to the tire sidewall and/or wheel, continue with **Section D. Replace the Park Brake Cable(s)**.
 - If there is damage to the tire sidewall and/or wheel, continue with **Section C. Replace Tire(s) and/or Wheel(s)**.

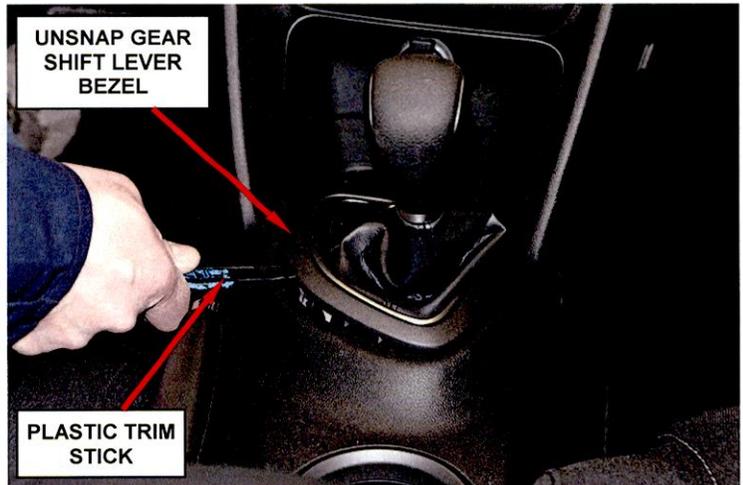
Figure 4 – Gear Shift Lever Bezel

1. Disconnect the negative battery cable from the battery.
2. Remove the center console using the following procedure:
 - a. Unsnap, but do not remove, the gear shift lever bezel (Figure 4).

- o. Install the gear shift bezel (Figure 4).
32. Continue with **Section E. Replace Rear Brake Caliper(s)**.

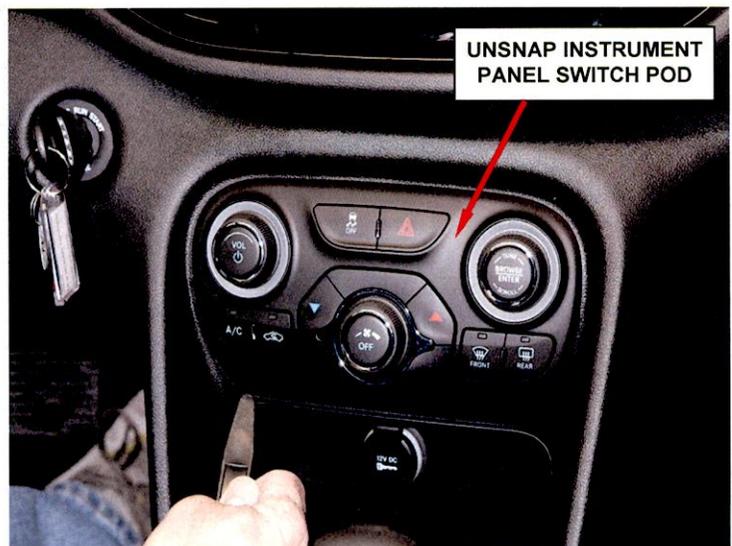
Figure 5 – Instrument Panel Switch Pod

- h. Remove and save the instrument panel switch pod (Figure 5).

- l. Install the right and left gap hider panels (Figure 6).
 - m. Install the instrument panel switch pod (Figure 5).
 - n. Install the park brake handle side cover.

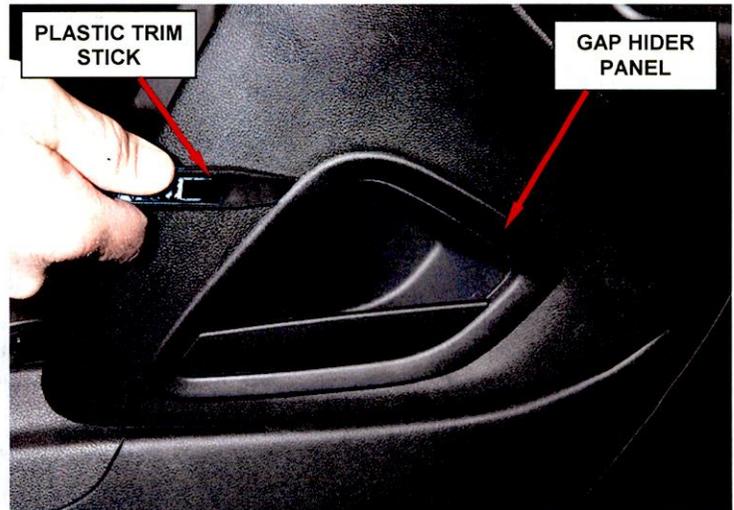
Figure 6 – Gap Hider Panels on Side of Center Console (right side shown)

i. Remove and save the right and left gap hider panels on the side of the upper console assembly (Figure 6).

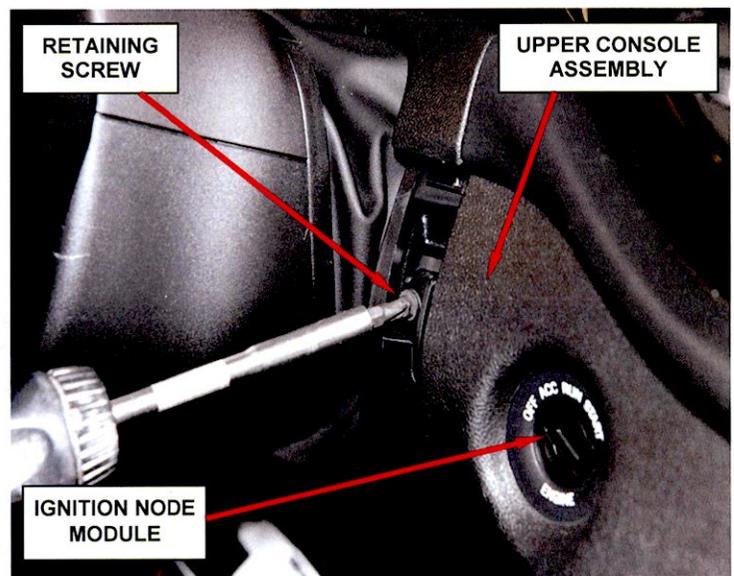
Figure 7 – Upper Console Assembly Retaining Screw

l. Remove and save the one upper console assembly retaining screw (Figure 7).

- i. Snap the upper console assembly into place and install the retaining screw (Figure 7 and 8).
 - j. Install the left side knee bolster.
 - k. Install the instrument panel left side end cap.

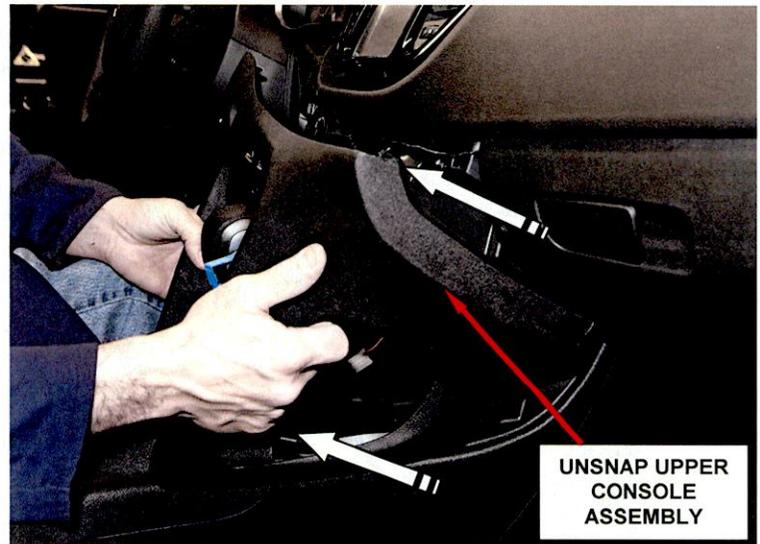
Figure 8 – Upper Console Assembly

- m. Remove and save the upper console assembly (Figure 8).
- n. Remove and save the center console bin.
- o. Remove and save the two center console front fasteners.
- p. Remove and save the right and left center console side panels (Figure 9).
- q. Disconnect the center console wire connectors (Figure 9).
- r. Remove and save the center console assembly from the vehicle.
- s. Release the park brake.

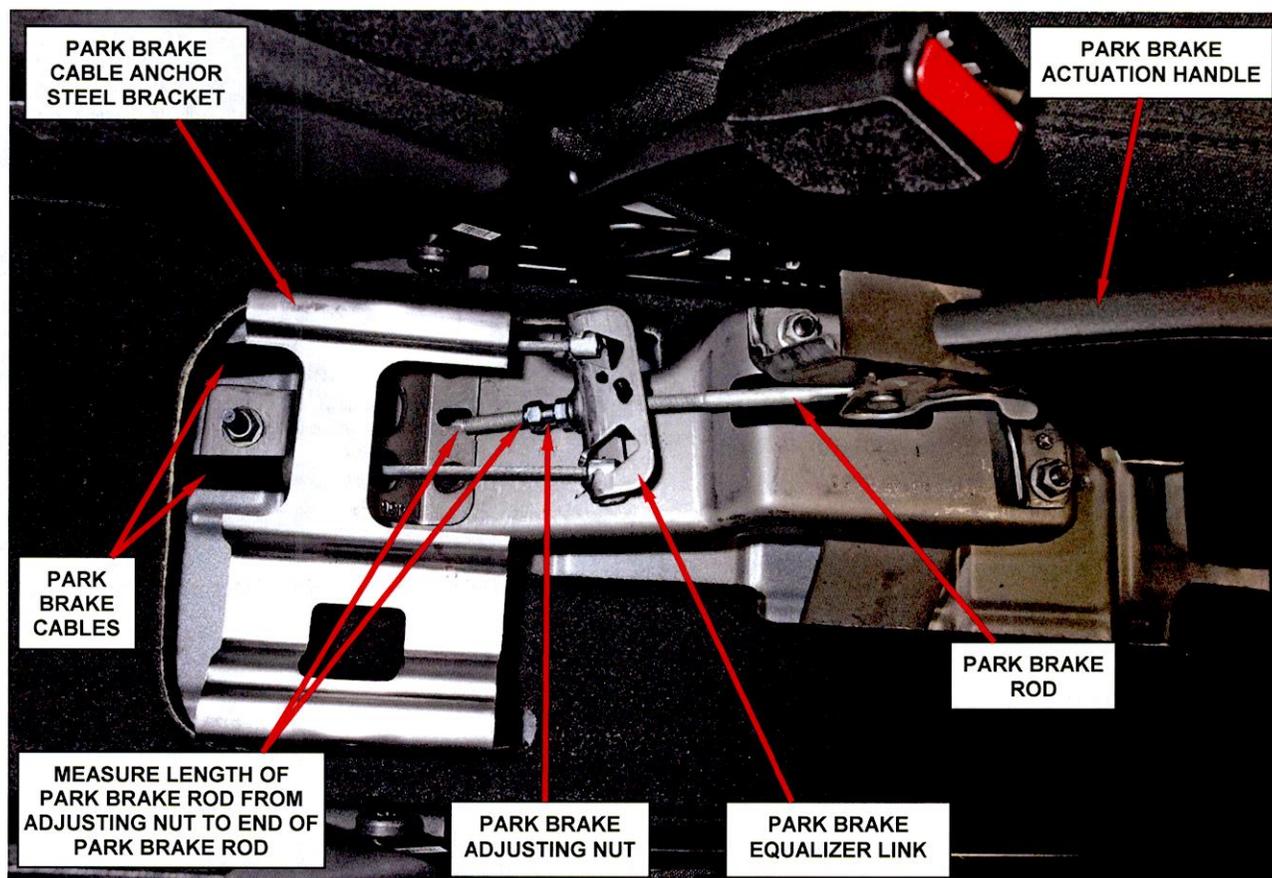
Figure 10 – Park Brake Components

3. Measure and record the distance the park brake rod sticks out past the park brake adjusting nut (Figure 10).

4. Loosen the park brake adjusting nut and disengage the park brake cable(s) from the park brake equalizer link (Figure 10).

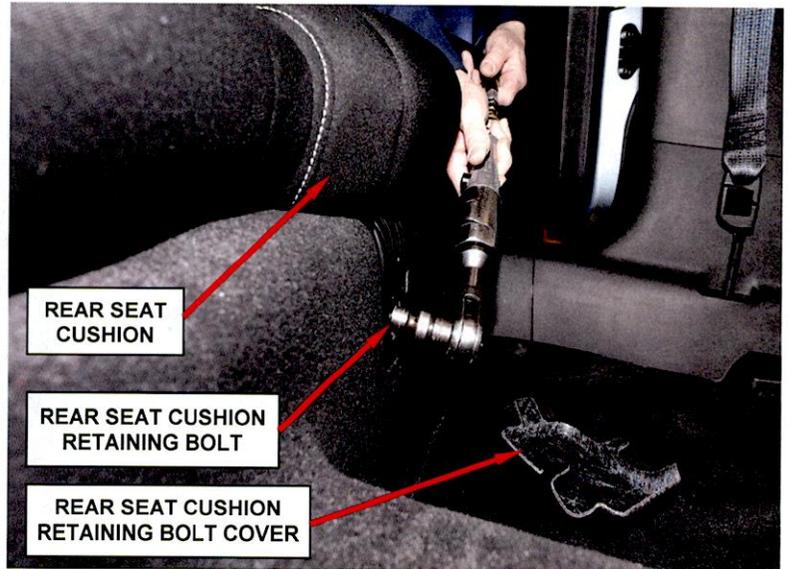
Figure 11 – Rear Seat Cushion Cover and Fasteners

5. Remove and save the right and left side rear seat cushion retaining bolt covers (Figure 11).
6. Remove and save the rear seat cushion retaining bolt bolts (Figure 11).
7. Remove and save the rear seat cushion from the vehicle.
8. Remove and save the right and left rear door opening sill plates.

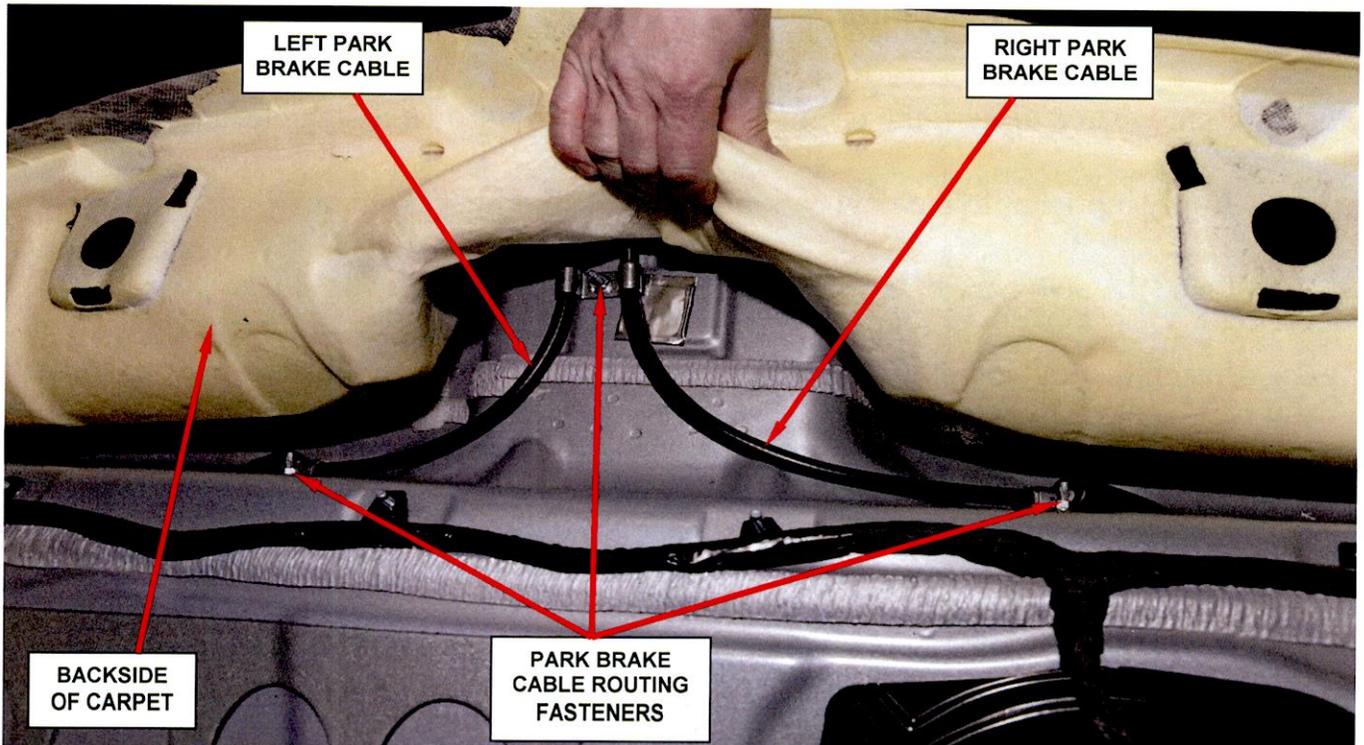
Figure 12 – Park Brake Cable Routing Fasteners

9. Pull the carpet back to gain access to the park brake cables (Figure 12).
10. Remove and save the park brake cable routing fasteners (Figure 12).

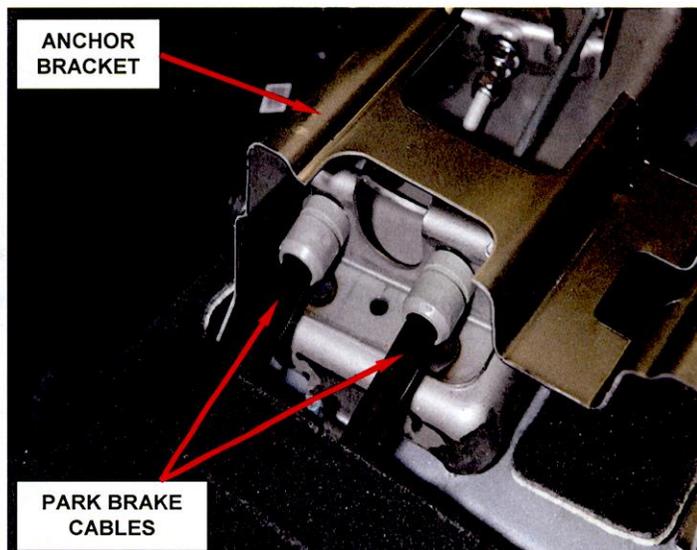
Figure 13 – Park Brake Cable Anchor Bracket

11. Disengage the park brake cable(s) from the park brake cable anchor bracket (Figure 13).

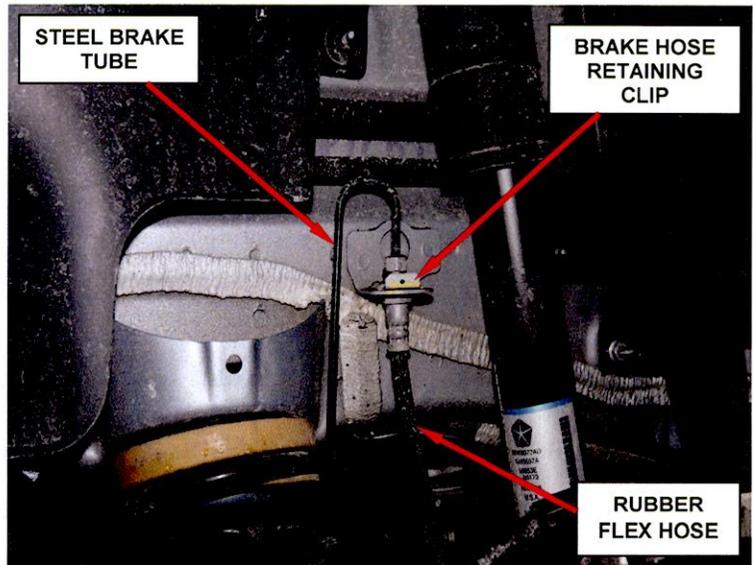
Figure 14 – Rubber Flex Hose Connection

1. Raise the vehicle on an appropriate hoist.
2. Disconnect the steel brake tube from the rubber flex hose at the frame rail (Figure 14).
3. Remove and save the rubber flex hose retaining clip at the frame rail bracket (Figure 14).
4. Disconnect the rubber flex hose bushing from the hose guide bracket (Figure 15).
5. Remove and discard the brake caliper pin retaining bolts.
6. Carefully remove the brake caliper from the brake caliper adapter bracket.

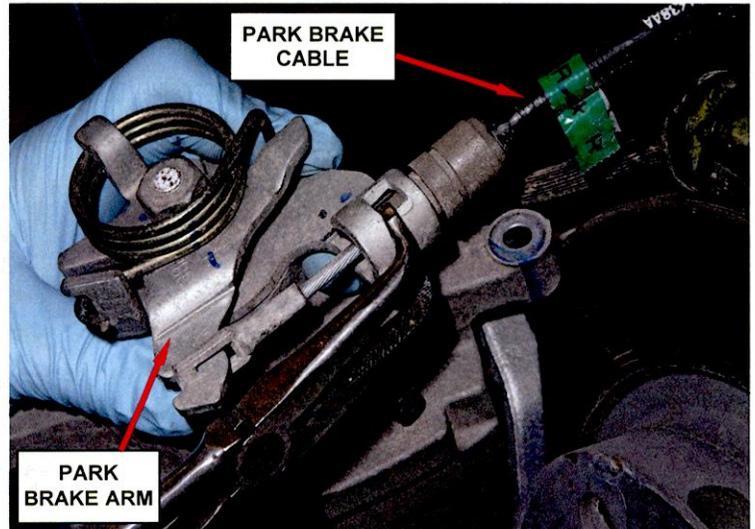
Figure 16 – Park Brake Cable at Brake Caliper

7. Disconnect the park brake cable from the brake caliper (Figure 16).

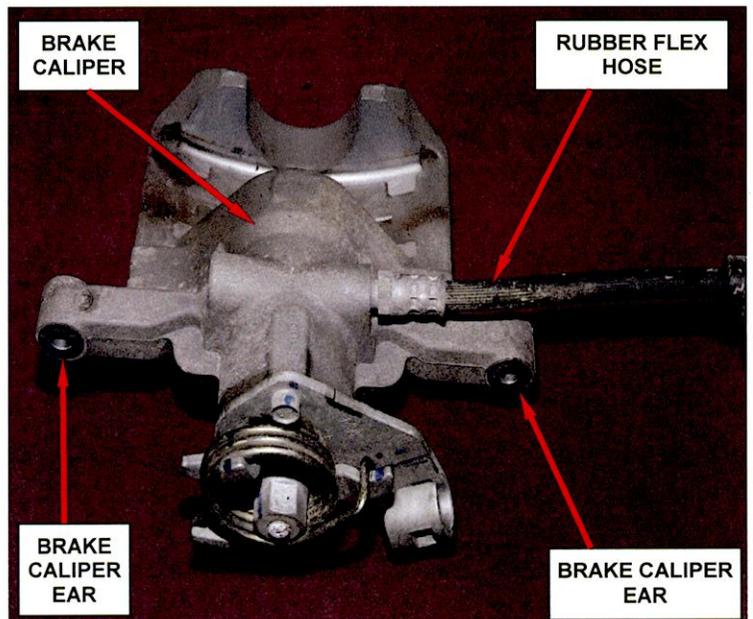
Figure 17 – Rubber Flex Hose at Brake Caliper

8. Transfer the rubber flex hose from the old brake caliper to the new brake caliper (Figure 17).

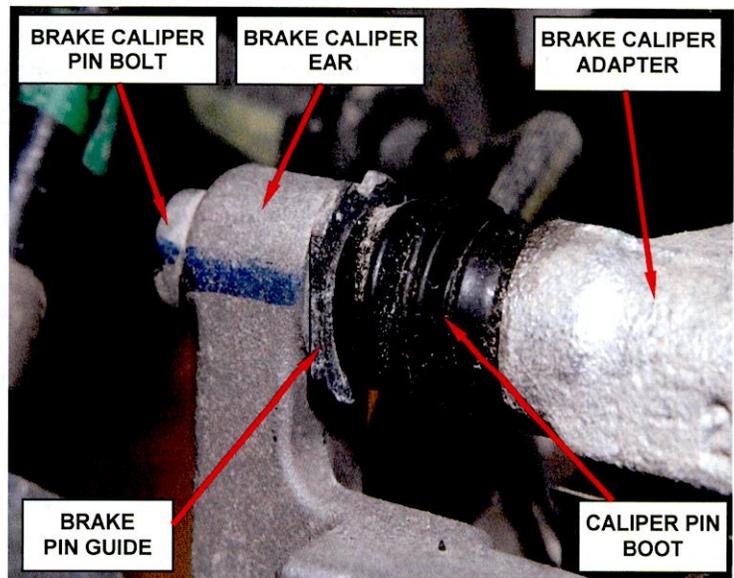
Figure 18 – Brake Pin Guide

9. Connect the park brake cable to the brake caliper.
10. Install the brake pads, brake pad springs, and new brake caliper.
11. Install the new brake caliper pin retaining bolts (Figure 18). Tighten the bolts to 26 ft. lbs. (34 N·m).

NOTE: The brake pin guide must be indexed as shown in Figure 18.

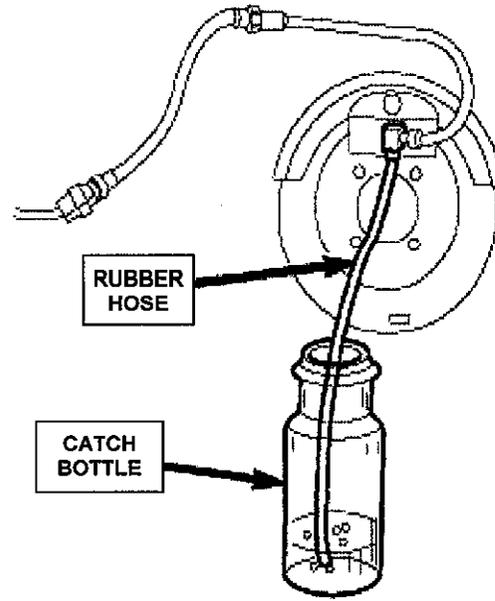
Figure 19 – Bleed Bottle and Hose (typical)

1. Fill the brake reservoir with Mopar DOT 3 brake fluid.
2. Raise the vehicle on the hoist.
3. Attach a hose and catch bottle to the bleeder screw (Figure 19).
4. Open the bleeder screw.
5. Pump the brake pedal several times or until no more air is in the catch bottle hose.
6. Close the bleeder screw.
7. Repeat Steps 1 through 6 if a second brake caliper requires bleeding.
8. Lower the vehicle from the hoist.
9. Continue with **Section G. Erase Diagnostic Trouble Codes.**
