Passenger Side Bench Seat D-Ring

2000-2012 VN, VHD

RVXX1204, Passenger Side Bench Seat D-Ring

(May 2013)

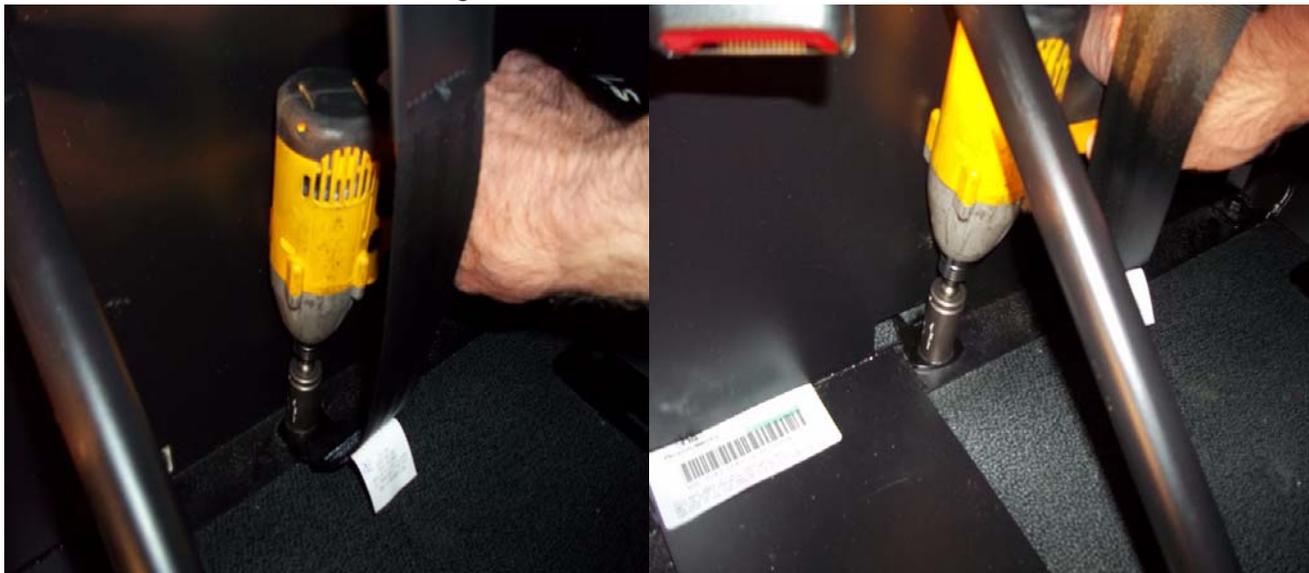
5. Remove the fasteners securing the seat belt tether brackets to the cab.

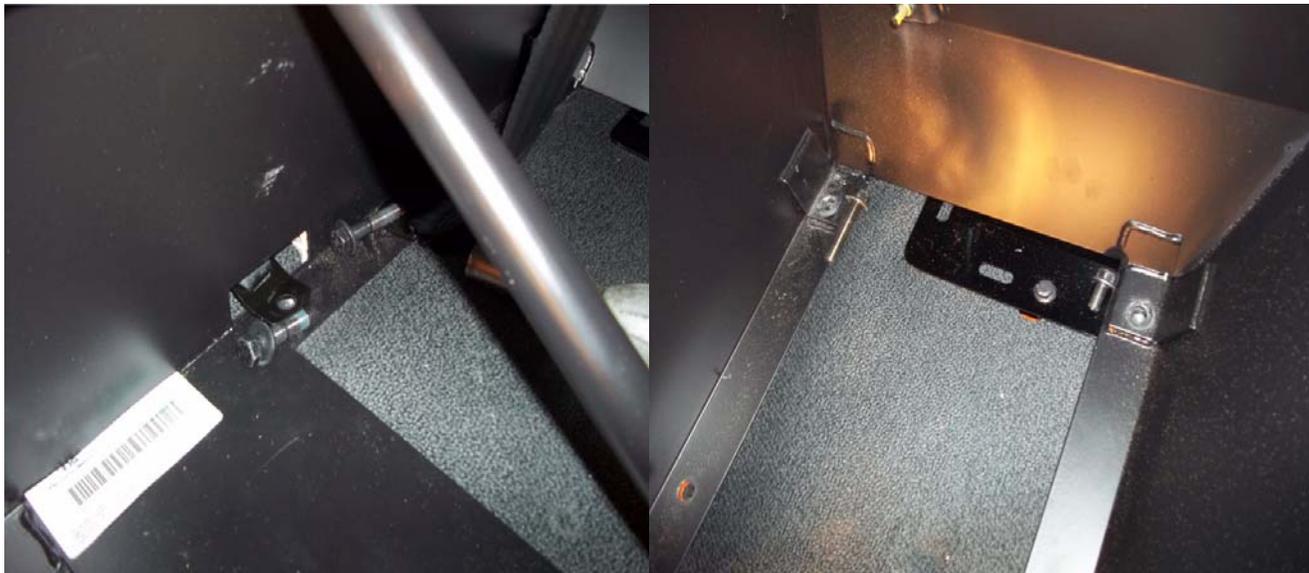
6. Remove the remaining fasteners securing the seat base. Note the fasteners location for reinstallation purposes.

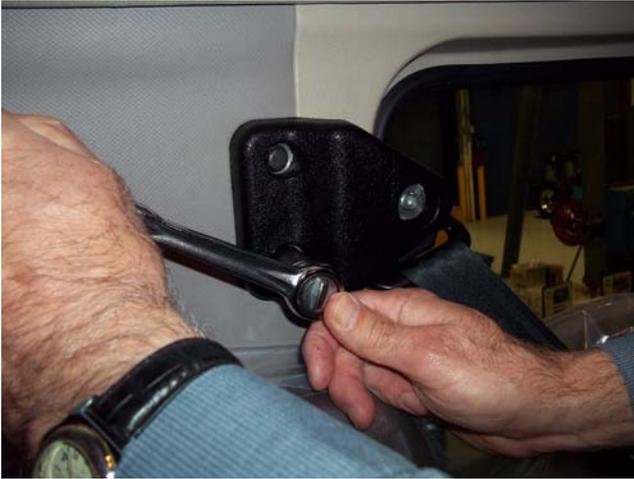
8. Remove the fasteners securing the D-ring bracket to the cab.

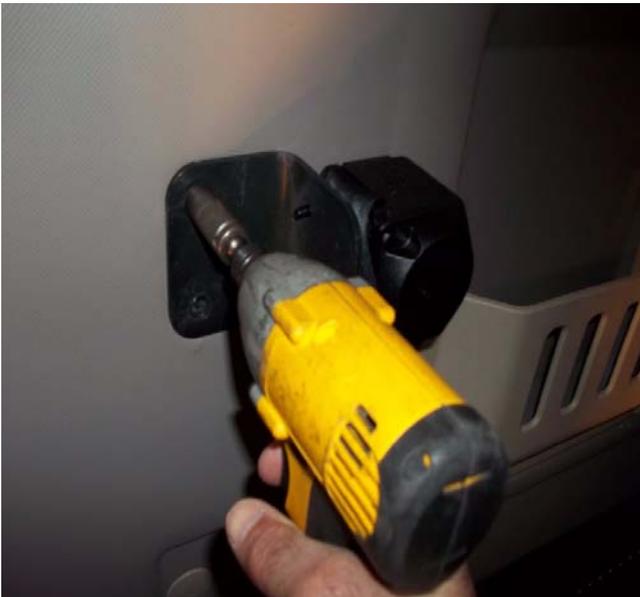
9. Remove the fasteners securing the retractor bracket to the cab.

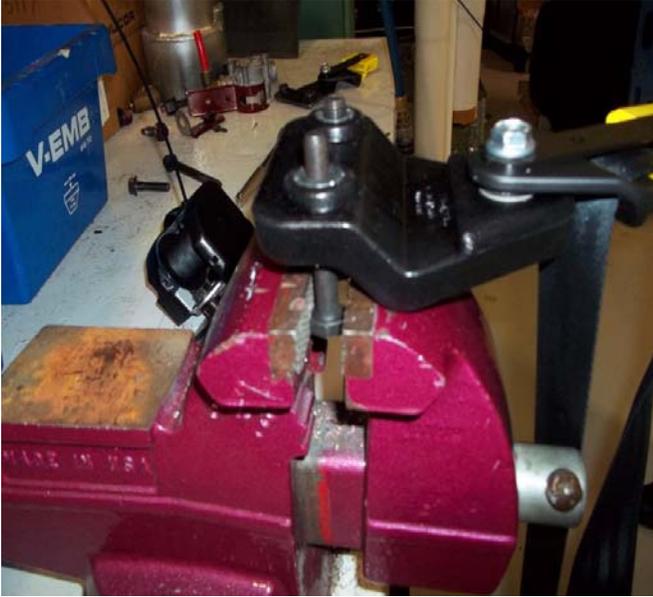
To avoid damage to the D-ring, do not clamp the D-ring directly into the vise.

11. Using suitable bolts or tools in a vise, secure the D-ring bracket.

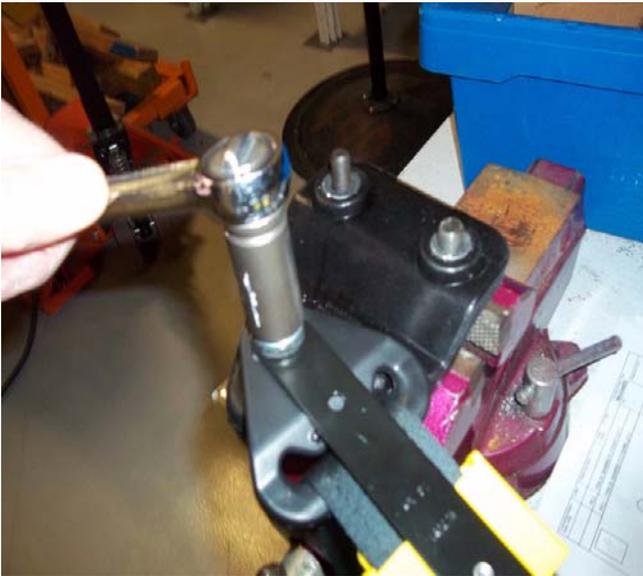
12. Remove the fastener securing the swivel and comfort latch to the D-ring bracket. Remove the D-ring.

To avoid damage to the D-ring, do not clamp the D-ring directly into the vise.

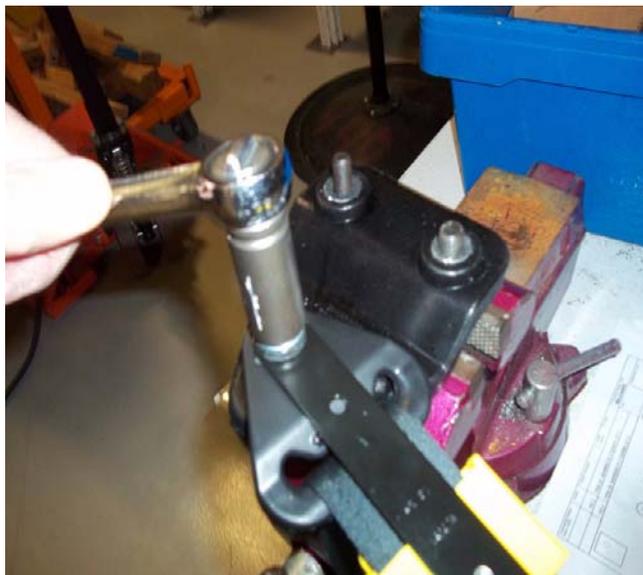
13. Using suitable bolts or tools in a vise, secure the replacement D-ring bracket (part number 82737225).
14. Using the supplied replacement fastener and original washers (1 x part number 85136912, bolt 7/16 UNF*32), attach the swivel and comfort latch to the replacement D-ring. Torque fasteners to 68 +/- 7 Nm (50 +/- 5 ft-lb).

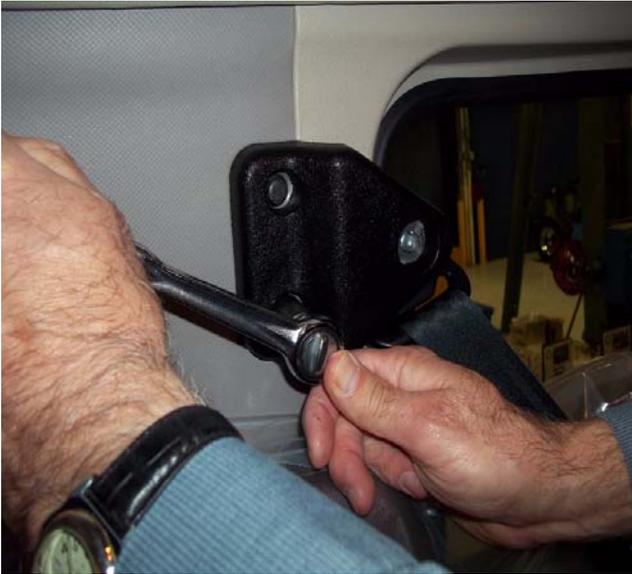
15. In the cab, using the supplied replacement fasteners, install the replacement D-ring. Torque the fasteners to:
Upper Fastener (Part Number 995466), Bolt M8*40: 24 +/- 4 Nm (18 +/- 3 ft-lb)
Lower Fastener (Part Number 979624), 7/16 UNF*51: 68 +/- 7 Nm (50 +/- 5 ft-lb)

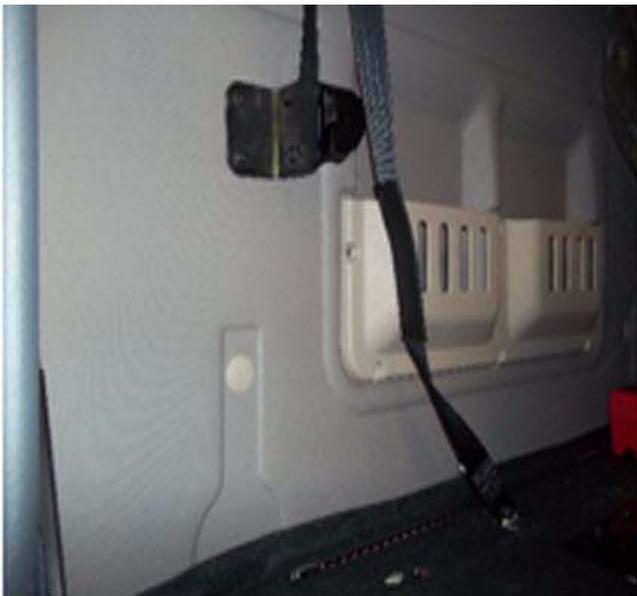
16. Using the supplied replacement fasteners (2 x part number 995466, Bolt M8*40), Install the retractor and bracket assembly in the cab. Torque the fasteners to 24 +/- 4 Nm (18 +/- 3 ft-lb).
