Bulletin No. R84002

To: CODA Service and Warranty**Subject:** Recall Campaign, Roof Mounted Side Curtain Airbag**Affected Vehicles:** CODA, Model Year 2012 VINs Listed**Release:** Initial Release

Purpose: Replace of both side curtain airbags

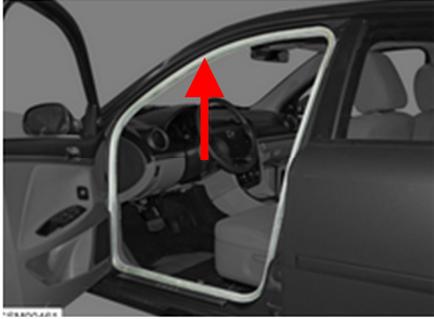
Curtain airbag must be situated in the “channel” between the door frame edge and the body guide bracket.

15. Replace both front Side Curtain attachment clips on A- pillar

16. Insure the side curtain airbag is found to be installed inboard of the body guide bracket, detach the tether at bottom of A-pillar and gently route the curtain airbag between the guide and the door frame edge and then re-attach the tether (torque 9 Nm / 7 lb-ft).
