Subject: Procedure for Replacement of BIM (Battery Isolation Manager) in
the BCC (Battery Control Center) –
Date: June 11, 2013
Release: WE_BIM_Service_Replacement_V2

This document outlines the steps to be taken for replacing Wurth Electronics Part No. X50748A, also referred to in this document as the “BIM” module.

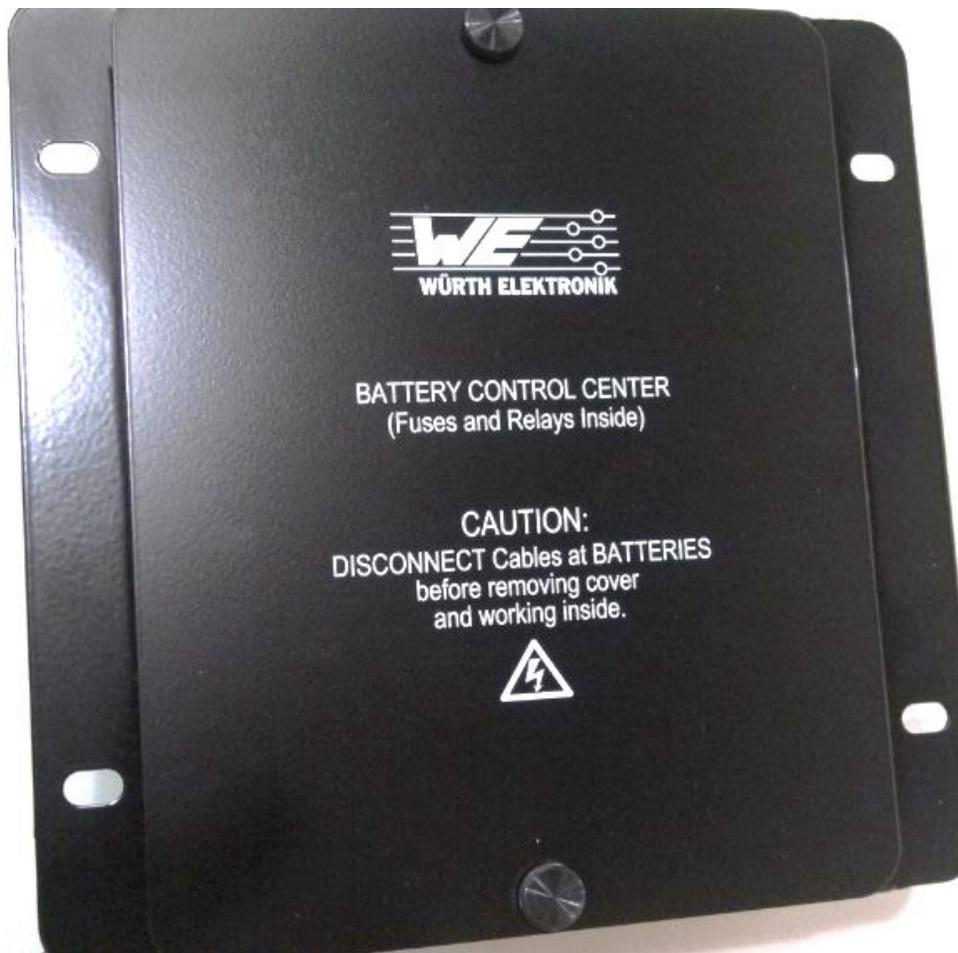
- 1.) Identify the Battery Control Center on the vehicle

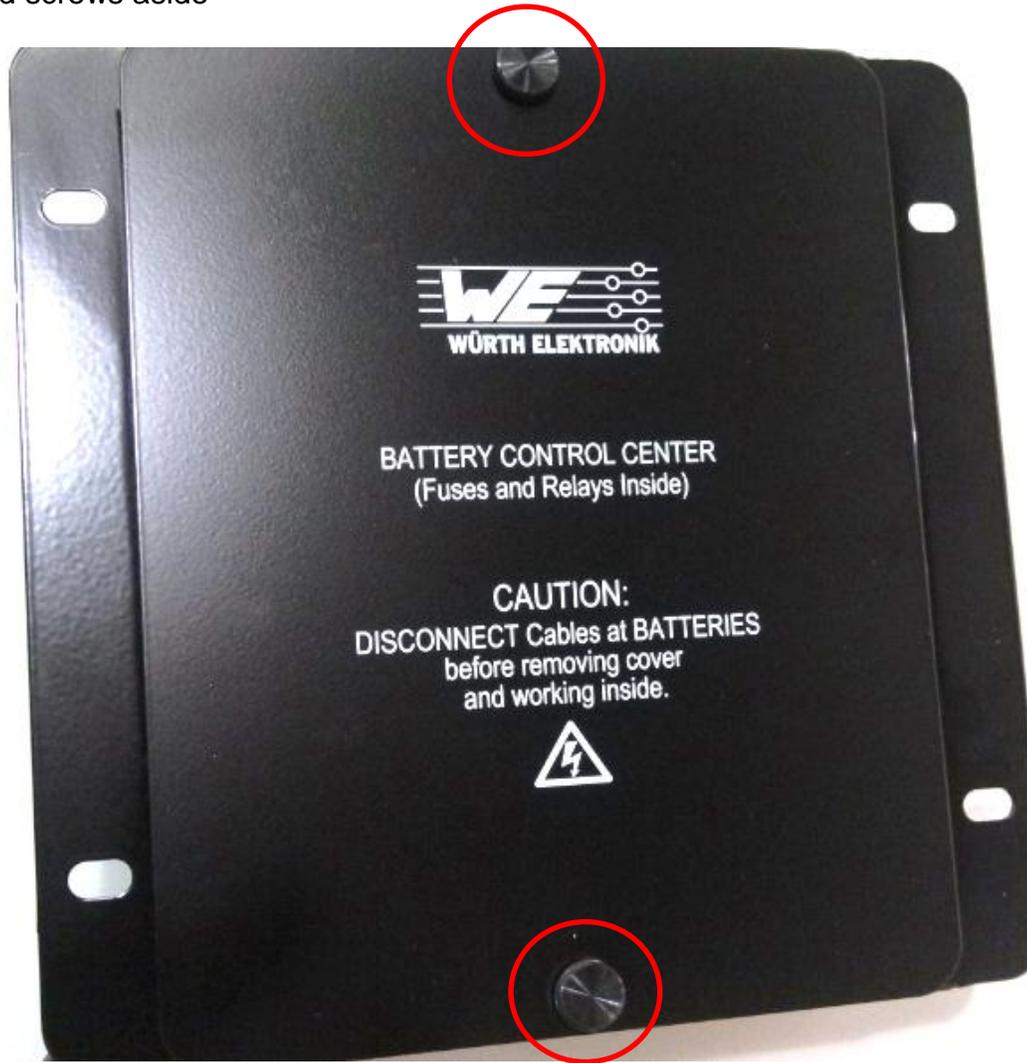
- 2.) Loosen and remove the two thumb screws from the cover and set cover and screws aside

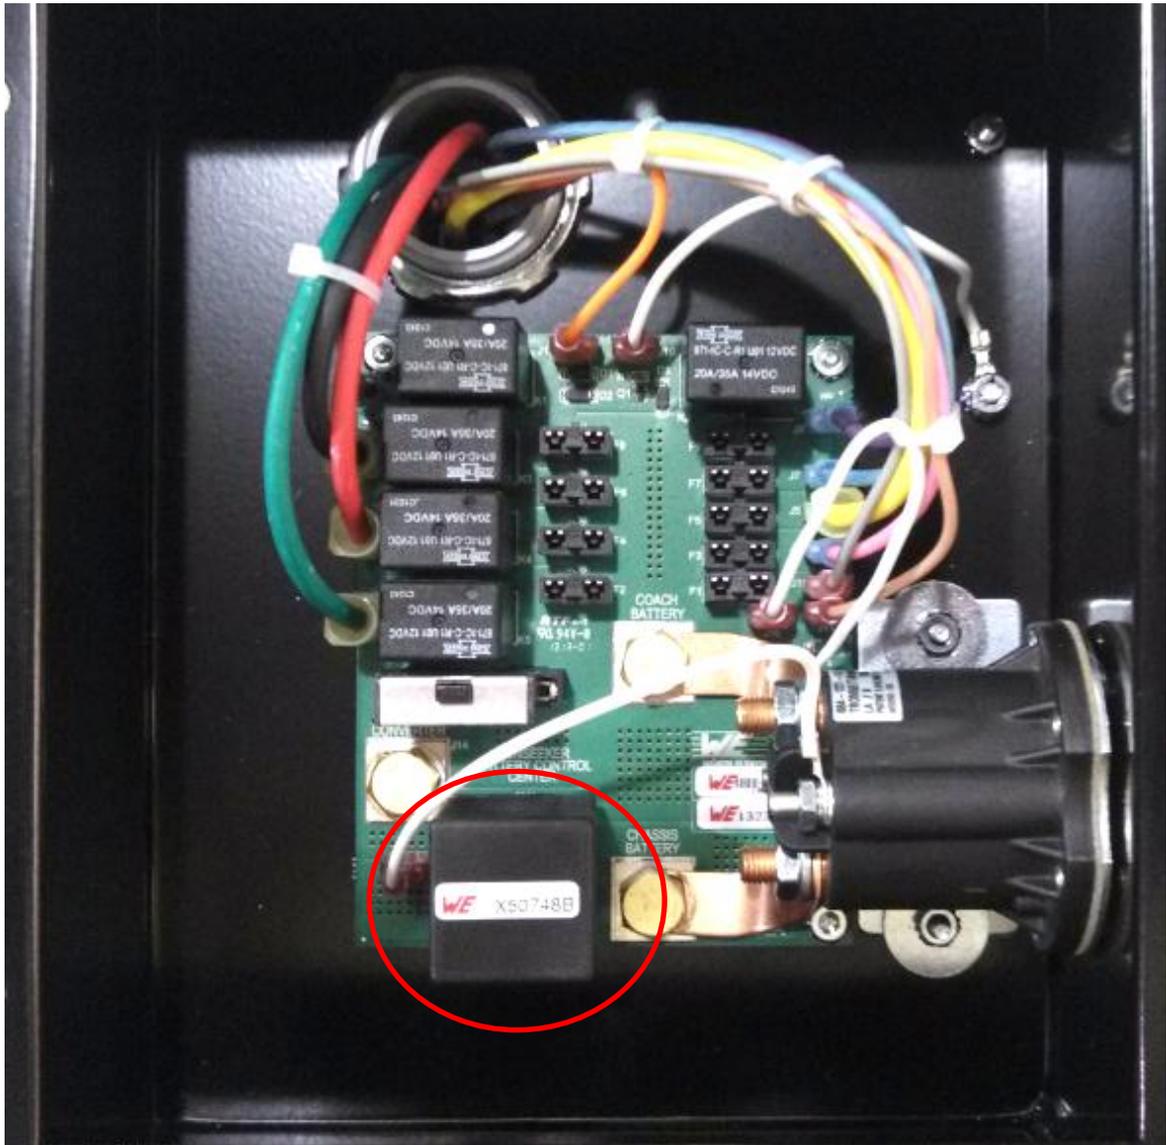
- 3.) The open Battery Control Center will then look like the image below. You can now easily identify the BIM (indicated by a red circle) at the bottom left of the Battery Control Center board.

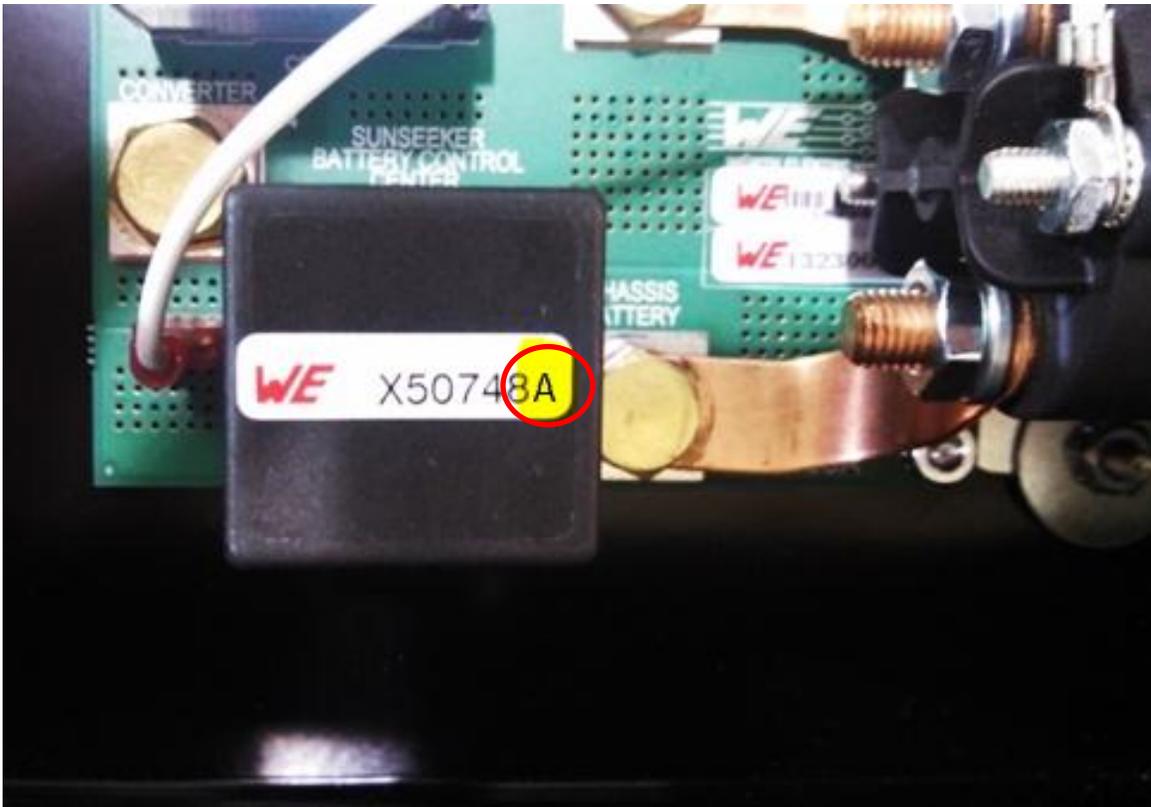
If the module part number ends with the letter "A" in the last character position it should be replaced...see the yellow highlighted character "A" below.

If the last character of the BIM part number is different from an "A" the module is fine and does not need to be replaced. In this case skip steps 5.) - 7.) and continue with step 8.)

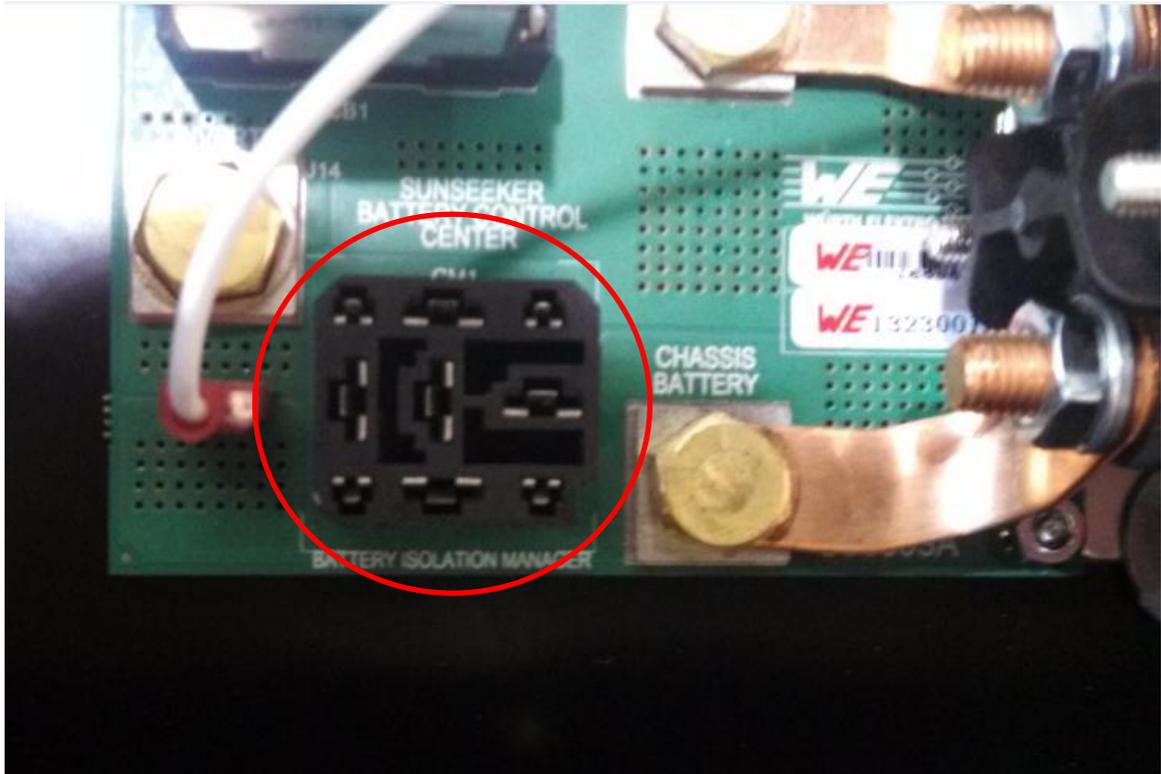
- 5.) Unplug the BIM with the “A” in the last character and dispose of it. It can be treated as standard waste as it is a RoHS compliant component. The Battery Control Center board now shows the empty BIM socket.

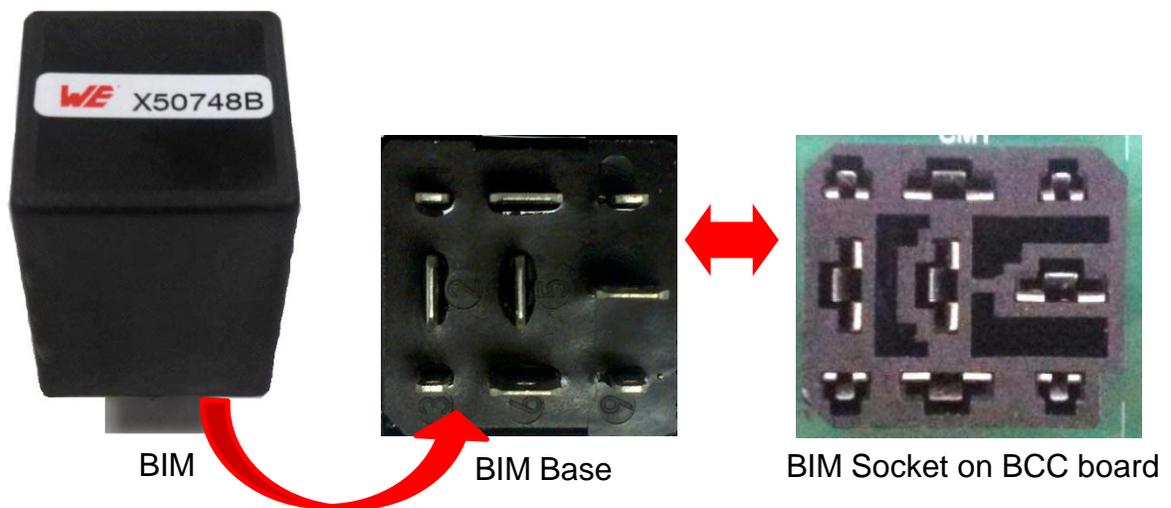
- 6.) Take the replacement BIM (does not have an “A” as the last character in the part number) and orientate the bottom interface with 9 contacts so that it matches the slot pattern of the socket in the Battery Control Center

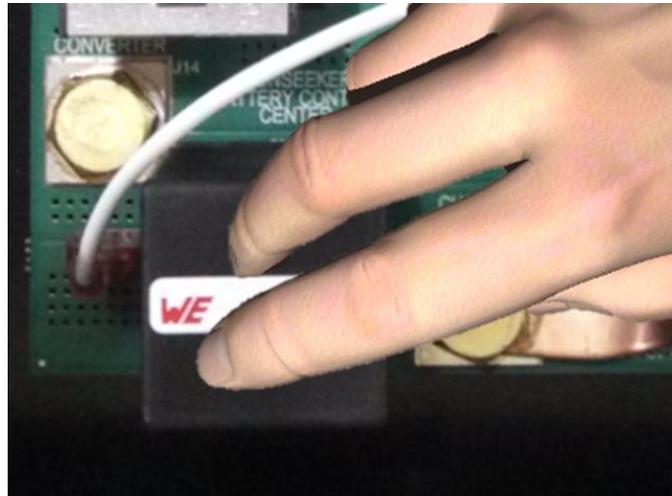
- 7.) Gently place the new BIM into the socket. If orientations of BIM and socket match the 9 blade connectors will sit inside the socket contact openings ready for being pushed down into the socket. Now push the BIM completely down into the socket.

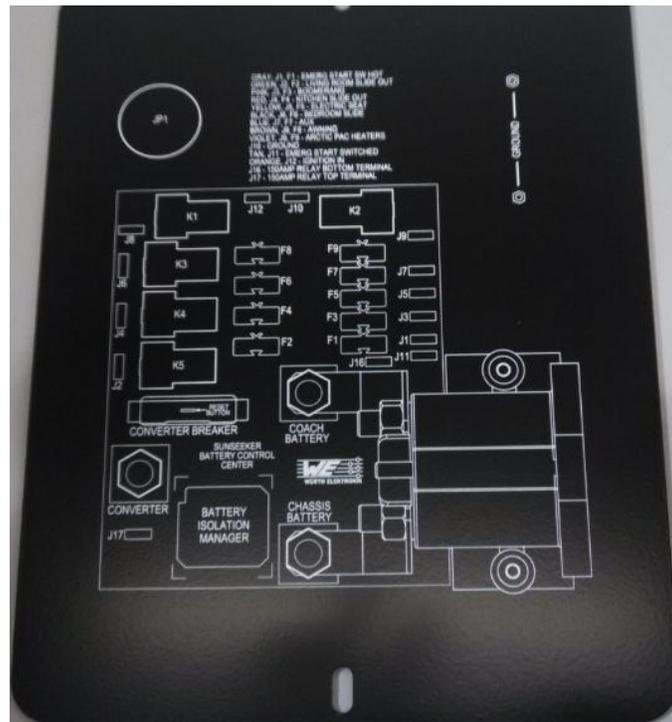
Battery Control Center – Cover / Inside Surface

- 8.) Place the cover back onto the Battery Control Center. Make sure the schematic (shown below) is on the inside.

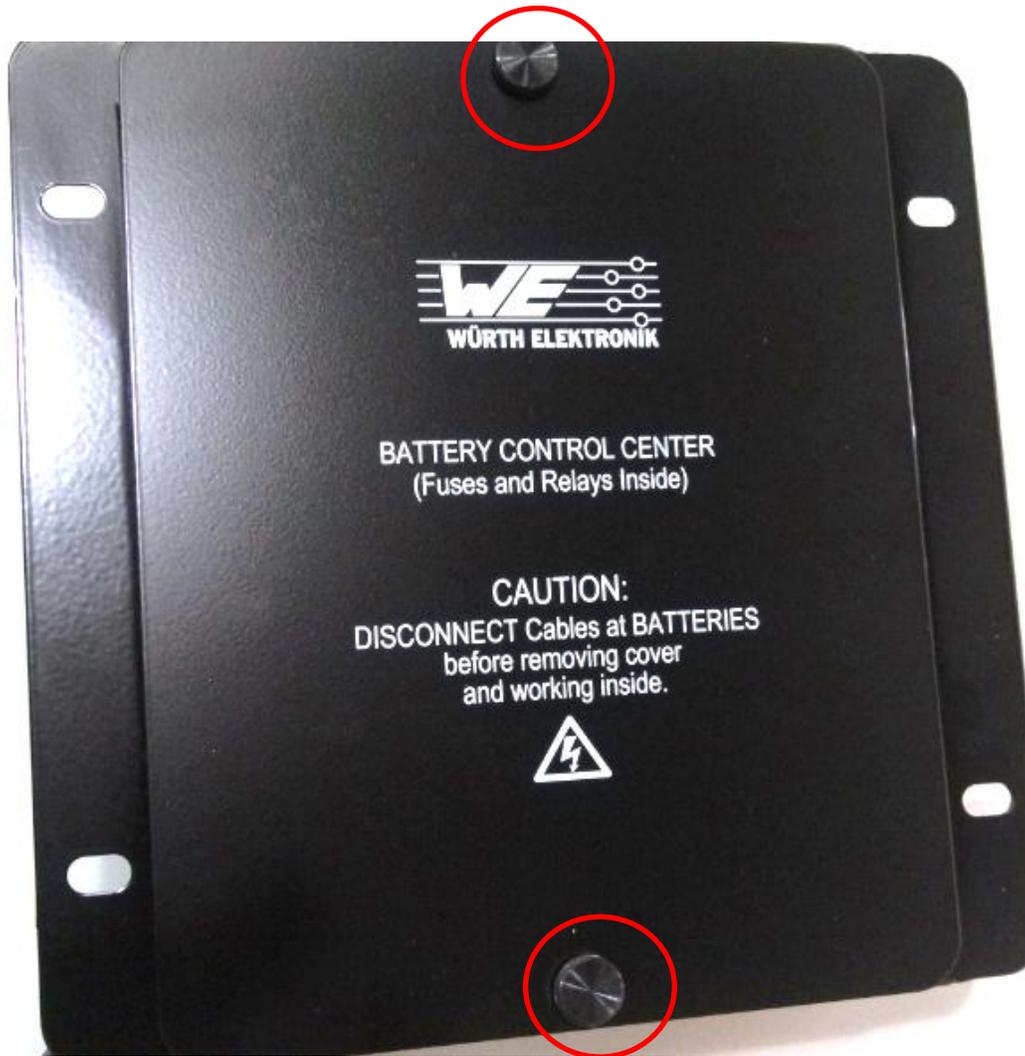
9.) Secure the cover on the Battery Control Center with the two thumb screws.
