R13WG

Service Brake Switch Adjustment Inspection

Models Affected: Certain 2014 Model Year Vision Buses Equipped with Ford 6.8L Propane Engines

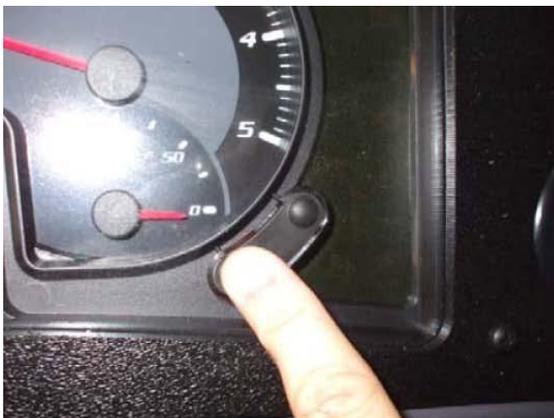
PICTURE 1

Step 3. Locate push button switches on instrument cluster. Switches are located in the bottom right corner. (See picture 1)

Step 4. Press and hold the lower push button switch (picture 1) until the display changes as shown in (picture 2)

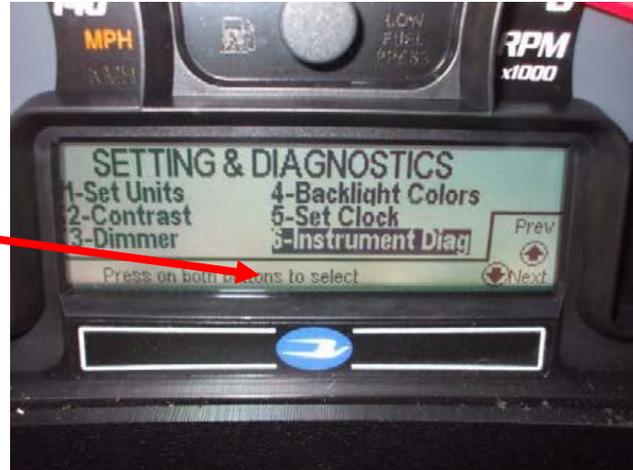
PICTURE 3

Step 5. Using the bottom button scroll through the menus, until you see highlighted: "6-INSTRUMENT DIAG" (see picture 3)

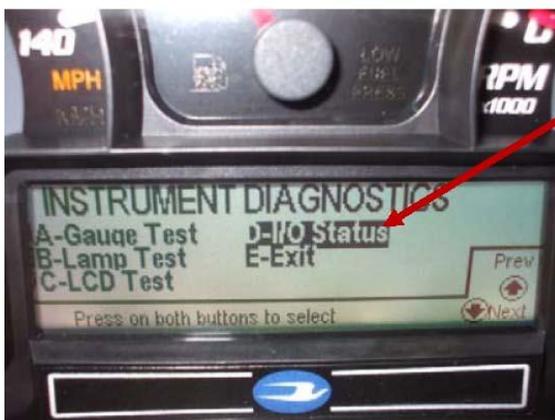
PICTURE 4

Step 6. Press both buttons simultaneously to select the highlighted choice. This will now bring you to the following screen shown in (picture 4): "INSTRUMENT DIAGNOSTICS"

Use the bottom button to scroll through and highlight: D-I/O STATUS.

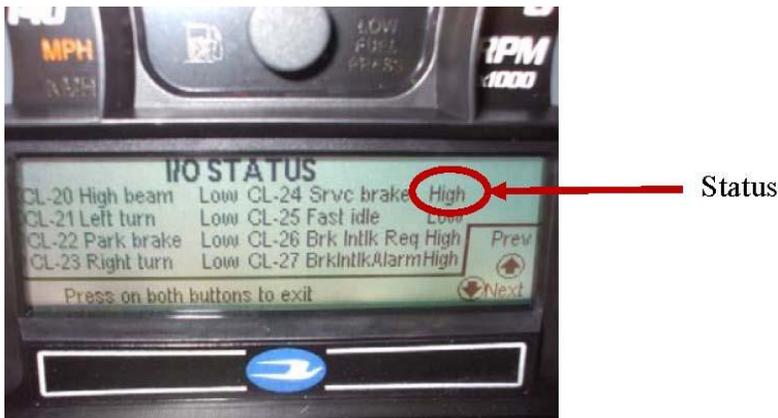
PICTURE 5

Step 7. Press both buttons simultaneously to enter into the I/O STATUS menu. (See picture 5). Using the bottom button, scroll through the menus until you come to “CL-24 Srvc brake”. This is shown in (picture 5).

At this point note the status should be displayed as “CL-24 Srvc brake High” when the brake pedal is NOT pressed.

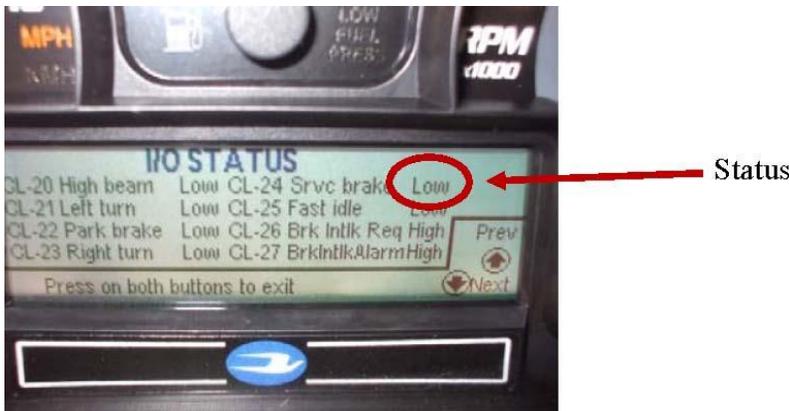
PICTURE 6

Step 8. Press the brake pedal down and note the status of CL-24. Within a downward pedal travel range of 0.50 inches or less the status should change to: “CL-24 Srvc brake Low”. (See picture 6)

If the display changed from High to Low, within the downward pedal travel range of 0.50 inches or less the service brake switch is adjusted correctly. Inspection procedure is complete. No adjustment required. Return bus to service.

If the display did NOT change from High to Low, within the downward pedal travel range of 0.50 inches or less the service brake switch is NOT adjusted correctly. See the following service brake switch adjustment and replacement procedure.

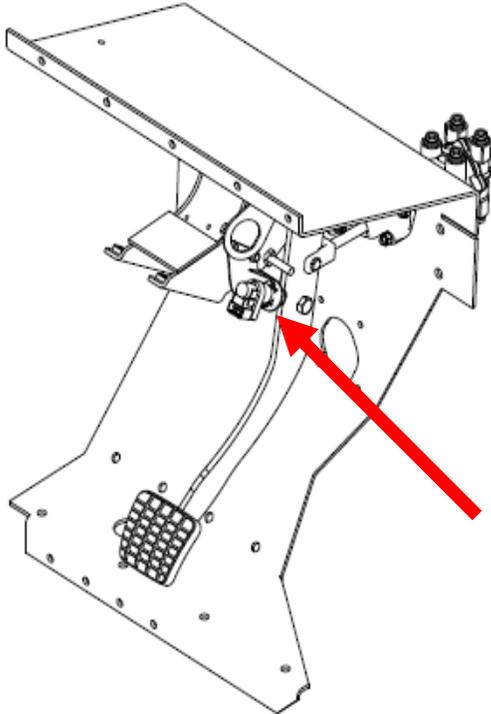
SWITCH INSTALLED

Step 1. Remove existing service brake switch. See "Switch Installed" detail for location of switch.

Note: New switch should **NOT** be installed until adjustment procedure is complete.

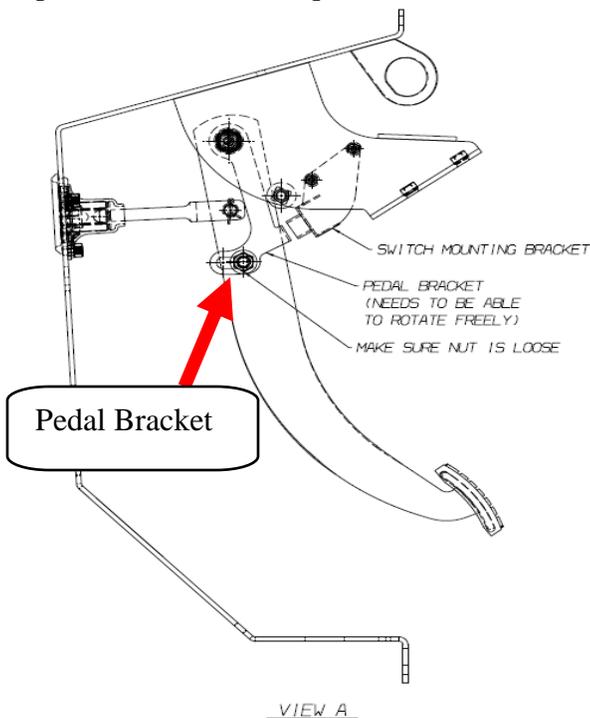
VIEW A

Step 2. Loosen lower nut securing pedal bracket so pedal bracket can rotate freely. See "View A".
Step 3. Rotate pedal bracket until it stops against the switch mounting bracket. Tighten bolt on pedal bracket to a torque of 50-57 ft-lbs. See "View B".

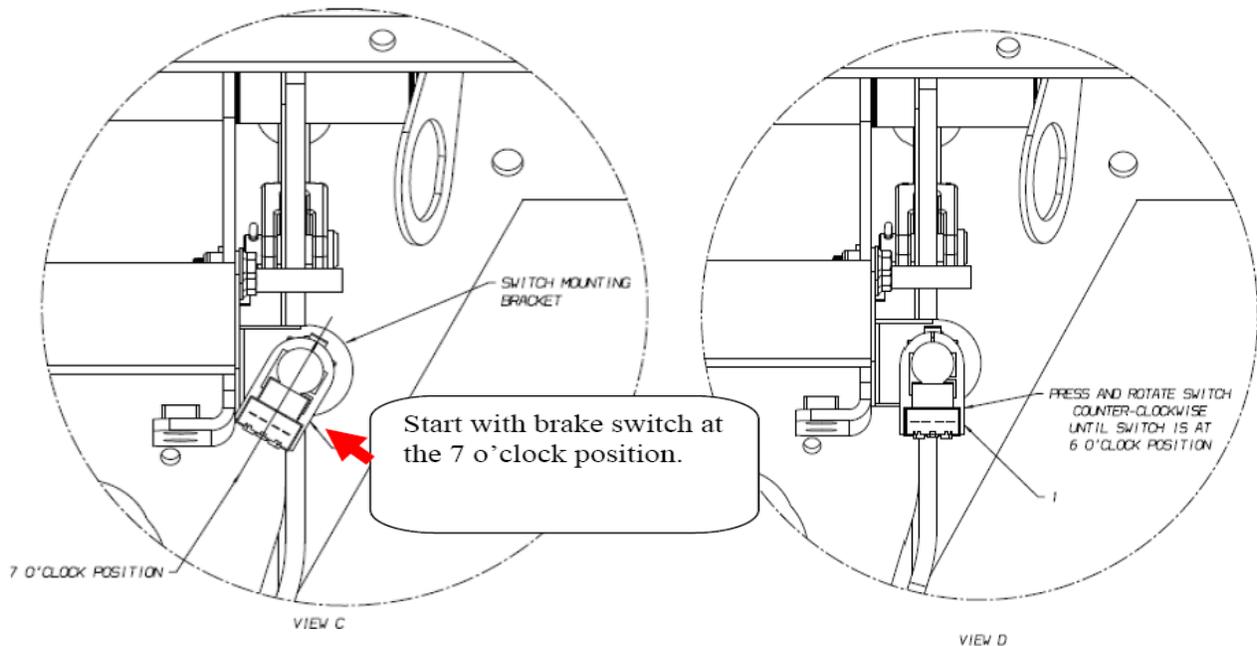
Step 5. Insert new service brake switch into the switch mounting bracket with the connector at the 7:00 o'clock position. See "View C".

Step 6. At the same time press and turn switch counter-clockwise until switch connector tabs lock into the mounting bracket at the 6:00 o'clock position. Switch self-adjusts during this step. See "View D".

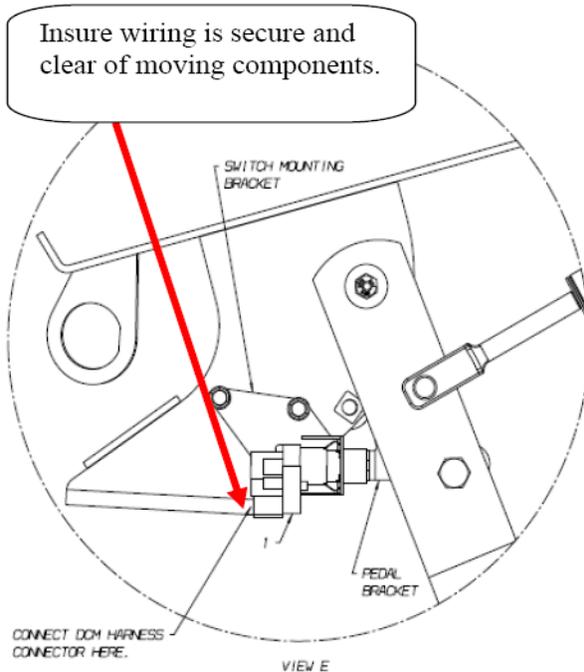
Step 7. Reconnect DCM wiring harness connector to service brake switch. See "View E".
