Service Bulletin

MOTORCYCLE DIVISION
GS/GSX/GSX-R NO. 226
DATE: 07/29/2013

SUBJECT: SAFETY RECALL CAMPAIGN — ABS HYDRAULIC CONTROL UNIT

MODELS: GSX1300RAL3, GSX1300RAZL3

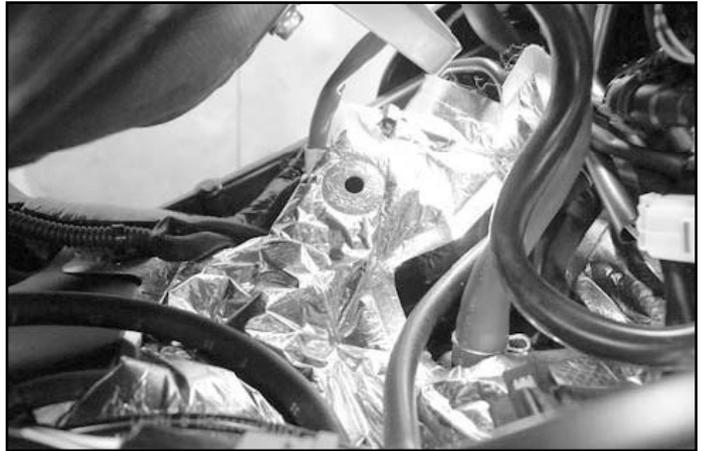
- 11) Turn over the heat shield.

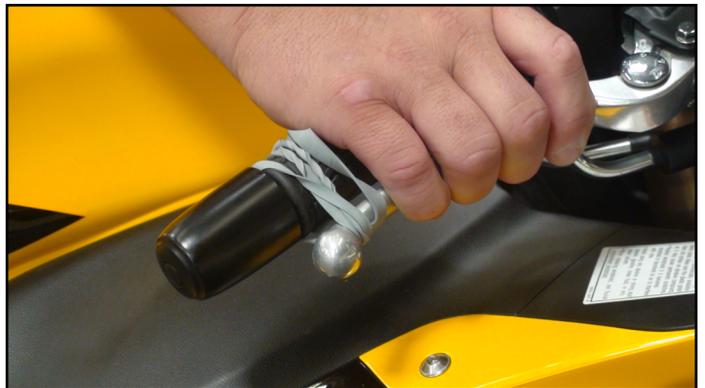
- 12) Place the motorcycle on a level surface and keep the handlebars straight.
- 13) To help prevent brake fluid leakage when disconnecting the brake lines, do this:

- Connect a bleed hose to the front caliper bleed valve.
- Pull the front brake lever fully against the handlebar **while** loosening the bleed valve.
- **Continue** to hold the lever firmly against the handlebar and secure it against the handlebar with a band or a zip tie.
- Close the bleed valve.

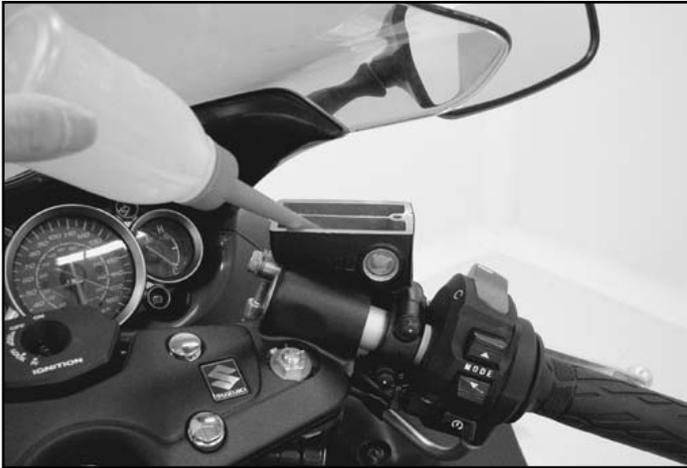
- 14) Remove the front **and** rear brake fluid reservoir caps and diaphragms, and remove as much of the old brake fluid as possible.

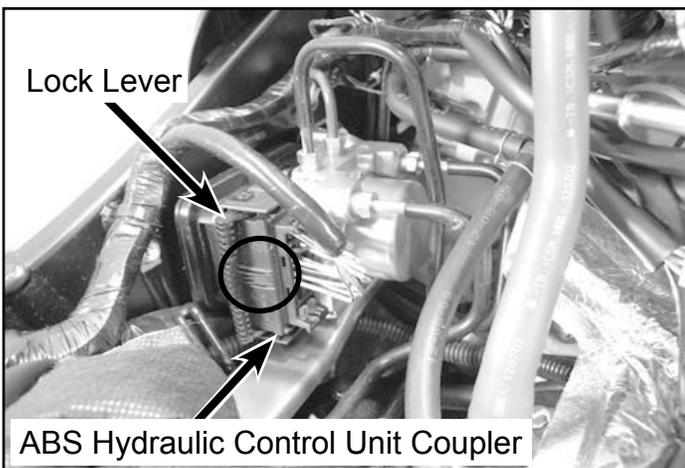
- 15) Press on the circled area in the illustration, release the lock lever and disconnect the ABS Hydraulic Control Unit from the coupler.

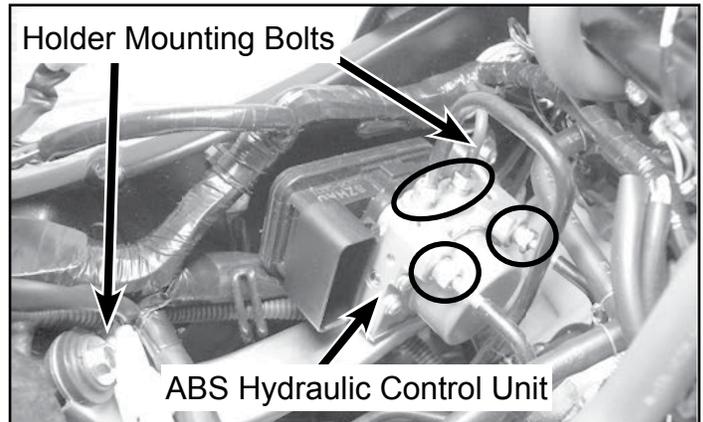
- 17) Loosen the flare nuts (circled), disconnect the brake lines, and remove the ABS Hydraulic Control Unit by removing the holder bolts.

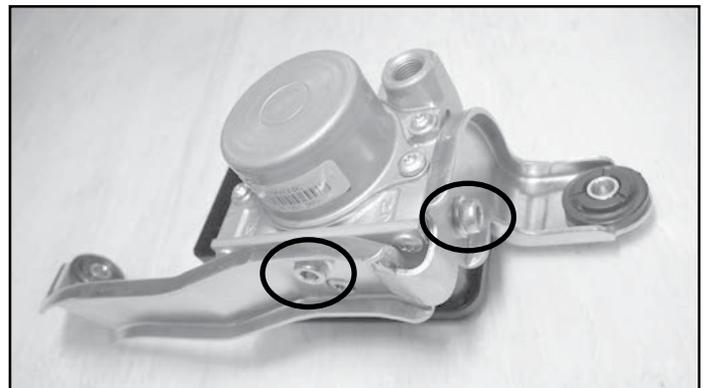
- 18) Remove the bolts (circled) and remove the ABS Hydraulic Control Unit from the holder.

**ABS Hydraulic Control Unit holder bolts:
7.0 lbf-ft (10 N·m)**

**ABS Hydraulic Control Unit mounting bolts:
8.0 lbf-ft (11 N·m)**

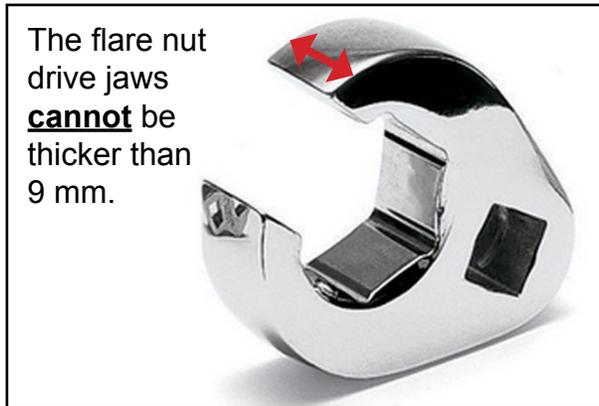
- You will need a flare nut drive, similar to the illustration below.
- The jaws of the flare nut drive jaws cannot be thicker than 9 mm. Otherwise, there will not be enough room to turn the flare nut drive while tightening the flare nuts.

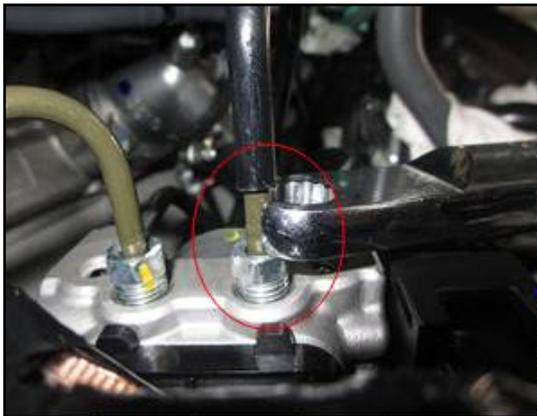
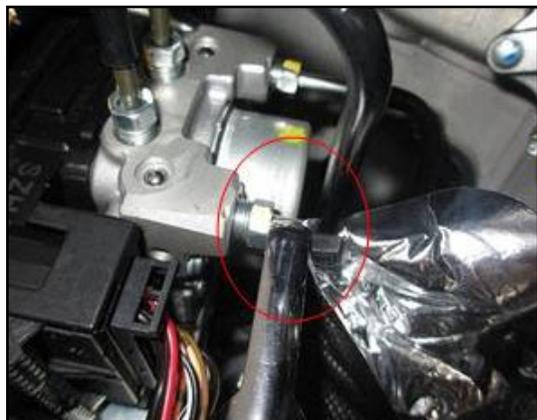
- **Very carefully and precisely tighten the flare nuts to the torque specification.**

Brake line flare nuts:
11.5 lbf-ft (16 N·m)

2) Route the brake hose lines correctly, and be sure to hold them while tightening the flare nuts so they are aligned correctly.
