**Regarding: 13V-298**

## SAFETY RECALL

### 2014 XVS95CE(C) MODELS

### FACTORY MODIFICATION CAMPAIGN – Wire Harness Routing

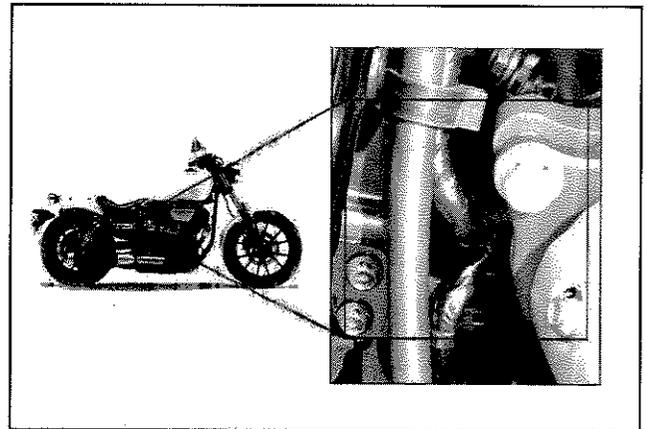
Yamaha Motor Corporation, U.S.A. has decided that a defect which relates to motor vehicle safety exists in certain 2014 XVS95CE/C "Bolt" model motorcycles. In affected motorcycles, there is a possibility that the wire harness is routed too close to the rear exhaust area allowing the wire harness to contact the rear exhaust. If this happens, heat from the exhaust could damage the wire harness which could result in engine stalling and the possibility of a crash with injury or death.

To correct this defect, Yamaha is initiating a Factory Modification Campaign. Affected units must have two retaining bands installed to hold the wire harness away from the rear exhaust area after first inspecting to be sure the wire harness has not been damaged.

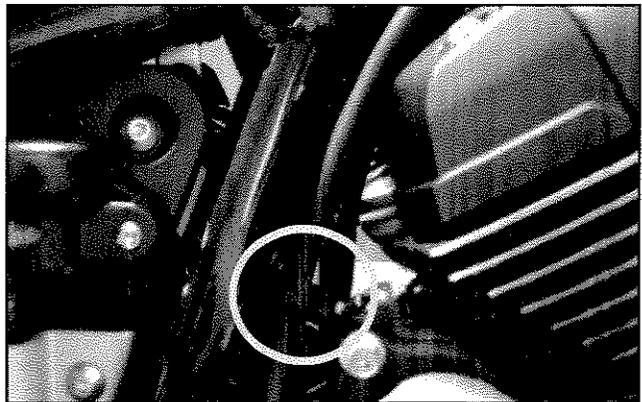
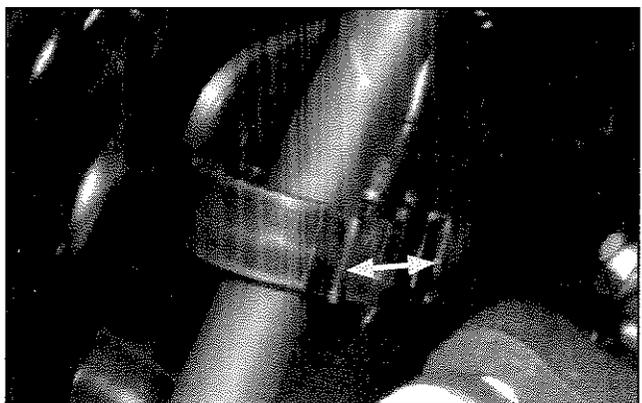
1. Make sure the engine is cold. If engine temperature is hot, allow the engine to cool before attempting this modification. Set the engine stop switch to "OFF" position to prevent engine start.
2. On sold units, check the wire harness for heat damage. If any damage is found, replace the wire harness assembly following the procedures in the XVS95CE(C) Service Manual (LIT-11666-27-30).
3. Release the clutch cable clamp (see adjacent photos).

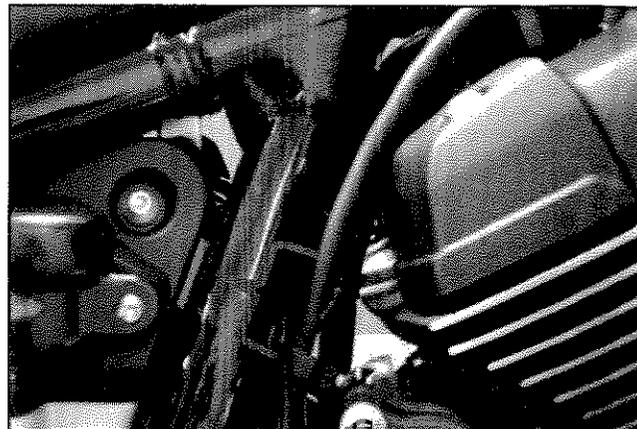
4. Take up the slack of the wire harness from the upper side of the clutch cable clamp by gently pulling it downward. Be sure the wire harness does not come into contact with the engine.

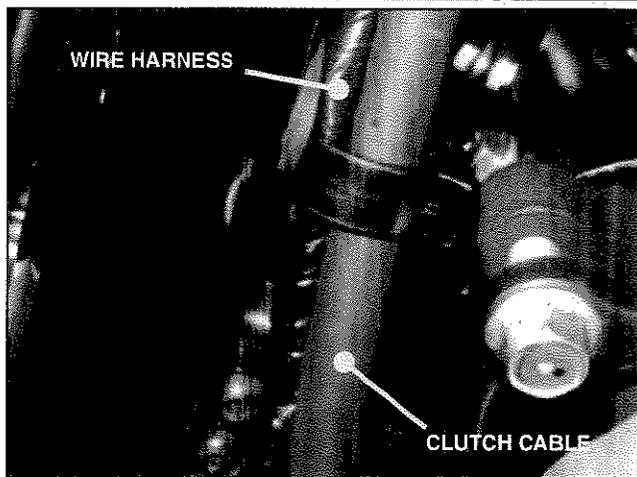
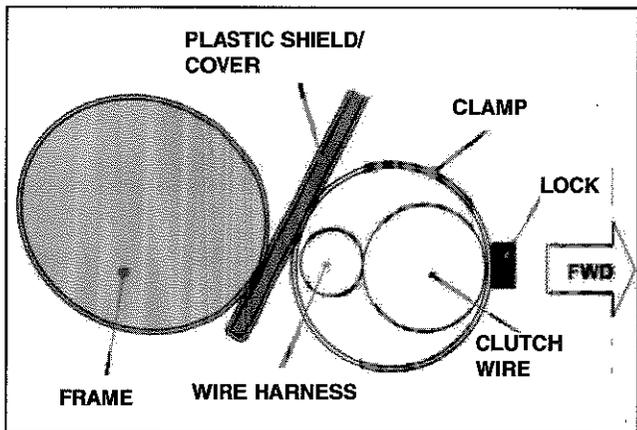
5. Route the clutch cable forward in the clutch cable clamp so that wire harness is located near the frame as follows.

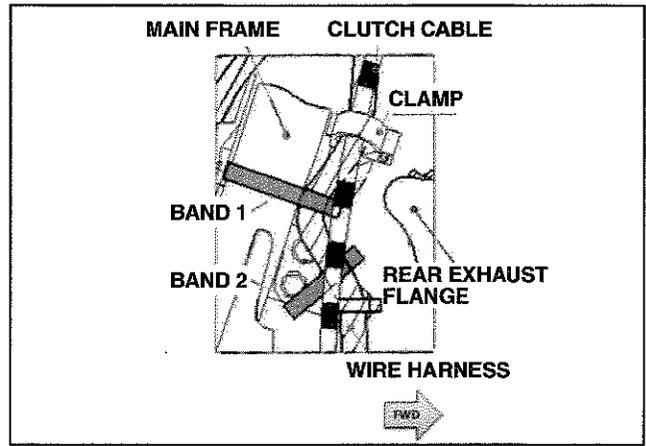
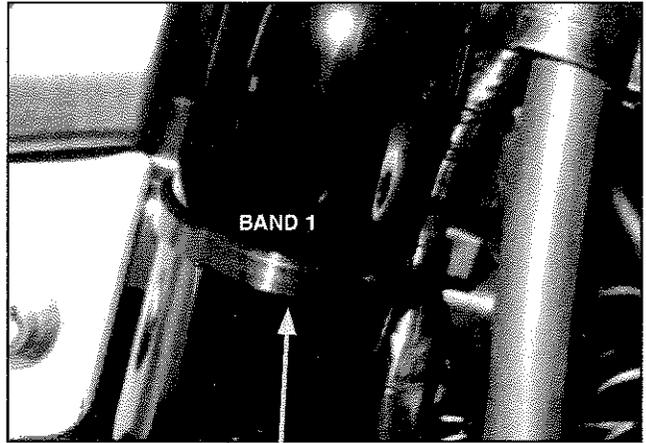
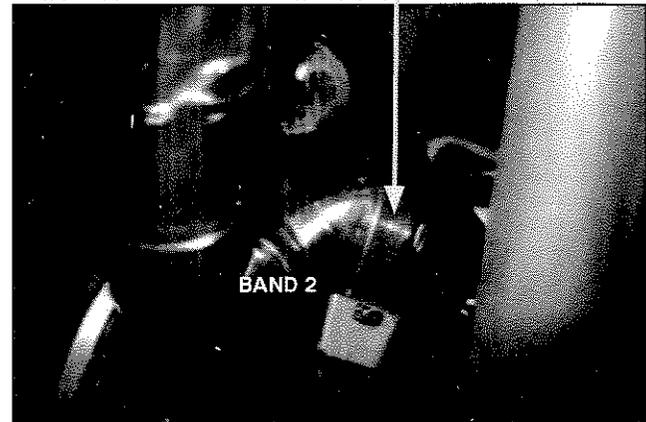
6. Fasten the wire harness to the frame with the new bands from the kit as follows:

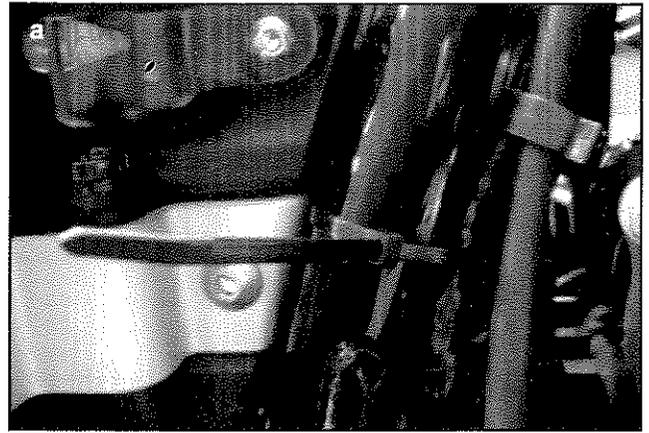
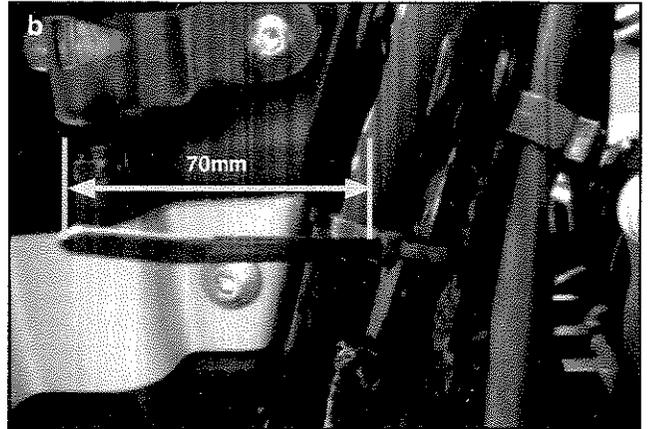
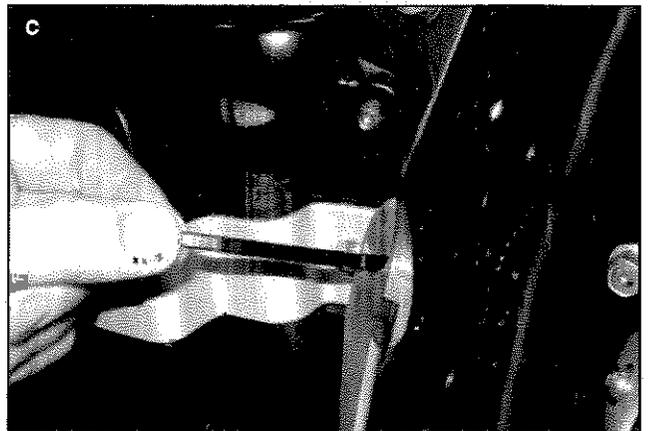
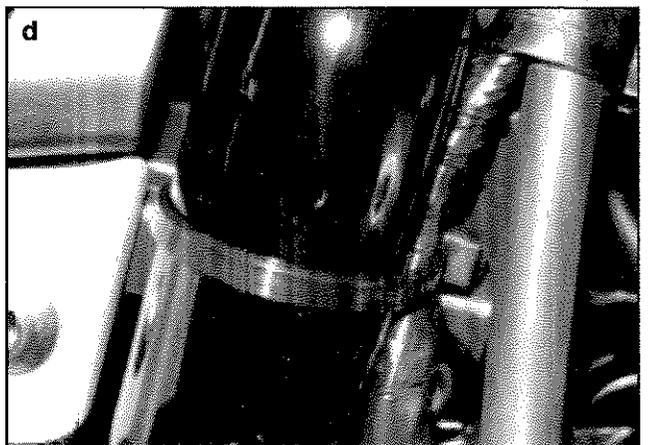
7. Starting with "Band 1," confirm that the wire harness follows the frame contour (a), then install and tighten the band to secure the wire harness.

The band is tight when more than 70mm of the end is sticking out of the band's lock (b).

Cut off the extra band (c) and make sure there are no sharp edges that could damage other parts.

Then rotate the band so its lock is to the inside of the frame (d).

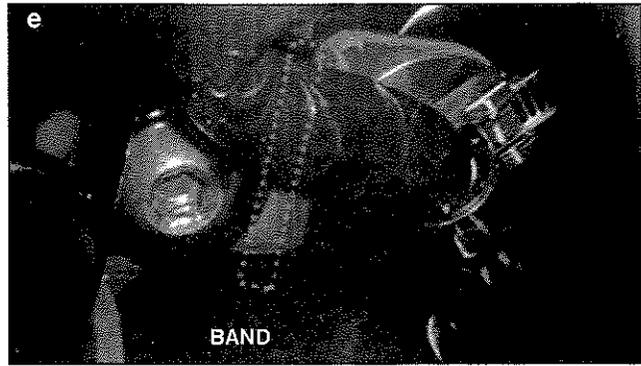
8. With "Band 2" in the groove of the bracket, fasten the wire harness to the bracket (e).

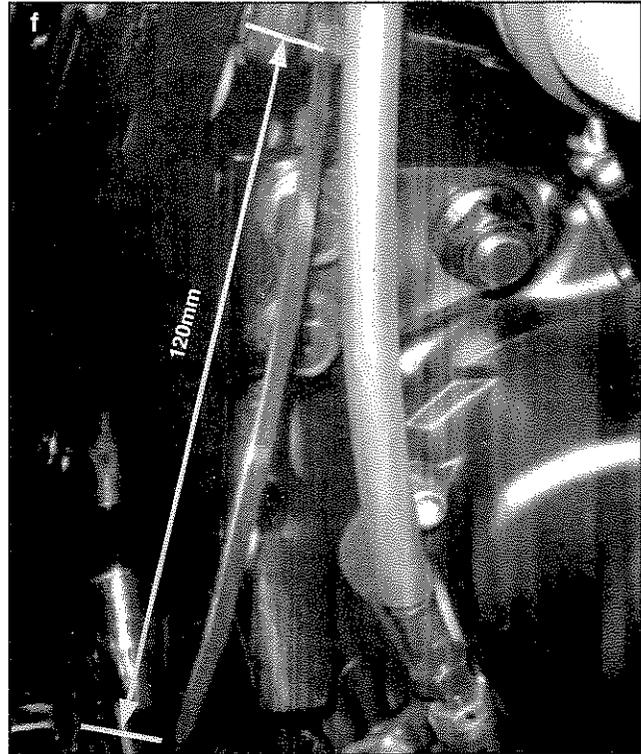
Tighten the band so that more than 120mm of the end is sticking out of the band's lock (f).

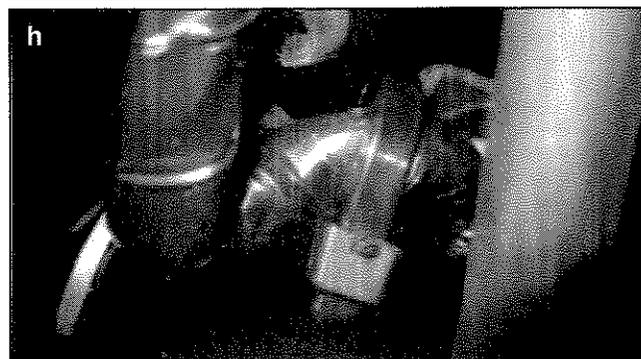
Then rotate the band so its lock is at the bottom of the bracket (h).

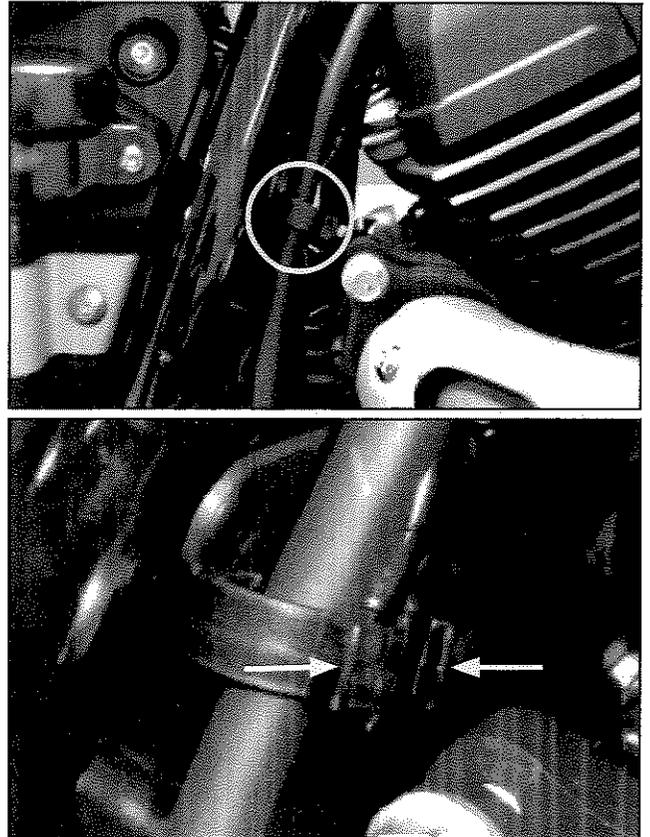
9. Lock the clutch cable clamp again.

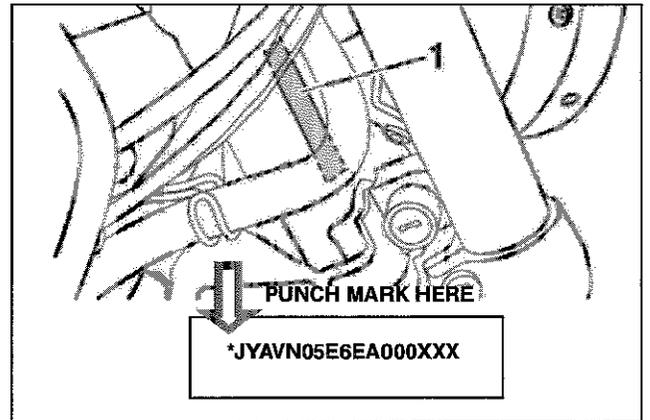
After modifying a unit, make a punch mark above the Vehicle Identification Number (VIN) as shown in the adjacent illustration (1). Check for this punch mark and the additional bands if you encounter an unfamiliar unit. You can also check unit status on YDS or by contacting your Regional Technical Advisor.
