R13WM

Adhesive Omitted at Transit Sliding Window Body Panel Joints

Models Affected: 2007 thru 2014 All American and Vision with optional Transit Sliding Windows

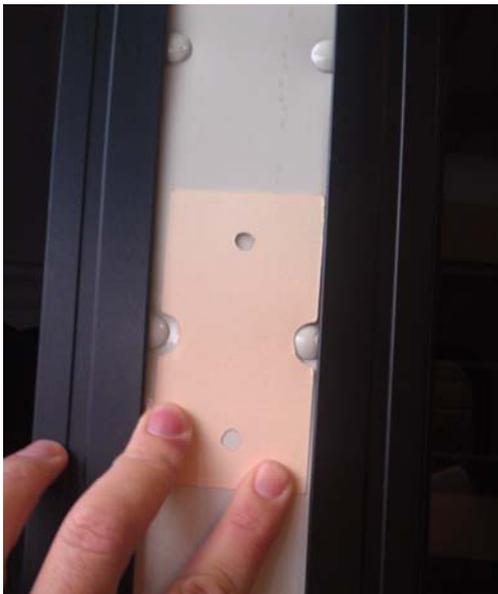
Fig. 1

1. Park bus on a level surface, apply parking brake, remove ignition key and chock wheels.
2. At the joints on the outside transit sliding window side panels, using template provided, mark new holes above and below existing rivets as shown in Figures 1 & 2.

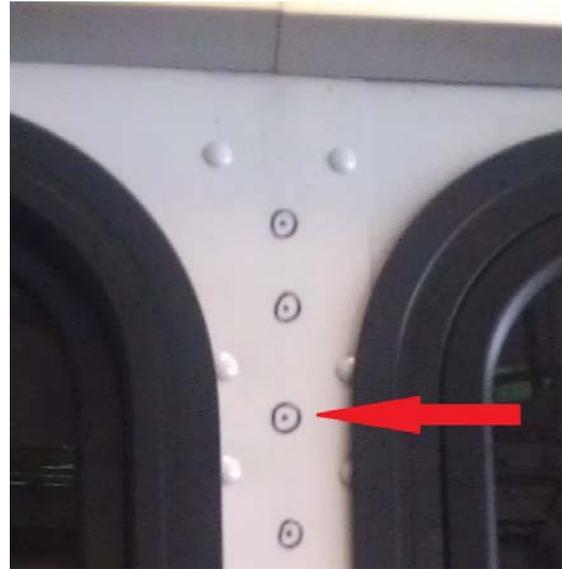
Fig. 3

3. Near the top of the bus are four rivets that are close together. Make a mark for one rivet in the center of these four existing rivet. (Fig. 3)
4. Mark an additional rivet 1.33" (1" and 11/32") below the bottom rivet. (Fig. 4)
5. Using a 17/64" drill bit, install provided drill stop at 1/2" (0.50). The drill stop must be used to prevent possible damage to wires in bow cavities. Be sure holes are centered between rivets. (Fig. 5) Take extra care in drilling through reflective tape where applicable.
6. Install part number #01854397 Rivet, Blind, .25 Dia, .38 grip, in each hole drilled using a rivet gun/tool. (Fig. 5) Be sure to use the rivets painted Exterior Fleet White.
7. Touch up each rivet with the provided Exterior Fleet White touch-up paint.

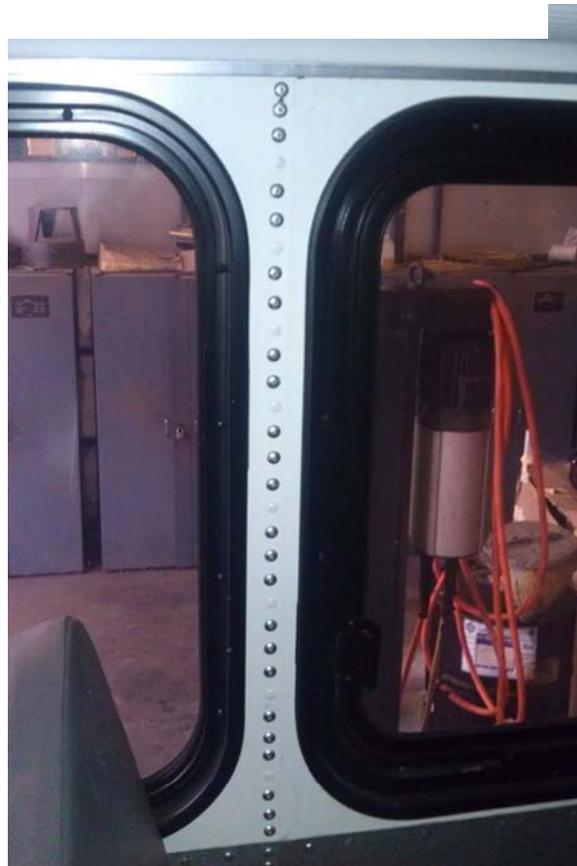
Fig. 6

8. Between the transit sliding windows, on the inside side panels, mark hole locations on 1" (one inch) centers, extending from the top of the inside side panel upwards to the lower wire molding extrusion. (Fig 6)
9. Center the holes between the windows, in line with the existing rivets.
10. Drill holes using 17/64" drill bit with drill stop set to 1/2 (.50) inch.
11. Install painted rivets. Be sure to use the Interior Astro White rivets.
12. Touch up rivets using Interior Astro White touch-up paint.
13. There should be 24 rivets installed between each window.
14. Repeat this procedure between each passenger window from front to rear of the bus, on each side.
