CB13-J-002

ENGINE

## **Safety Recall Oil Pan Heater Extension Cord - #13V-259 (Transport Canada # TC2013-212/213)**

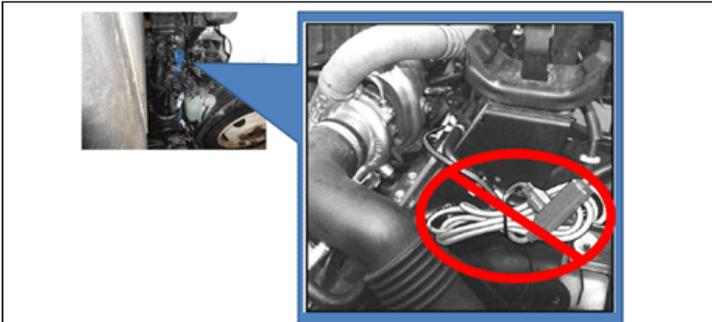
- 1. Locate the blue oil pan heater extension cord and remove it from the vehicle. Cut the extension cord into at least 2 pieces using wire cutters and retain at least one end for warranty part return.

Figure 1 – Optional Oil Pan Heater Cord Location

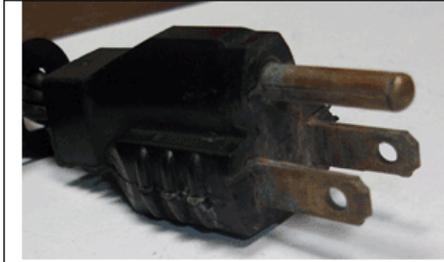
When the optional oil pan heater was installed at the port, the installer was instructed to connect the extension cord to the oil pan heater plug and secure the cord to the exterior of the vehicle. Isuzu recently learned that during vehicle use over time, dust, dirt and moisture may collect at the contact point between the oil pan heater plug and the extension cord causing a carbon tracking phenomenon. This condition may cause overheating of the extension cord, which could melt the oil pan heater plug and/or block heater plug (if equipped), producing odor and smoke and result in an increased risk of fire.

Figure 2 – Dirty, Dusty Plug

3. Inspect the oil pan heater plug (and block heater cable plug if equipped). Dirt, dust and carbon tracking evidence must be cleaned from the plug terminals (Figure 2). Use a wire brush, emery cloth or medium grade sanding pad (Figure 3) to clean the plug terminals. After cleaning blow away any residual debris with air pressure or electrical contact cleaner.

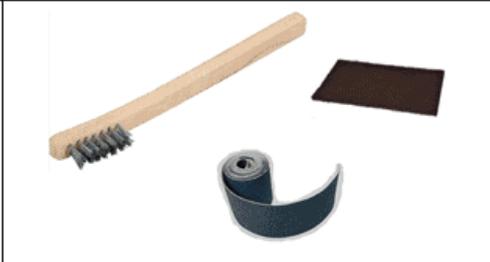
Figure 3 - Suggested Cleaning Methods

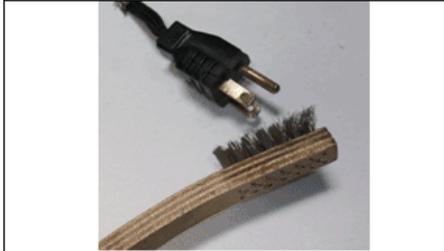
Figure 4 - Plug End and Wire Brush

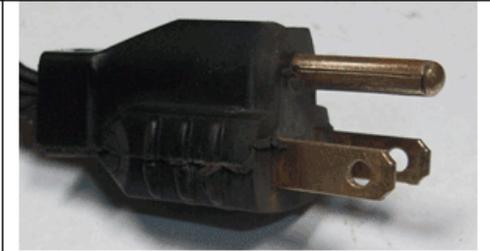
Figure 5 - Clean Plug End

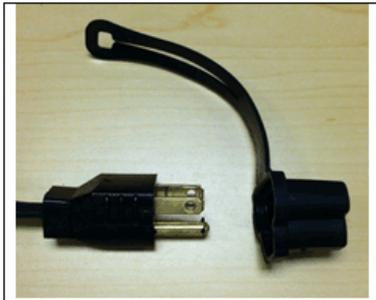
Figure 6 – Plug and Protective Plug Cap

4. Remove and discard the original plug cap. Install a new plug cap onto the oil pan heater plug (and block heater cable plug if equipped).
