Re: Toyota Safety Recall 13V-133 Updated Remedy Instructions

**TECHNICAL INSTRUCTIONS
FOR
SAFETY RECALL D0F
FRONT PASSENGER AIRBAG INFLATOR MODULE
CERTAIN 2003 – 2004 MODEL YEAR TUNDRA
2002 – EARLY 2004 MODEL YEAR SEQUOIA**

UPDATED SEPTEMBER 5, 2013

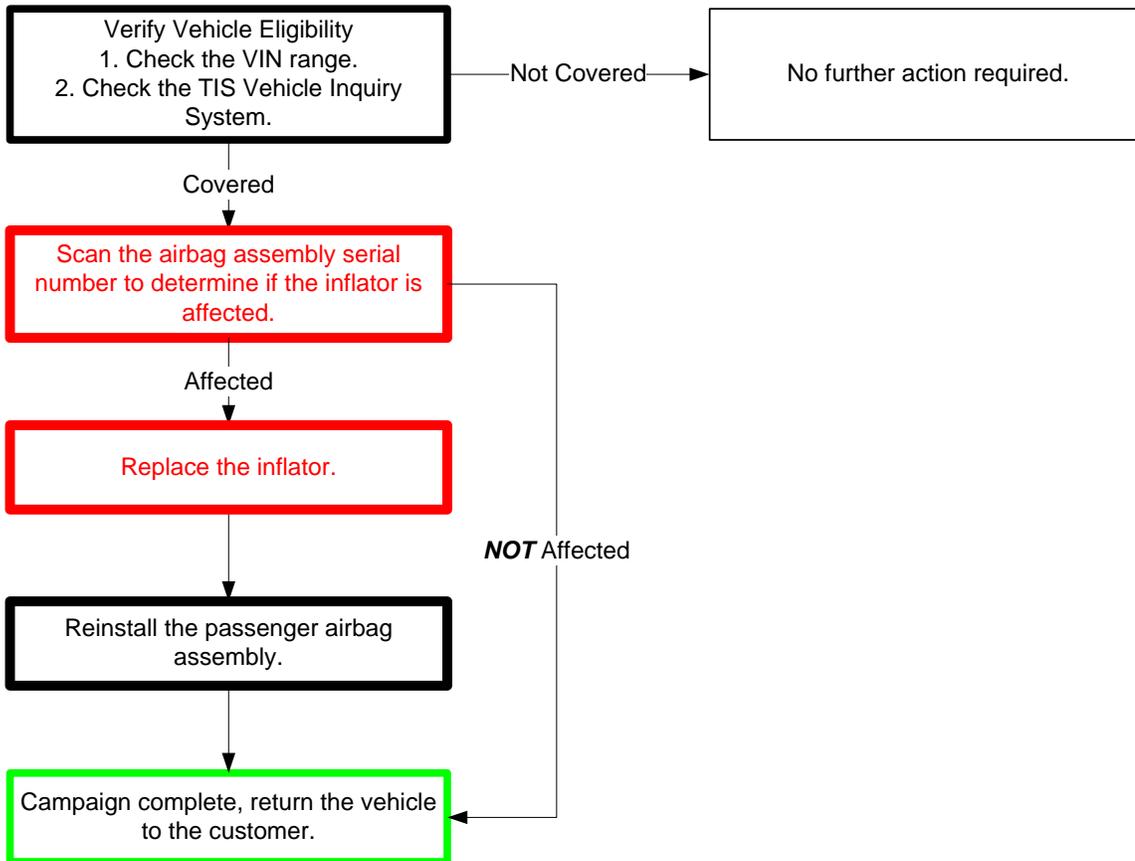
I. OPERATION FLOW CHART

The flow chart is for reference only. **DO NOT** use it in place of the full technical instructions. Follow **ALL** steps as outlined in the full technical instructions to confirm the campaign is completed correctly.

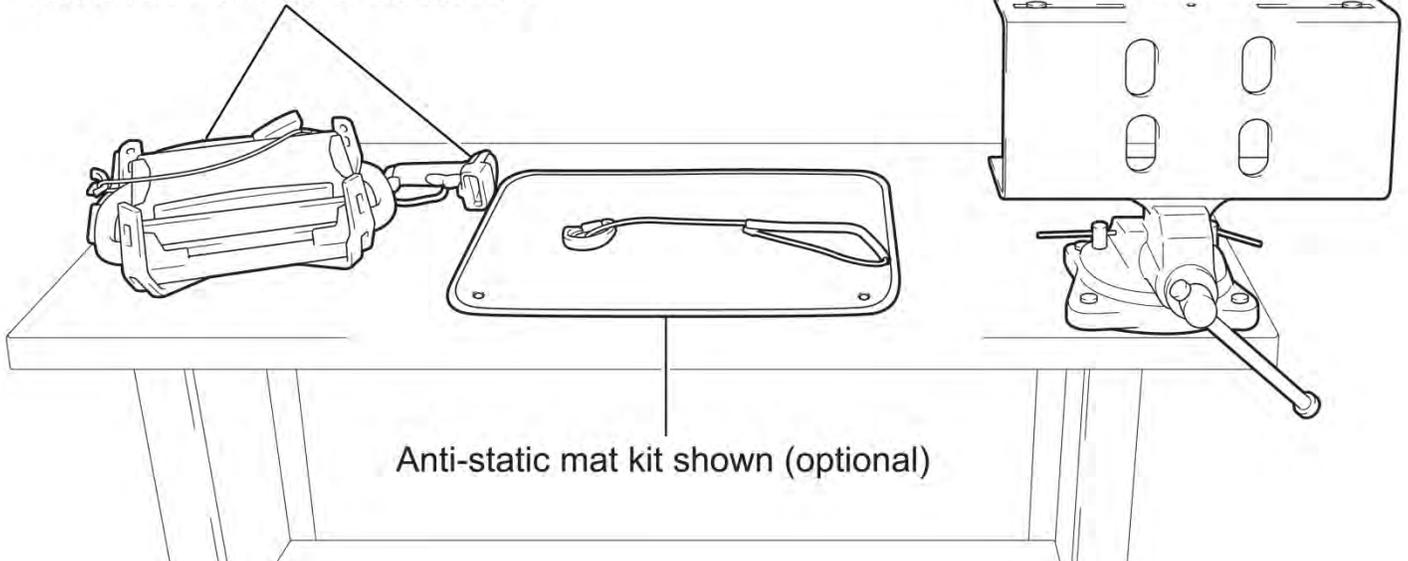
The bracket assembly that was provided at the launch of this campaign is a critical added-safety feature that **MUST** be used when replacing the inflator module. Confirm the bracket assembly is installed securely in the vise and confirm the work area being used is appropriate. The anti-static mat set that is an essential SST may be available at your dealership and is optional to use during inflator replacement. If the anti-static kit is not available, before starting work and periodically while working on the vehicle, touch a metallic part of the vehicle to discharge static electricity in the body.

Bracket securely mounted in vise

Techstream and barcode scanner

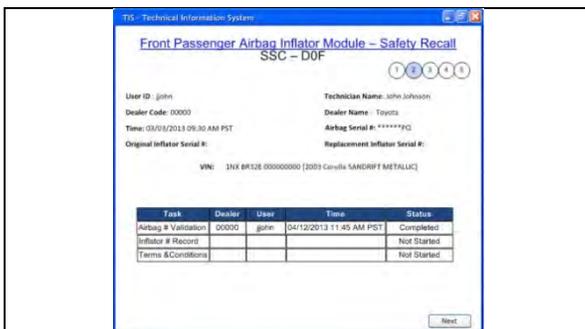
d) Reenter TIS password in the serial number checker application.

NOTE: The person logged-in to TIS should be the person performing the repair.

- A task status screen will populate next and at other intervals during the repair. This screen will indicate if the inspection has previously been performed, who performed it, and where it was performed; review this information and then click 'next' to proceed to the next step. This information will be used for record keeping by TMS.
- If this screen indicates that the campaign has already been completed on this VIN, there is no need to perform campaign again.

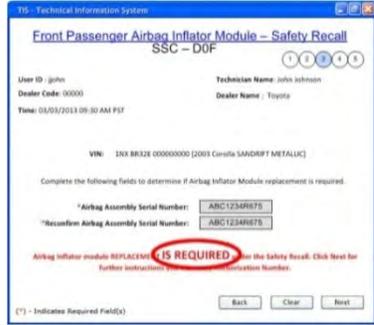
CONDITION 1

Inflator replacement **REQUIRED**

The inflator is affected and replacement is required. Proceed to **STEP VIII.** for instructions on inflator replacement.

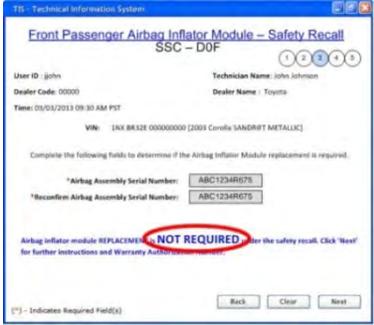
CONDITION 2

NO NEED to replace inflator

The inflator **IS NOT** affected and **DOES NOT** need to be replaced. Complete the following steps:

1. Record the Warranty Authorization # provided at the end of the serial number checker application to be included in the warranty claim.
2. Reassemble the vehicle.
3. Perform a health check on the vehicle.

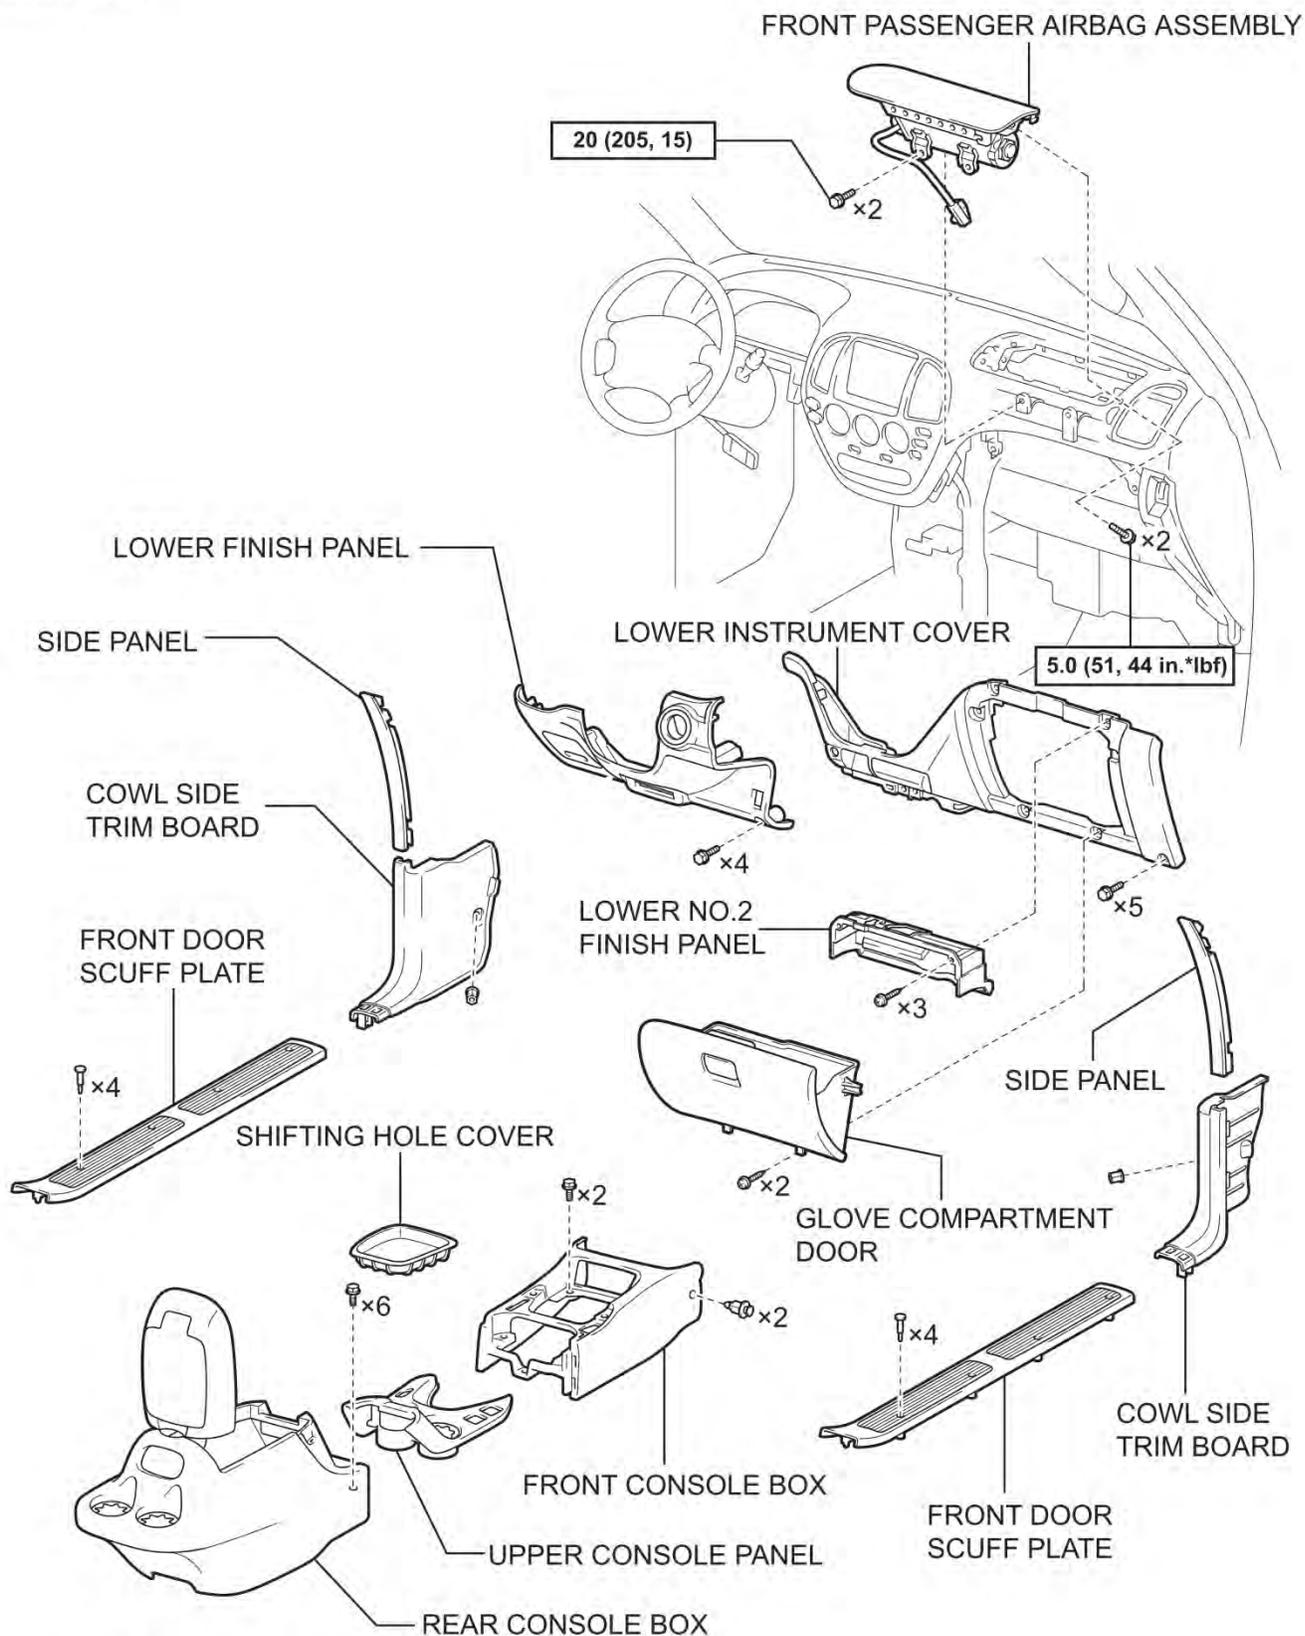
R1302220006

Sequoia, Tundra Double Cab

Double cab:

N*m (kgf*cm, ft.*lbf) : Specified torque

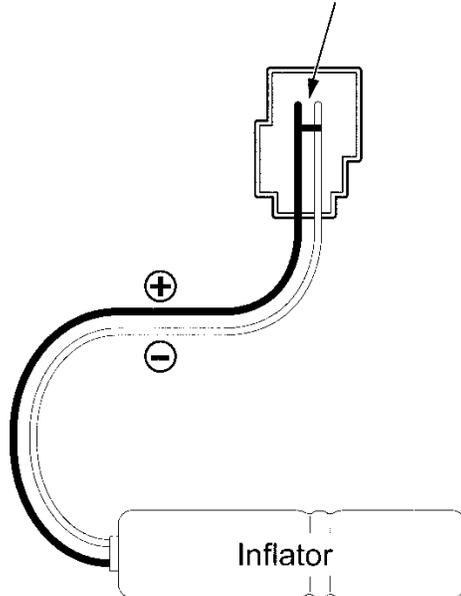
The connector of the inflator module contains a short circuiting mechanism to eliminate voltage variances when the connector(1) is disconnected. To allow for the replacement of the inflator module, a new short circuit(2) **MUST** be created before cutting the wires(3) and removing the inflator. The following steps **MUST** be followed exactly as described to ensure the work is completed correctly and safely.

(1)
Short circuiting on both sides.

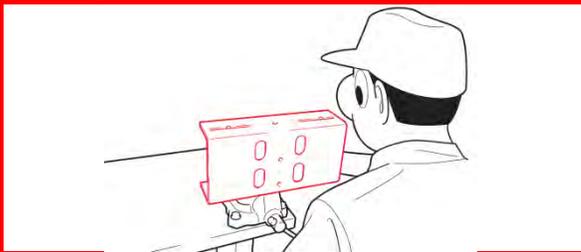
CRITICAL INFORMATION – READ THOROUGHLY

ALWAYS keep as much of your body as possible in front of the bracket when working on the airbag assembly.

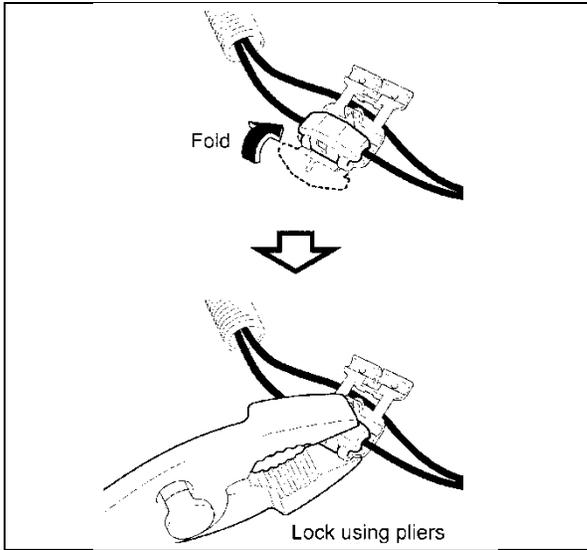
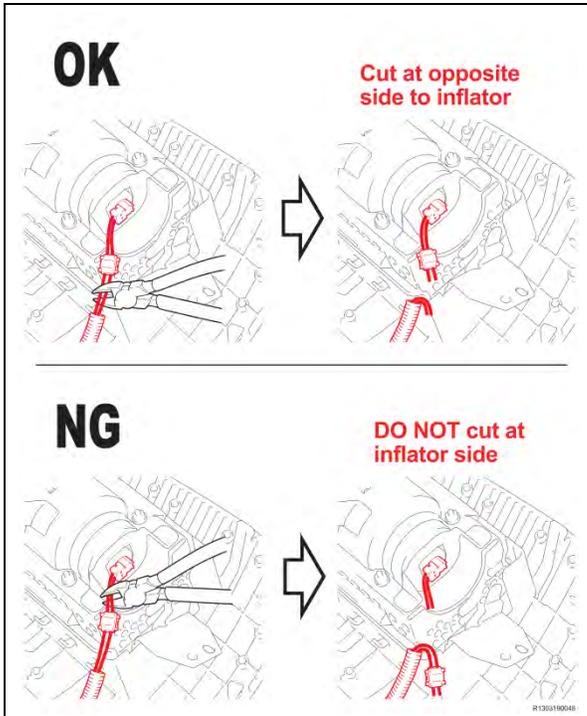
- b) Cut off the tab of the electro tap shown in the illustration.

This tab **MUST** be removed to ensure a good short.

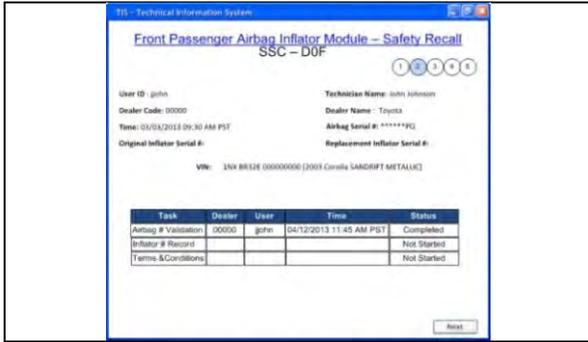
- A task status screen will populate next and at other intervals during the repair. This screen will indicate if the inspection has previously been performed, who performed it, and where it was performed; review this information and then click 'next' to proceed to the next step. This information will be used for record keeping by TMS.
- If this screen indicates that the campaign has already been completed on this VIN, there is no need to perform campaign again.

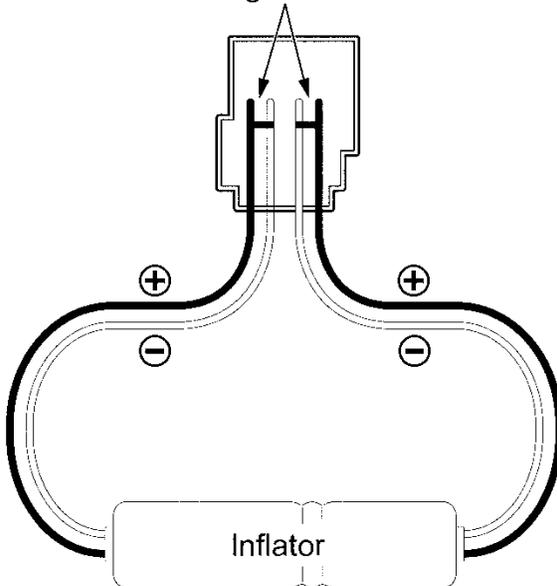
The connector of the inflator module contains a short circuiting mechanism to eliminate voltage variances when the connector(1) is disconnected. To allow for the replacement of the inflator module, a new short circuit(2) **MUST** be created before cutting the wires(3) and removing the inflator. The following steps **MUST** be followed exactly as described to ensure the work is completed correctly and safely.

Short circuiting on both sides.

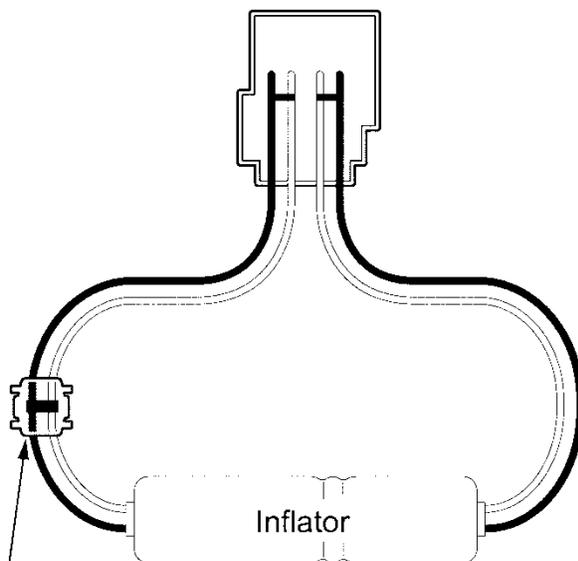
(2)

Create new short circuit using electro tap.

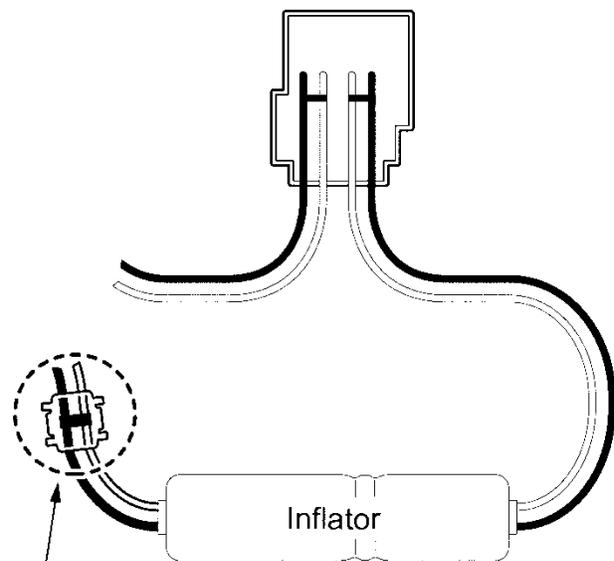
(3)

Short circuiting is maintained even after cutting harness.

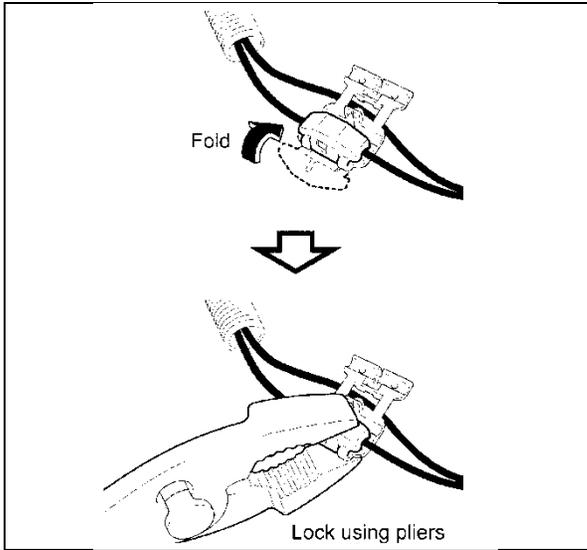
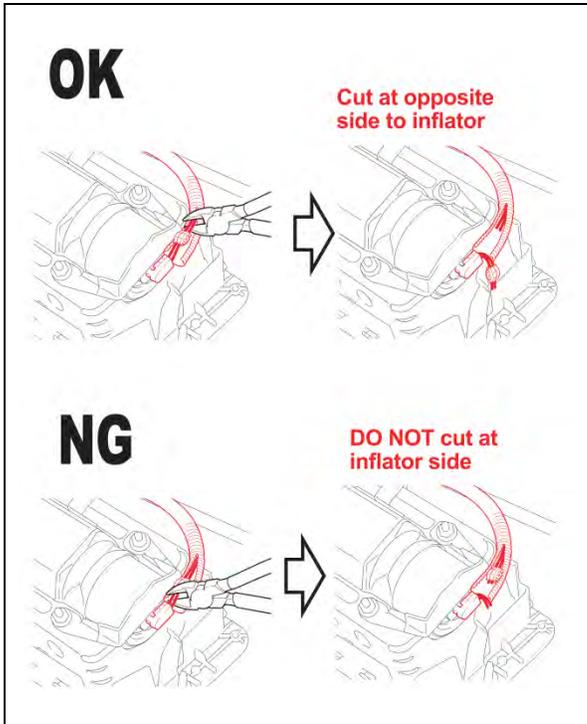
- b) Cut off the tab of the electro tap shown in the illustration.
NOTE: The electro tap is included in the inflator parts kit.

This tab **MUST** be removed to ensure a good short.
