Re: Toyota Safety Recall 13V-133 Updated Remedy Instructions

**TECHNICAL INSTRUCTIONS
FOR
SAFETY RECALL DLC
FRONT PASSENGER AIRBAG INFLATOR MODULE
CERTAIN 2002 – 2003 & 1 (one) 2004 MODEL YEAR SC430**

UPDATED SEPTEMBER 5, 2013

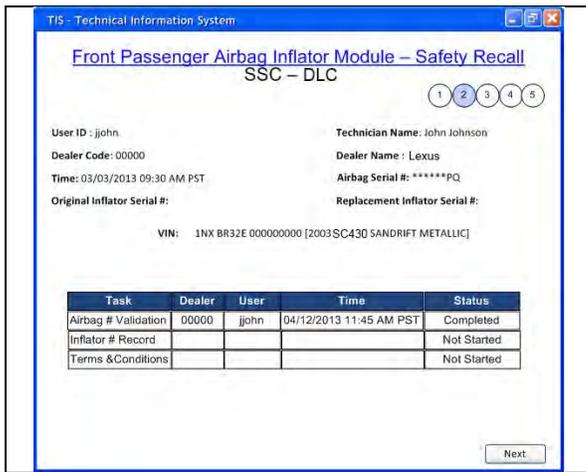
NOTE: The person logged-in to TIS should be the person performing the repair.

- A task status screen will populate next and at other intervals during the repair. This screen will indicate if the inspection has previously been performed, who performed it, and where it was performed; review this information and then click 'next' to proceed to the next step. This information will be used for record keeping by TMS.
- If this screen indicates that the campaign has already been completed on this VIN, there is no need to perform campaign again.

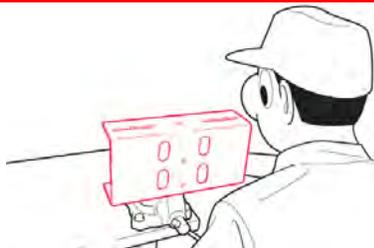
ALWAYS keep as much of your body as possible in front of the bracket when working on the airbag assembly.
