NHTSA Safety Recall 13V-400

TO: Winnebago Industries, Inc. Dealers
SUBJECT: Campaign #130 – Child Seat Tether

INSTRUCTIONS TO PERFORM CAMPAIGN 130

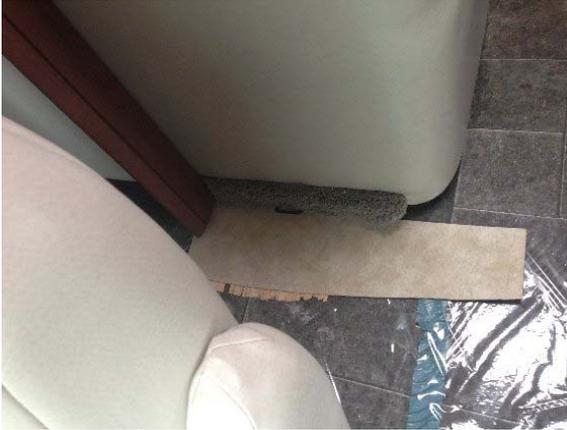
1. Slide passenger seat all the way forward.
2. Place protective material on the back of the dinette seat back and floor area surrounding the tether anchor to prevent damage.

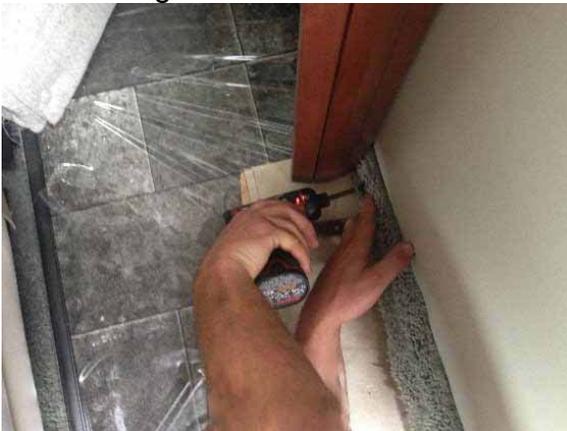
3. Using a screw gun with a magnetic tip, locate and remove the screws from the slideout floor carpet surrounding the child tether anchor.

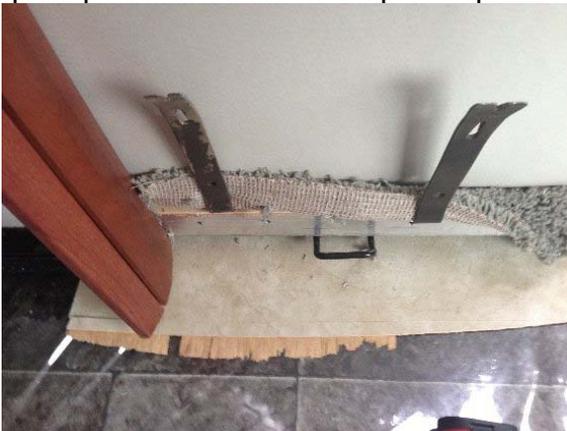
4. Pull carpet up and secure in the upward position away from the tether anchor.

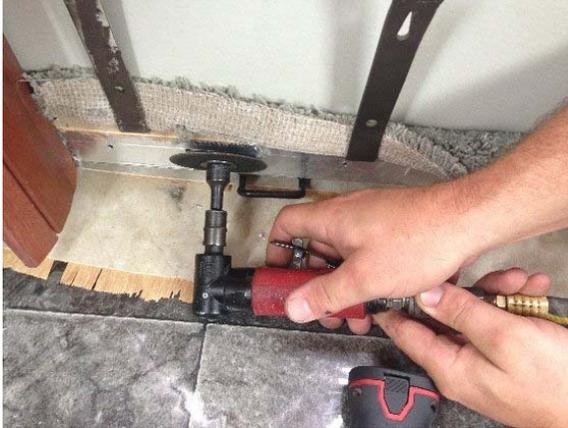
5. Use a cutting wheel or bolt cutters to cut-off the protruding portion of the tether. Smooth the edges of the remaining bracket using the cutting wheel or a die grinder. *NOTE: If using the cutting wheel or die grinder, it may be necessary to use additional protective material.*

(Cutting Wheel shown)

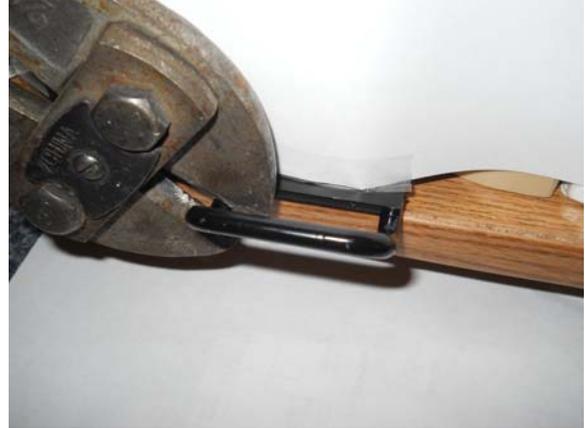
(Bolt Cutter shown)

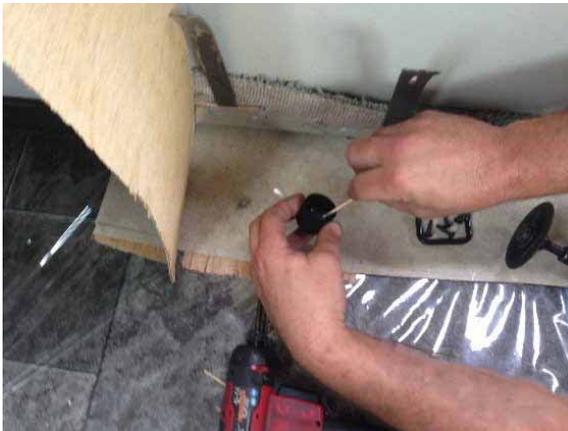
6. Apply black touch-up paint (from shop supplies) to the cut ends of the remaining bracket to prevent rust.

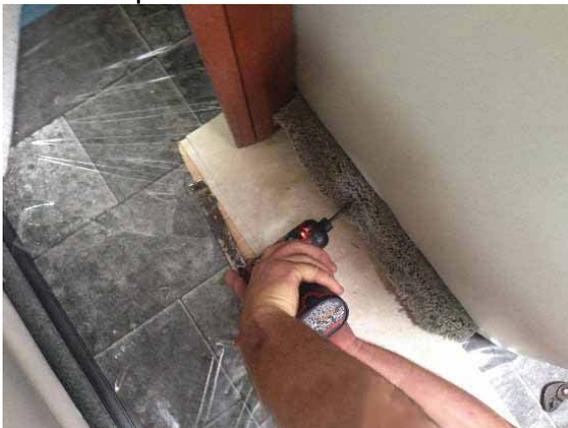
7. Reinstall the carpet.
