SAFETY RECALL ALERT

Bulletin: SRA-M13-03
Date: October 9, 2013
Replaces: N/A
Action: **YES**

Subject: Safety Recall, SC0371, Loose Spindle Nuts

SC0371, Pro-Torq Inspection and Repair

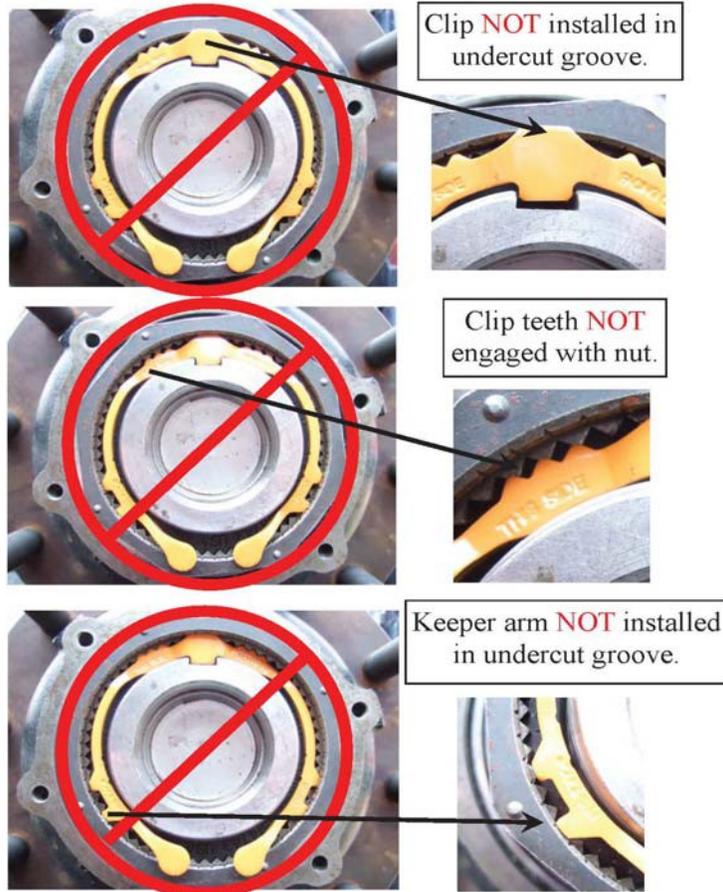
INCORRECTLY Installed Clip

Failure to properly install the clip could cause wheel end separation.

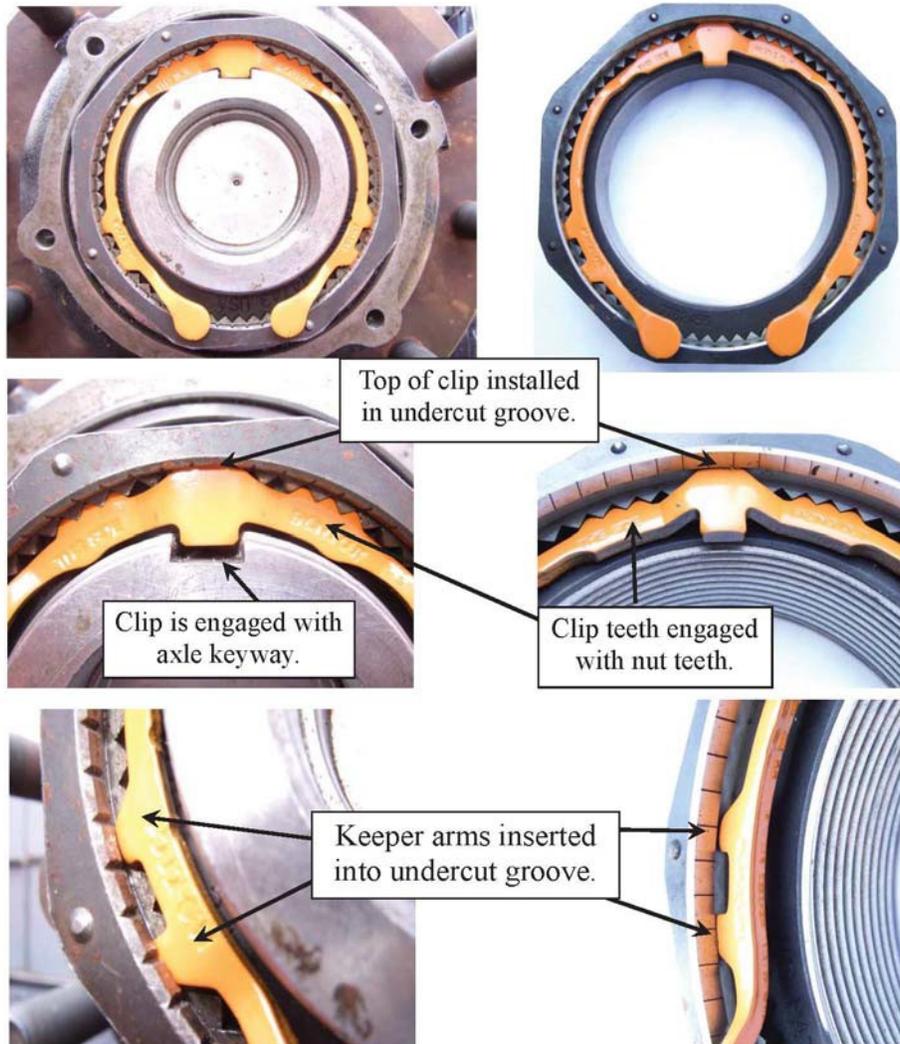
CORRECTLY Installed clip

Warning: Failure to properly install the clip could cause wheel end separation.

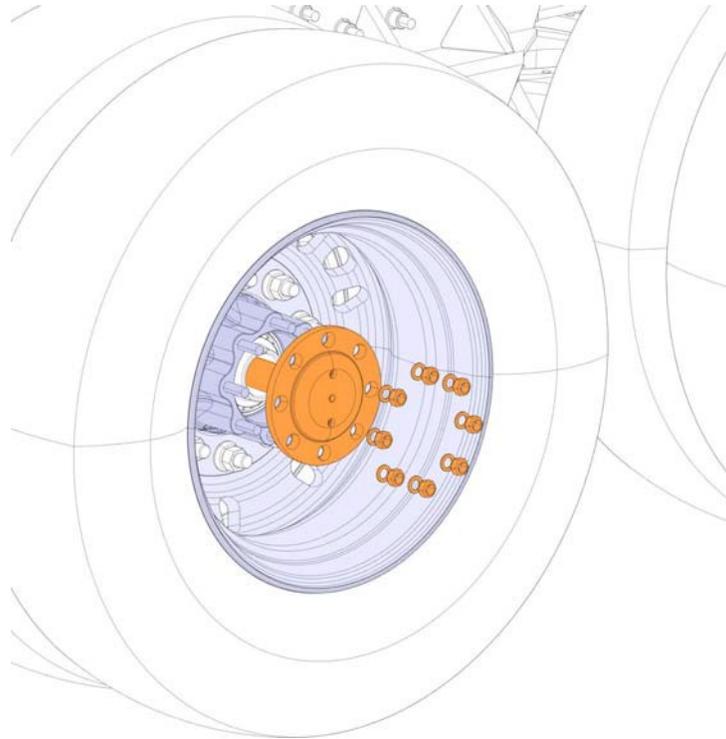
Rear Axle (If applicable):

1. Remove the axle flange nuts and washers. Catch the oil with a suitable drain pan.
2. Remove the axle shaft.
3. Inspect the snap ring and check for proper seating.
 - If the snap is in place and seated properly, install and secure the axle along with new gasket.
 - If the snap ring is not installed correctly, follow the repair procedure below.
4. Repeat the procedure until all wheel ends have been inspected.
5. Top up or fill the rear axle with the required lubricant.

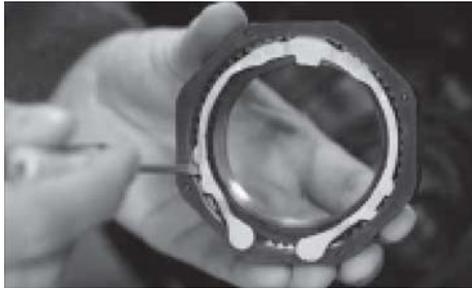
1. Raise the axle to be repaired and place the wheel end(s) on jack stands.
2. Remove the Pro-Torq nut assembly from the axle spindle and dispose. Inspect the spindle for damage. If necessary, repair burrs or damaged threads before reinstallation.

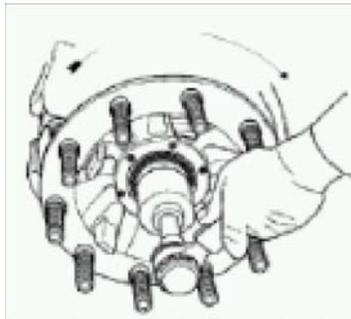
New nut will contain snap ring within the groove in the nut.

3. Pry the snap ring out of the new nut before installation.

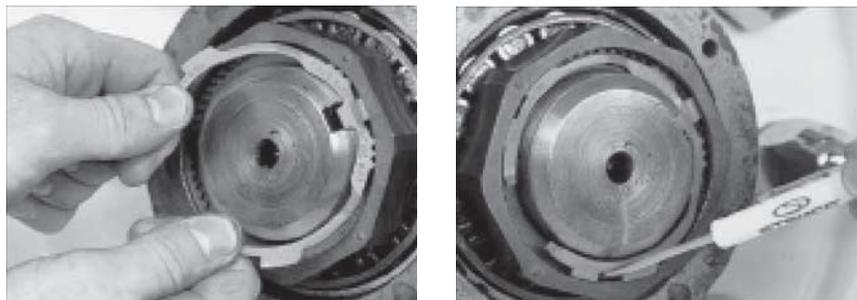
5. Install the snap ring (orange side out).

- Install the tab into the undercut groove of the nut and engage the tang in the axle keyway.
- Engage and align the mating teeth on the snap ring.

- Compress and insert the snap ring arms, one at a time, into the undercut groove with a small screwdriver (orange side out).
