RECALL CAMPAIGN BULLETIN

NTB11-064g

VOLUNTARY SAFETY RECALL CAMPAIGN 1996-2004 PATHFINDER IN SALT STATES FRONT STRUT HOUSING CORROSION

CAMPAIGN ID #: R1107
NHTSA #: 11V-244
APPLIED VEHICLES: 1996 – 2004 Pathfinder (R50)

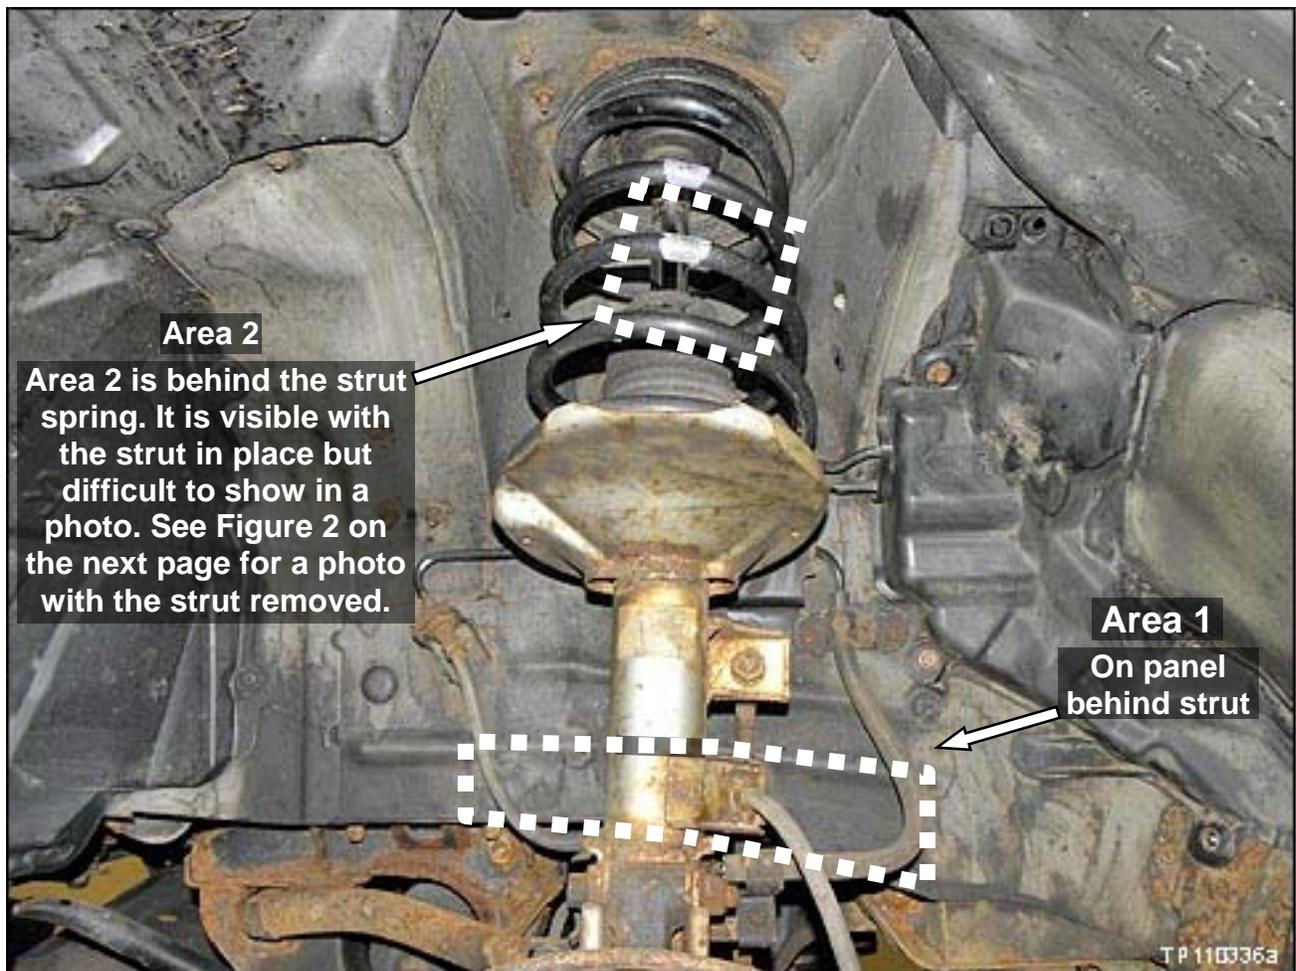
Figure 1

3. Inspect for corrosion on the driver side AND passenger side in the wheel house Area 1 and strut housing Area 2 (see Figures 1, 2, 3, and 4).

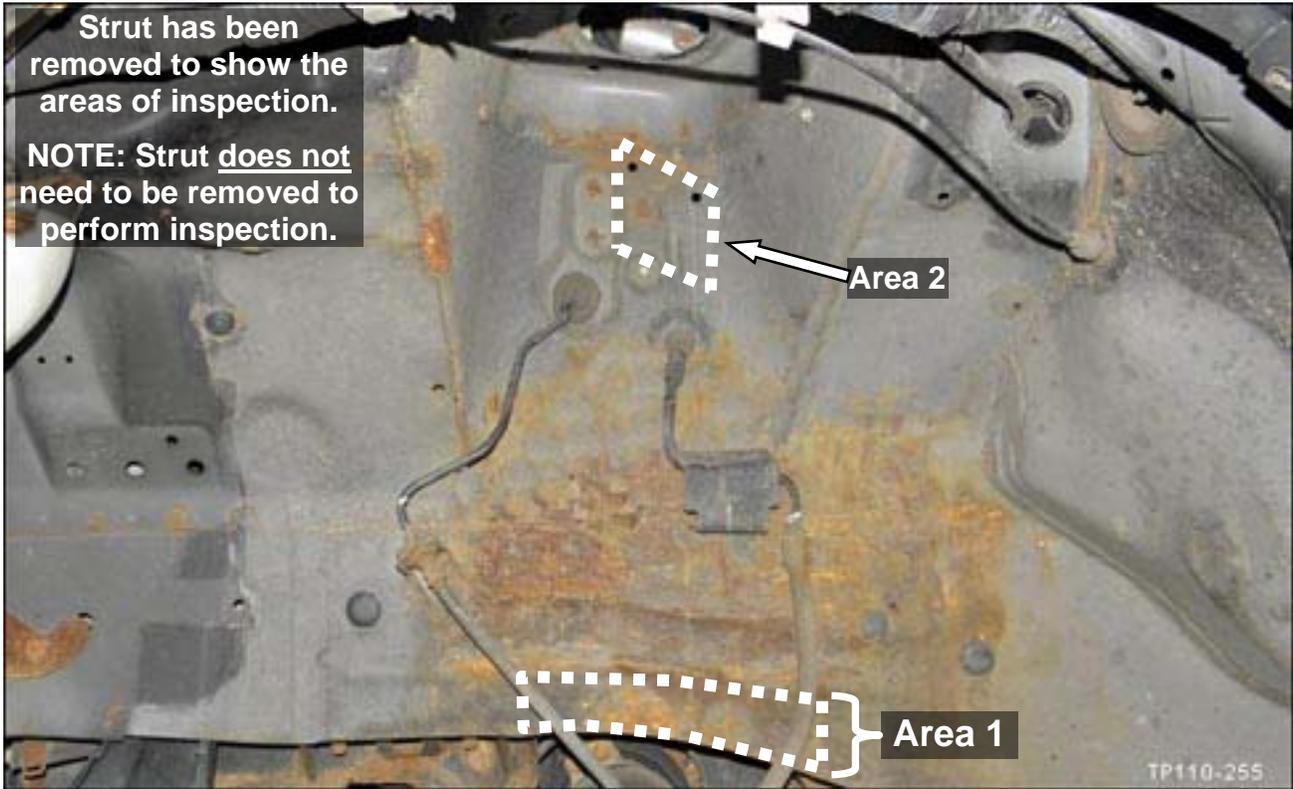
Figure 2

This example photo shows the inspection areas in relation to the repair bracket installation.

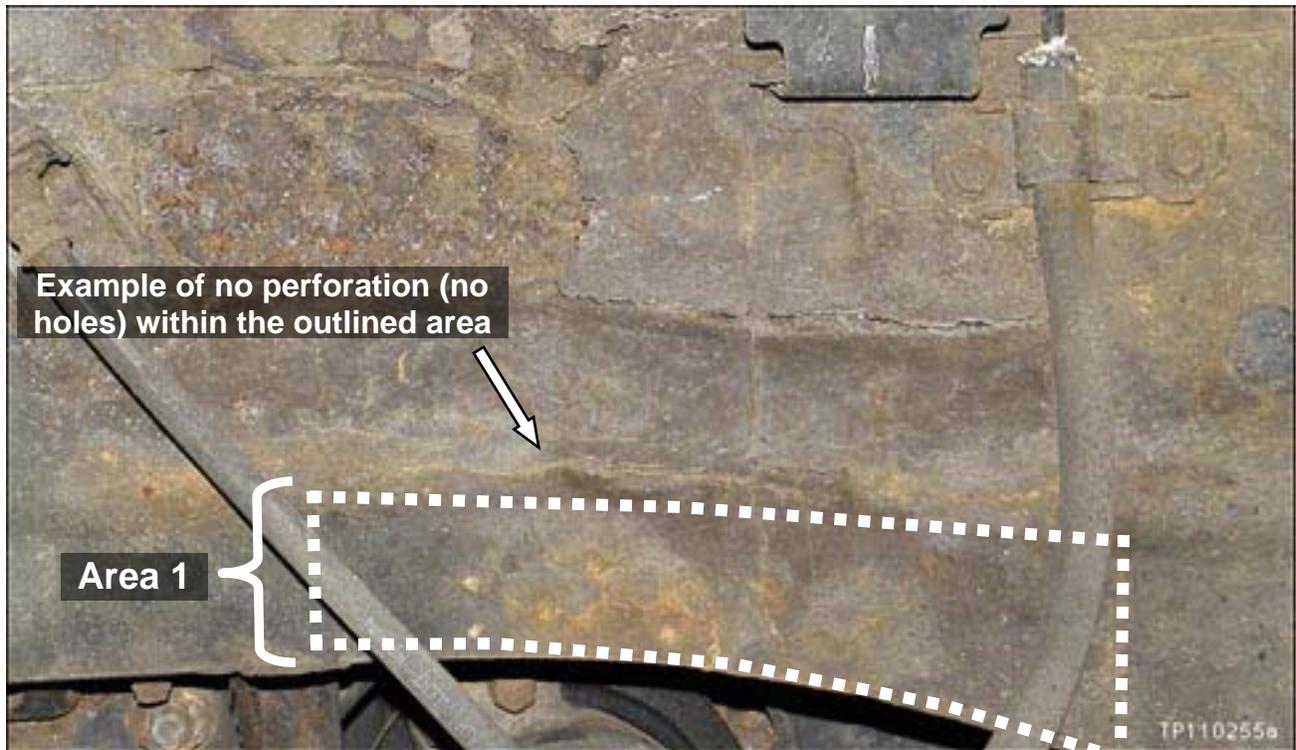
Figure 3

Area 1: Look for perforation (holes) in the metal only in the area outlined above.

- a. Retain the vehicle at the dealer. (The vehicle is not repairable.)
- b. Supply the customer with a rental car.
- c. Fax a completed Non-Repairable Report to Morley (see page 54).

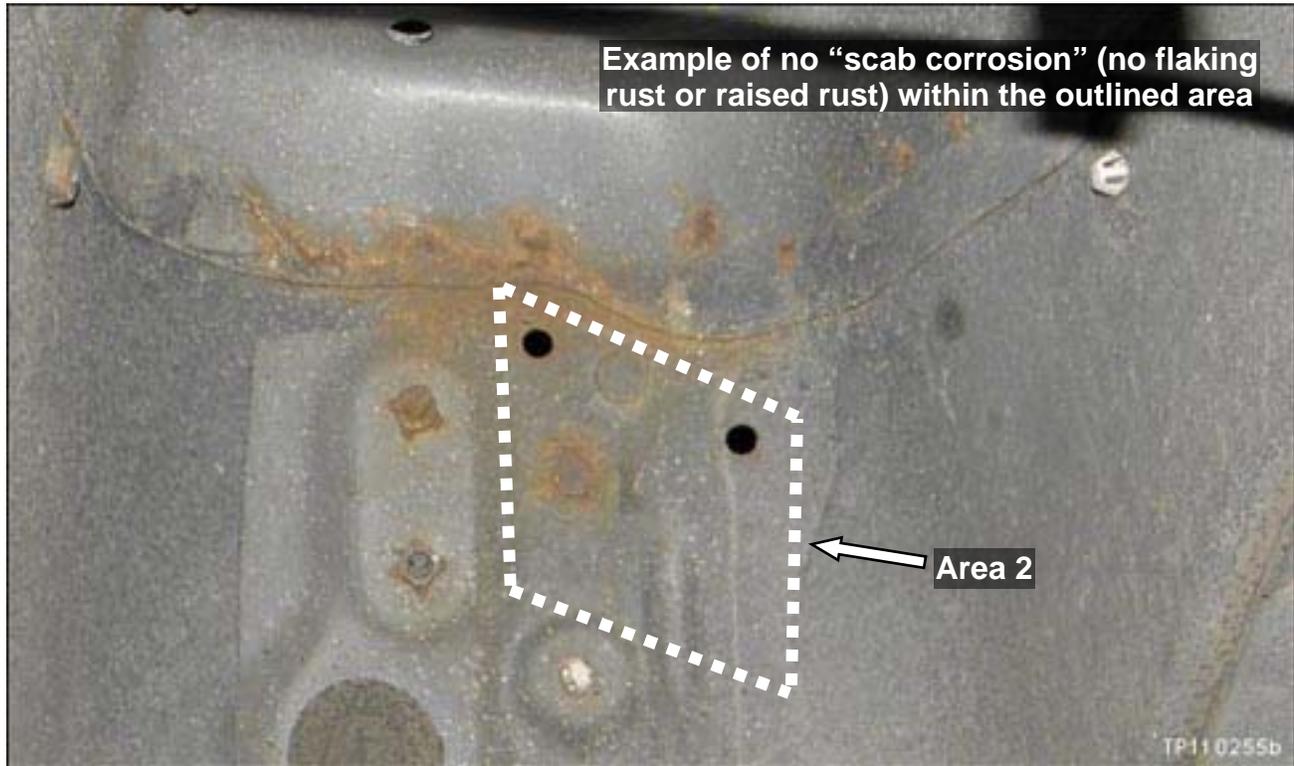
Area 2: Look for “scab corrosion” (flaking rust or raised rust) on driver side **AND** passenger side **only in the area outlined above.**

- The area shown in Figure 4 applies to driver side **AND** passenger side.
- If needed, refer to examples (additional photos) of Area 2 scab corrosion inspection on page 47.

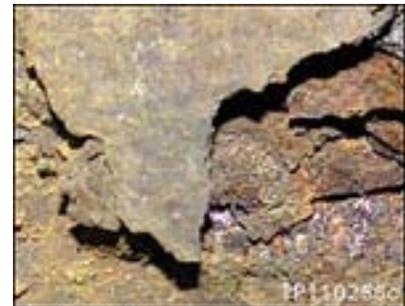
Figure 5 is an example of “scab corrosion” (flaking and raised rust).

If there is **scab corrosion** (flaking or raised rust) in Area 2, driver side **OR** passenger side:

- a. Retain the vehicle at the dealer. (The vehicle is not repairable.)
- b. Supply the customer with a rental car.
- c. Fax a completed Non-Repairable Report to Morley (see page 54).

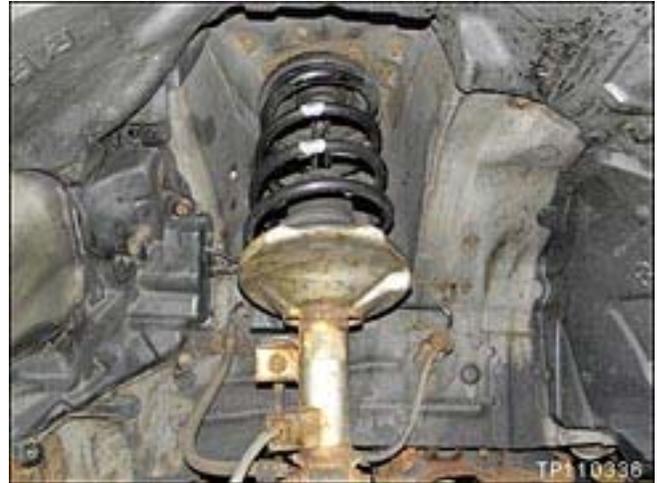
Figure 6

NOTE: Passenger side is shown, driver side is similar.

2. Visually inspect for corrosion and rust on the wheel housing panel and the strut housing panel (driver and passenger side).
 - Inspect for corrosion and rust on the panels only.

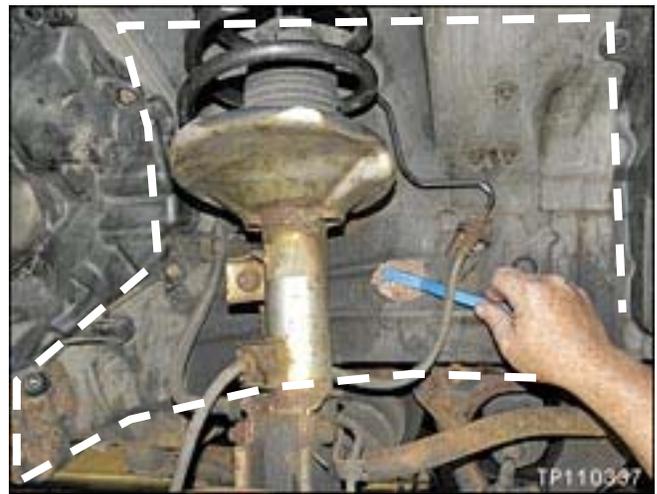
Figure 7

1. Use a wire brush to remove loose rust in the area shown with dashed line.

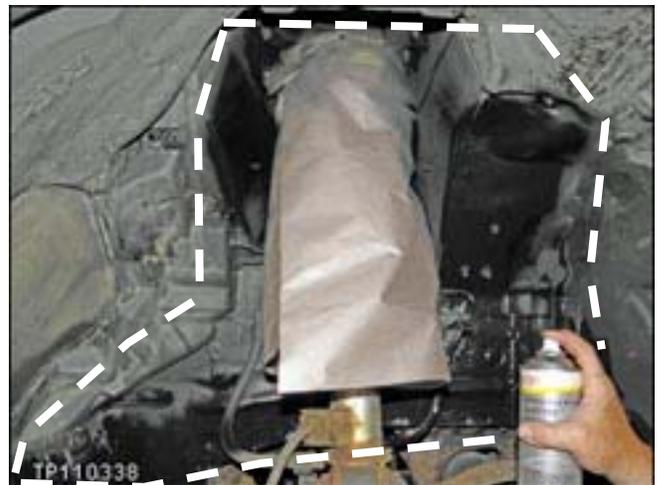
Figure 8

2. Clean dust, dirt, or other debris from the wheel housing and strut housing area.

3. Cover the strut so it is protected from overspray.

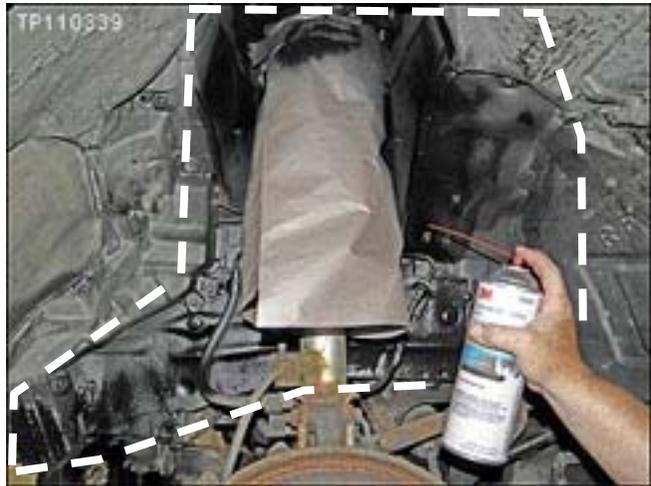
Figure 9

- Use 3M™ Rubberized Undercoating (P/N 051135 – 08883) or equivalent.
- Follow all product instructions.
- Coat all of the exposed metal areas on the strut housing and wheel house panels.
- Use a spray nozzle to spray the areas behind the strut and other hard to reach areas.

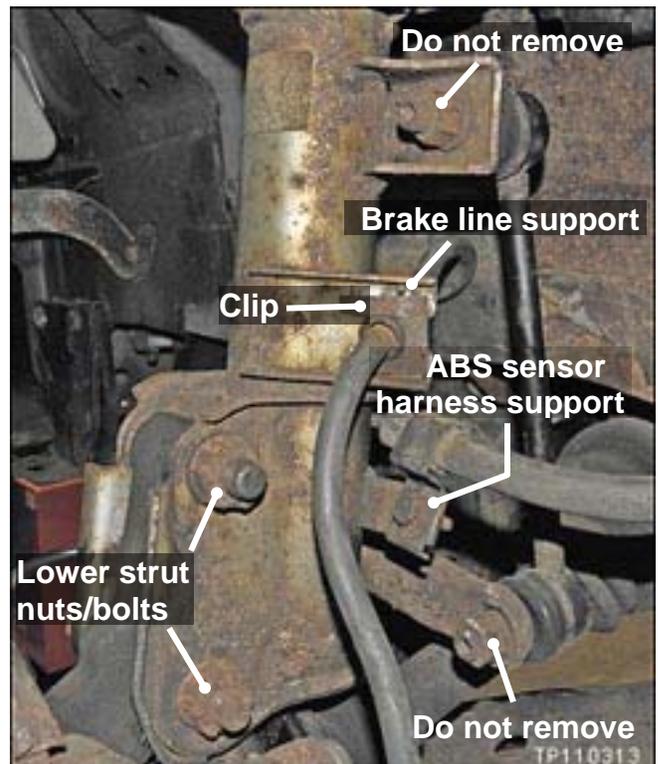
Figure SR2

2. Disconnect the following items:
 - Remove clip and take the brake hydraulic line loose from its support.
 - Discard the clip, use new clip for reassembly.
 - Remove the bolt for ABS sensor harness support.
 - Take the ABS sensor harness loose from support on the other side of strut (not shown).
 - Remove the lower strut bolts.
 - Discard the nuts, use new ones for reassembly.

NOTE: **Do not** remove the nuts from the stabilizer connecting rod.

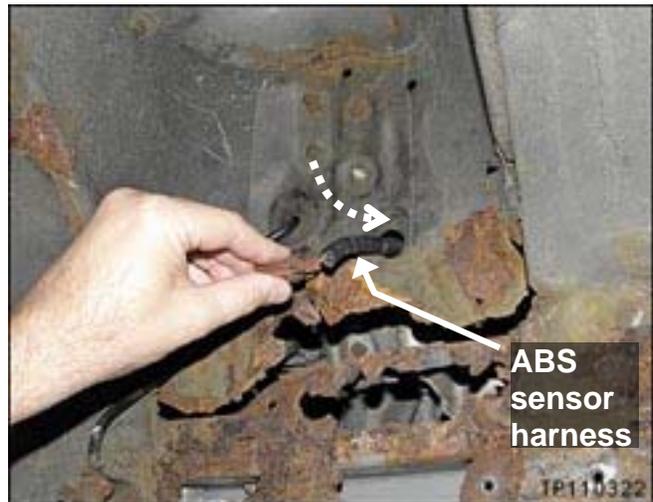
Figure RB1

1. Inspect the ABS sensor harness for damage. If damaged, repair as necessary.
2. Push the ABS harness and connector through the panel.
 - The harness/connector will now be out of the working area.

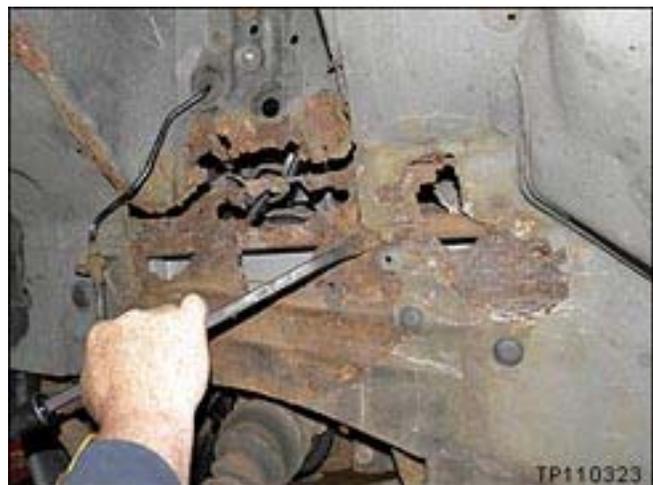
Figure RB2

3. Use a scraper bar to scrape off loose flaking rust and corrosion.

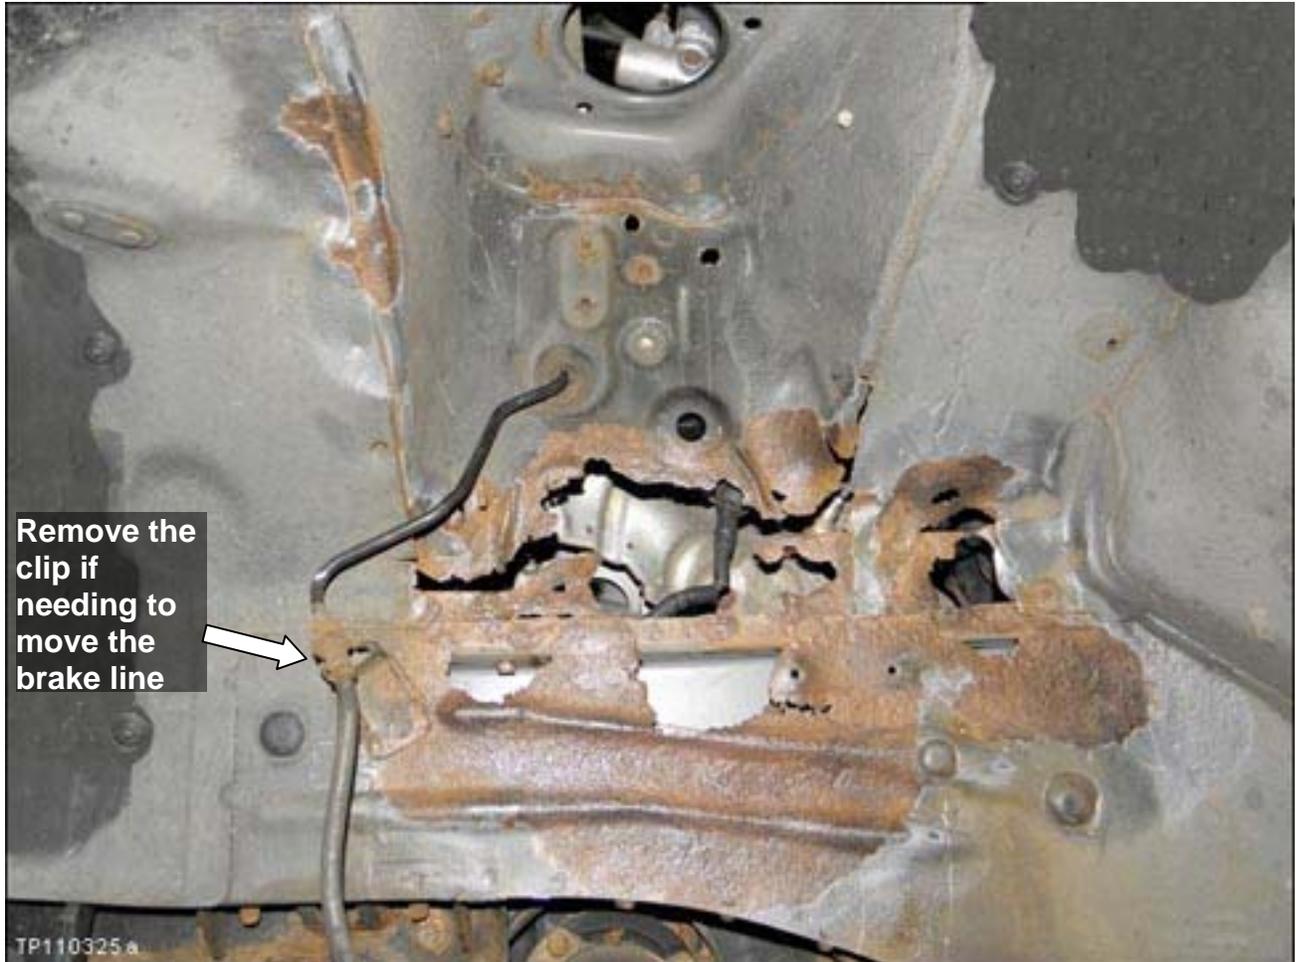
Figure RB3

4. Clean all the loose rust from the strut housing and wheel house areas (see Figure RB3).

NOTE: If the brake line is in the way of an area that needs cleaning, move it out of the way by first removing the clip from the mount.

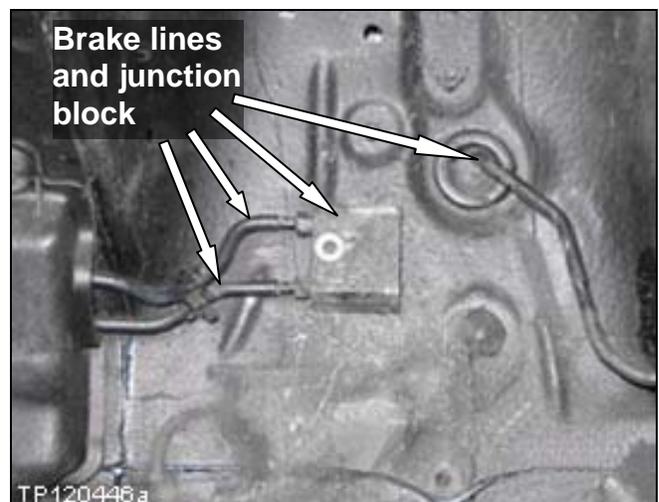
Figure RB4

4a. Passenger side: work around the 2 brake lines and junction block best as possible (see Figure RB4).

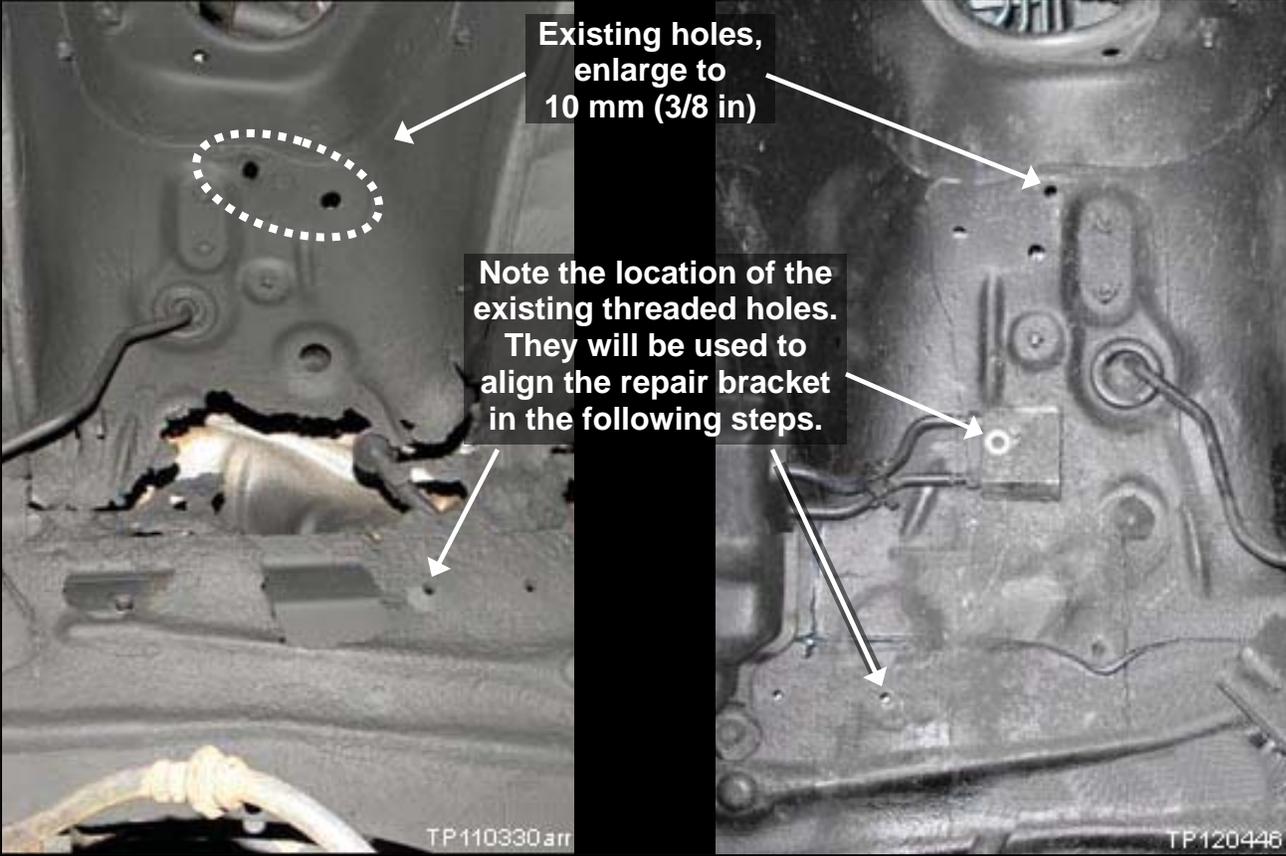
Figure RB8a

12. Driver side: Locate the 2 existing holes at the upper area of the strut housing panel (see Figure RB8a).

- With a drill bit, enlarge the one existing hole to 10 mm (3/8 in).

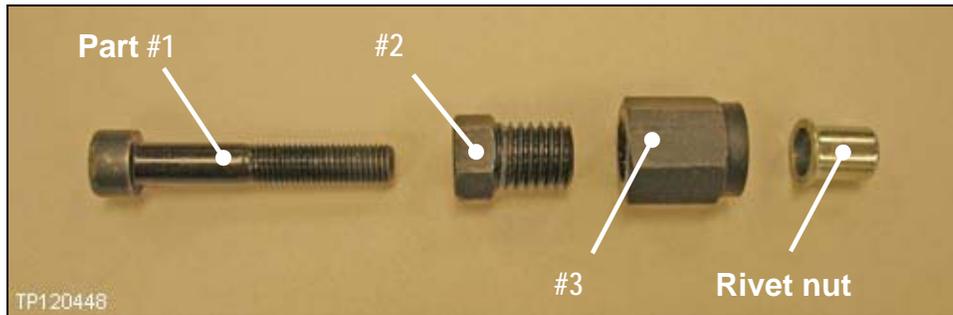
RB13 – Rivet Tool

NOTE: Rivet Tool J-50835 comes with extreme pressure lubricant. Apply to the threads and contact points of part #2 and part #3 for approximately every 60 rivet nuts installed (enough for 15 brackets).

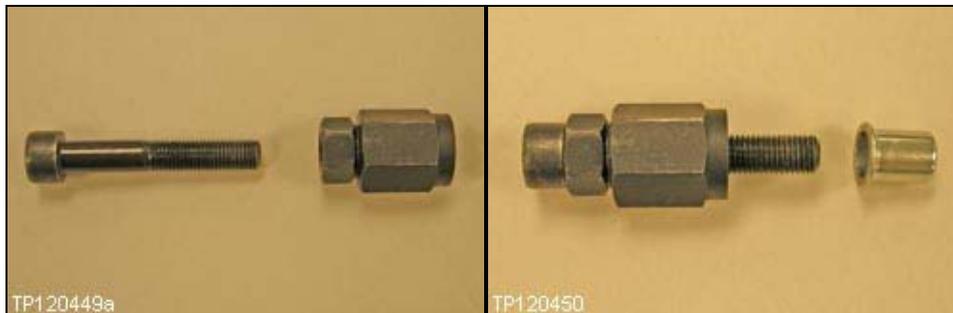
Figure RB14

1. Thread no more than finger tight part #2 into part #3 until it bottoms out (see Figure RB14).
 - This is a left handed thread.
2. Insert part #1 through part #2 and part #3 (see Figure RB15).

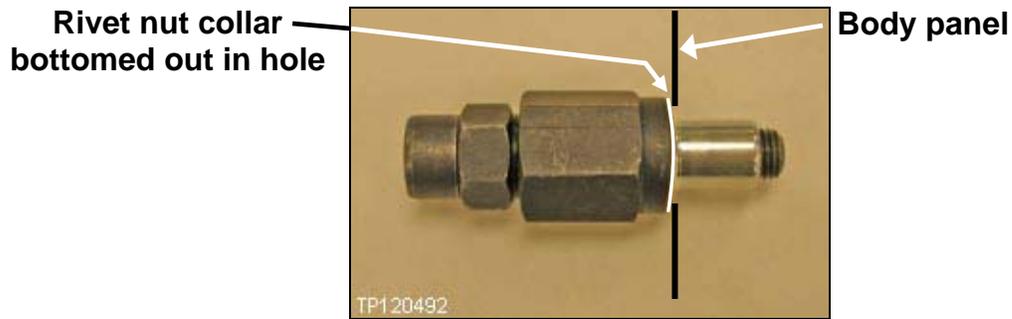
Figure RB17

4. Insert the rivet nut into the 13.1 mm (33/64 in) hole until it bottoms out on its collar.

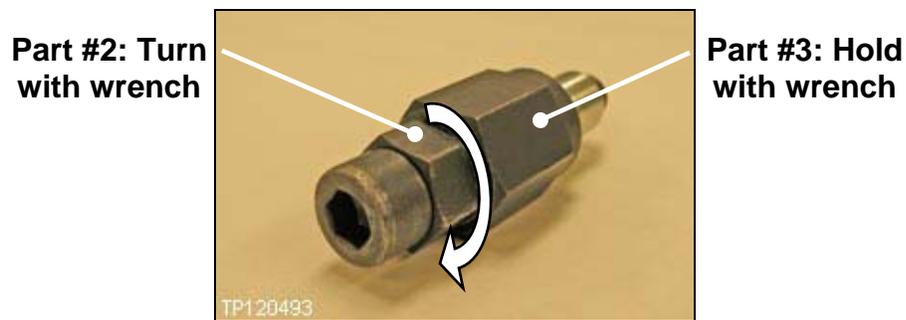
Figure RB18

5. Install the rivet by performing the following:
- Hold the rivet nut and tool against the body panel with moderate pressure.
 - Hold stationary part #3 while turning part #2 clockwise.
 - Turn part #2 approximately 2 turns or until turning resistance increases.
 - At this point, the rivet nut is installed.

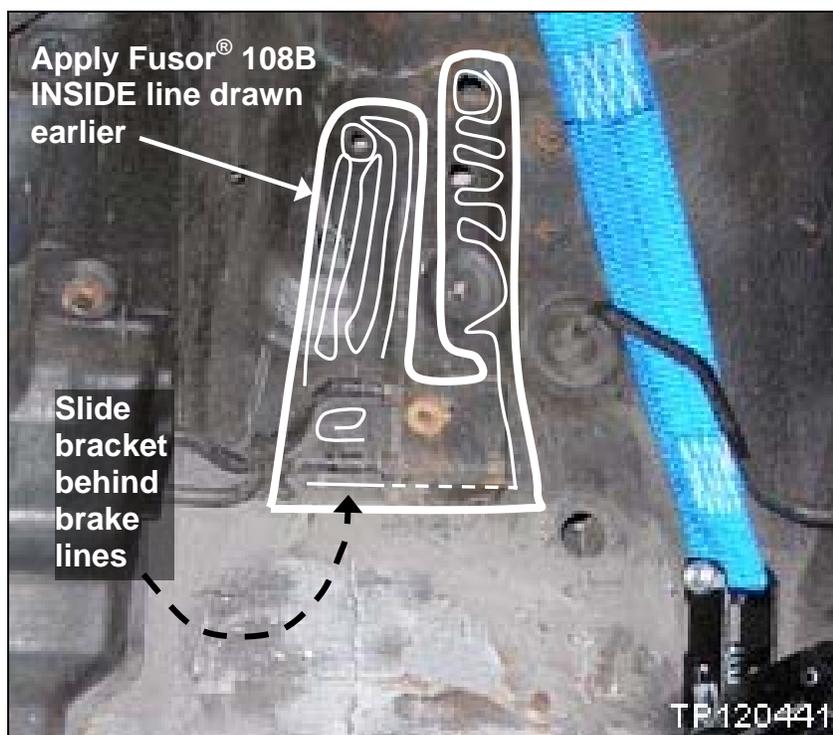
RB24 – Passenger side

27. Passenger side: Liberally apply Fusor® 108B on the strut housing area within the white line drawn earlier (see page 24, step 20, and Figure RB24 below).

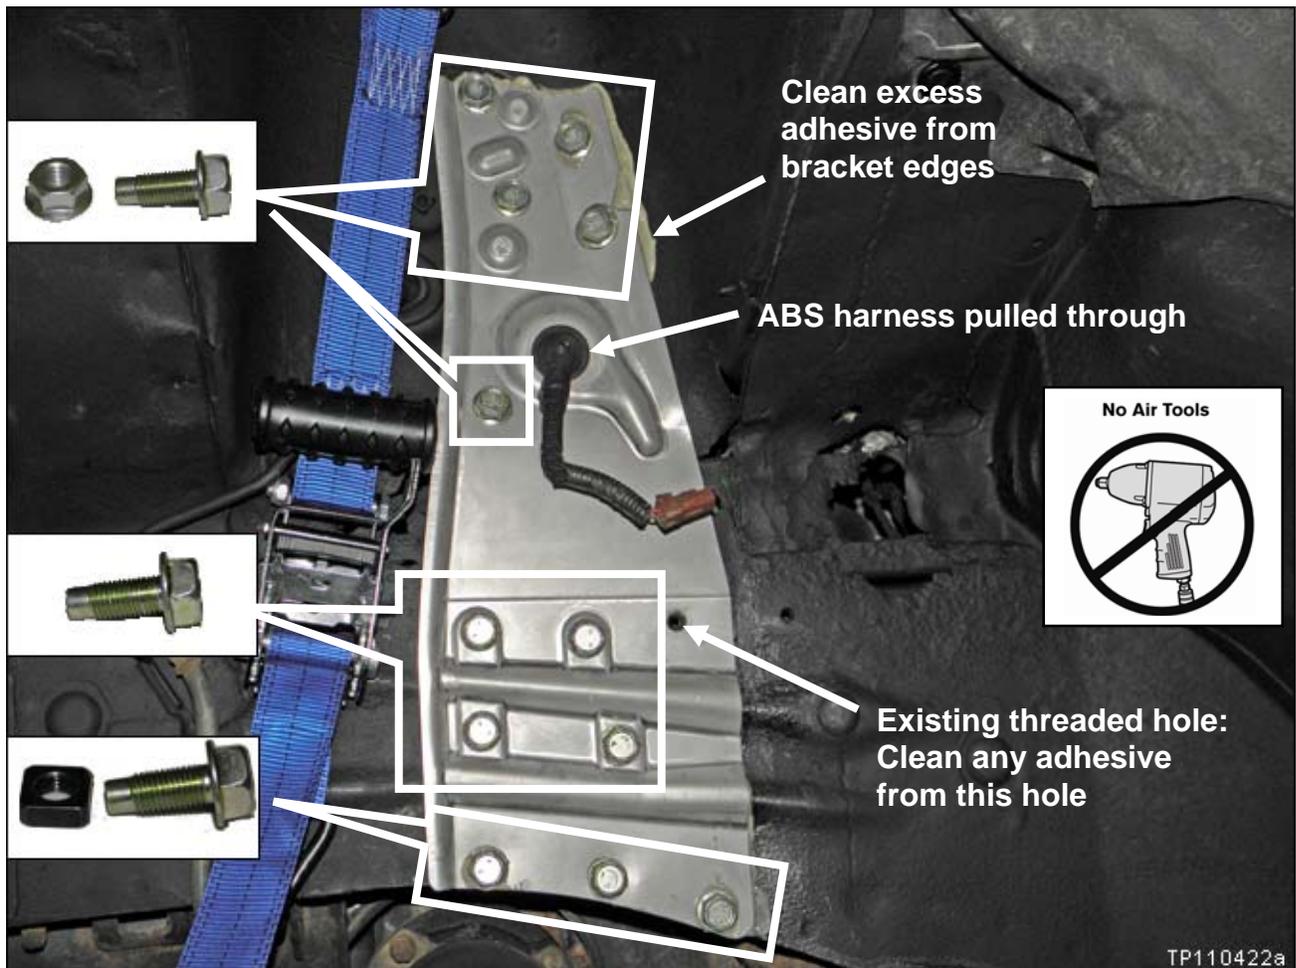
Figure RB25 – Driver side

- Driver side: make sure the ABS harness is pulled through its hole in the repair bracket.
- Use the correct nuts (see Figure RB25, or RB26 on next page, as it applies).
- **Do not use air tools to tighten the bolts.**
- Torque all new bolts/nuts to 50 N•m (5.1 kg-m, **37 ft-lb**).
- Secure all existing bolts.

NOTE: See additional repair bracket [bolt installation information](#) on page 33.

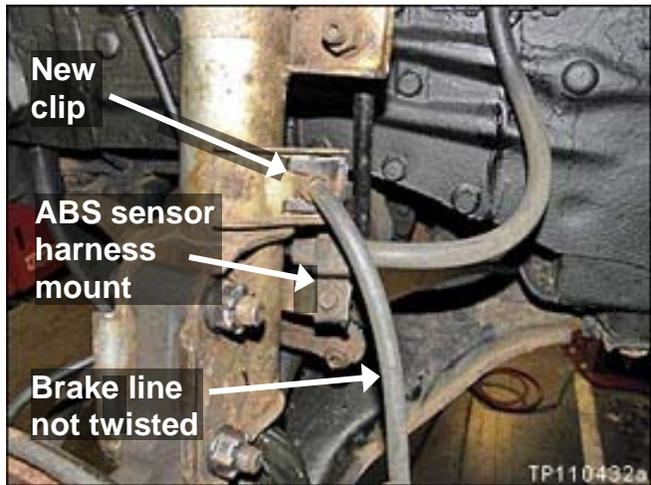
Figure RB37

- Use a new clip for the brake line mount (P/N 46206 – 2J00A).
- Confirm the ABS sensor harness is mounted correctly as shown in Figure RB37.
- Make sure the brake line is not twisted.

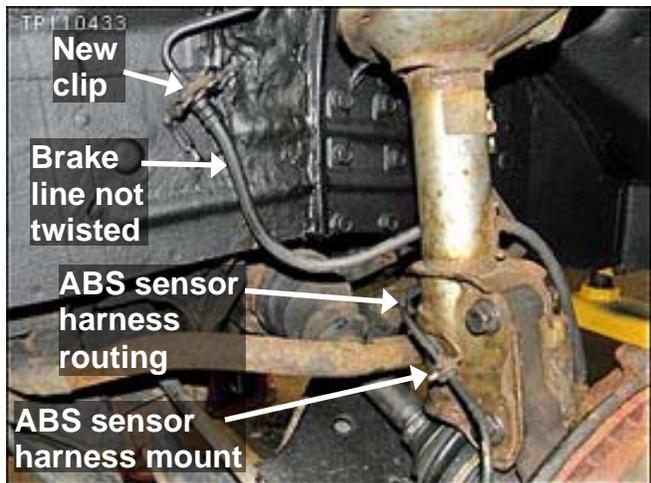
Figure RB38

- Use a new clip for the brake line mount (P/N 46206 – 2J00A).
- Make sure the brake line is not twisted.
- Confirm the ABS sensor harness is routed correctly behind the strut.
- Make sure the ABS sensor harness is mounted correctly as shown in Figure RB38.

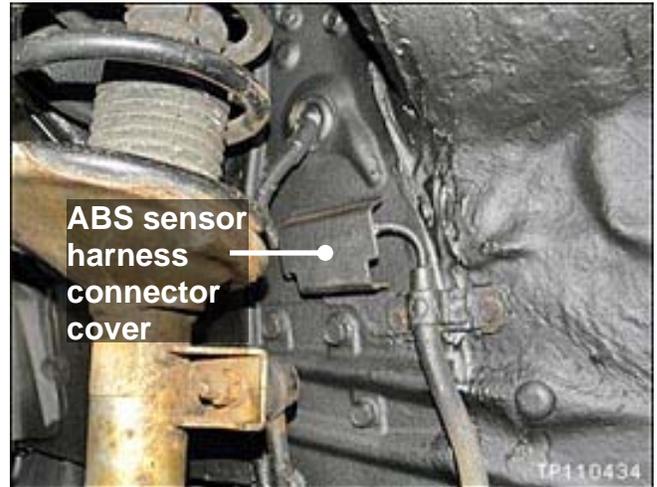
Figure RB39

- Make sure the ABS sensor harness connector cover is installed as shown.
 - If the cover is missing, install a new one.
 - Coat the cover with 3M Rubberized Undercoating (P/N 051135 – 08883); don't get any undercoat on the strut rod.

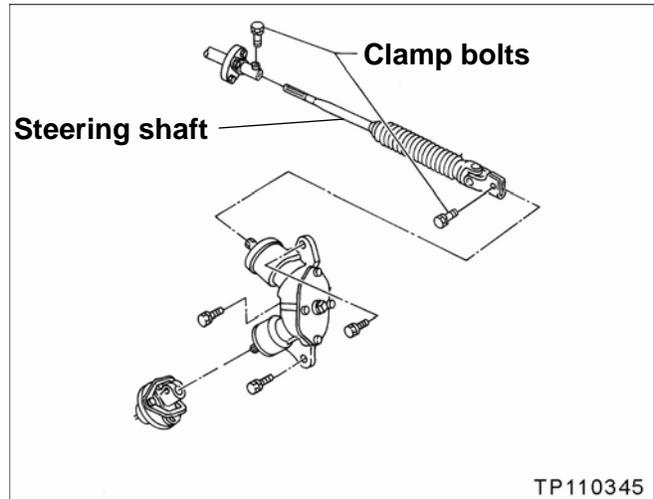
Figure SS1

2. Remove the clamp bolts at each end of the steering column upper joint (steering shaft).

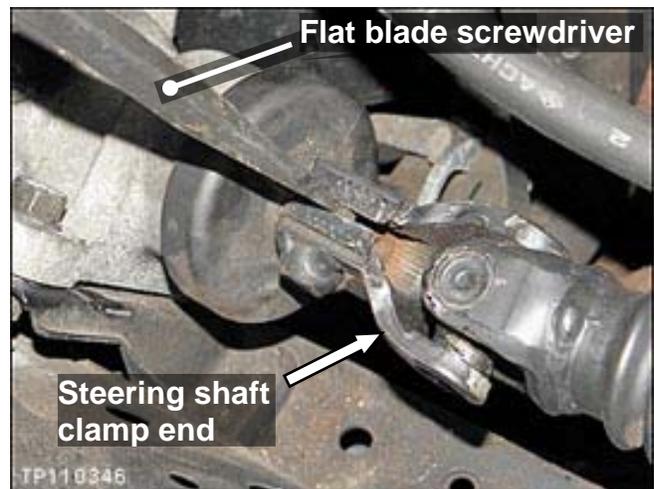
Figure SS2

3. Use a flat blade driver or other suitable tool to loosen both clamp ends of the steering shaft.

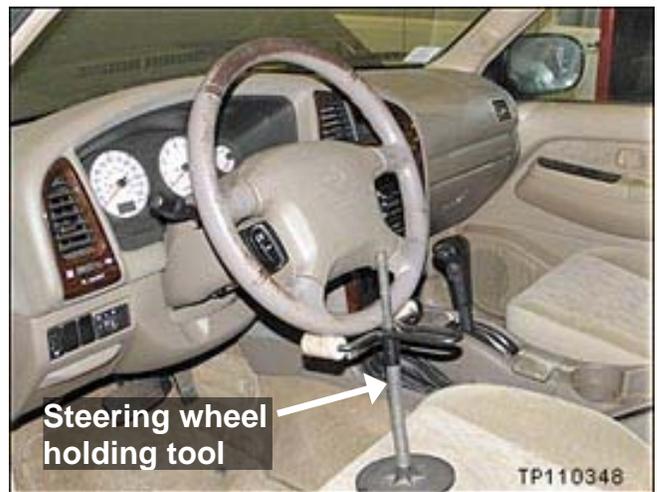
Figure SS4

5. Set the steering wheel in the straight ahead position.
6. Position a steering wheel holding tool as shown.
 - This will keep the steering wheel stationary while replacing the steering shaft.

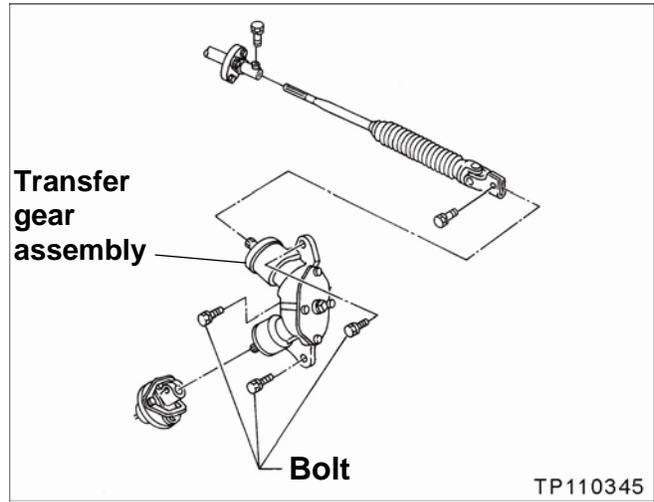
Figure SS6

7. Remove the 3 transfer gear assembly mounting bolts.

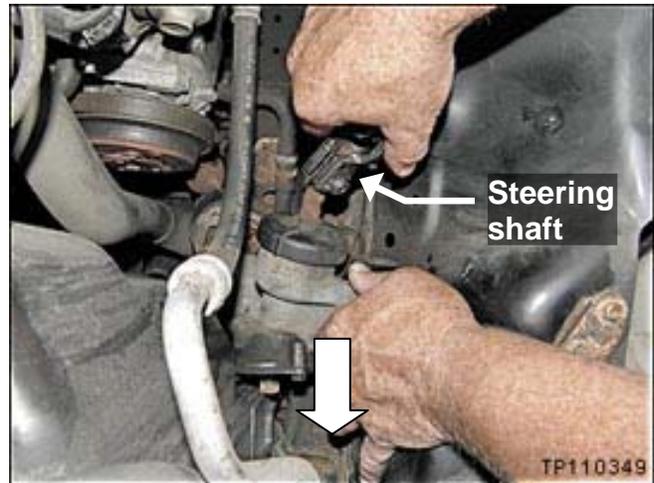
Figure SS7

8. Push the transfer gear assembly forward and remove the steering shaft.

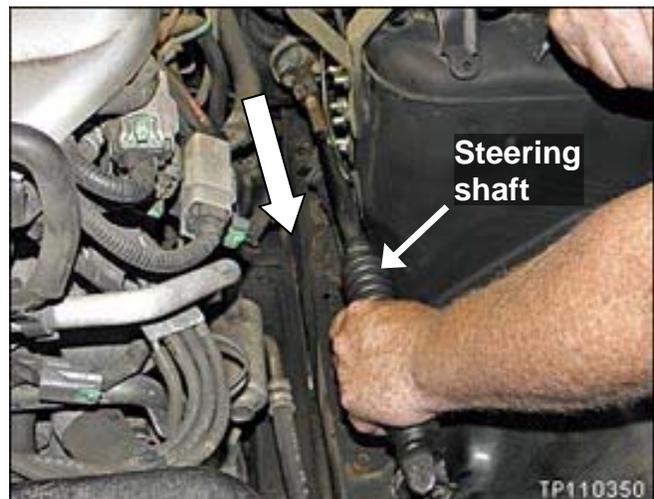
Figure SS8

9. Pull the steering shaft to remove it from the other end.
