Spartan Motors Chassis, Inc.

SERVICE BULLETIN

RSB13-320-003

SUBJECT: Park brake cable routing.

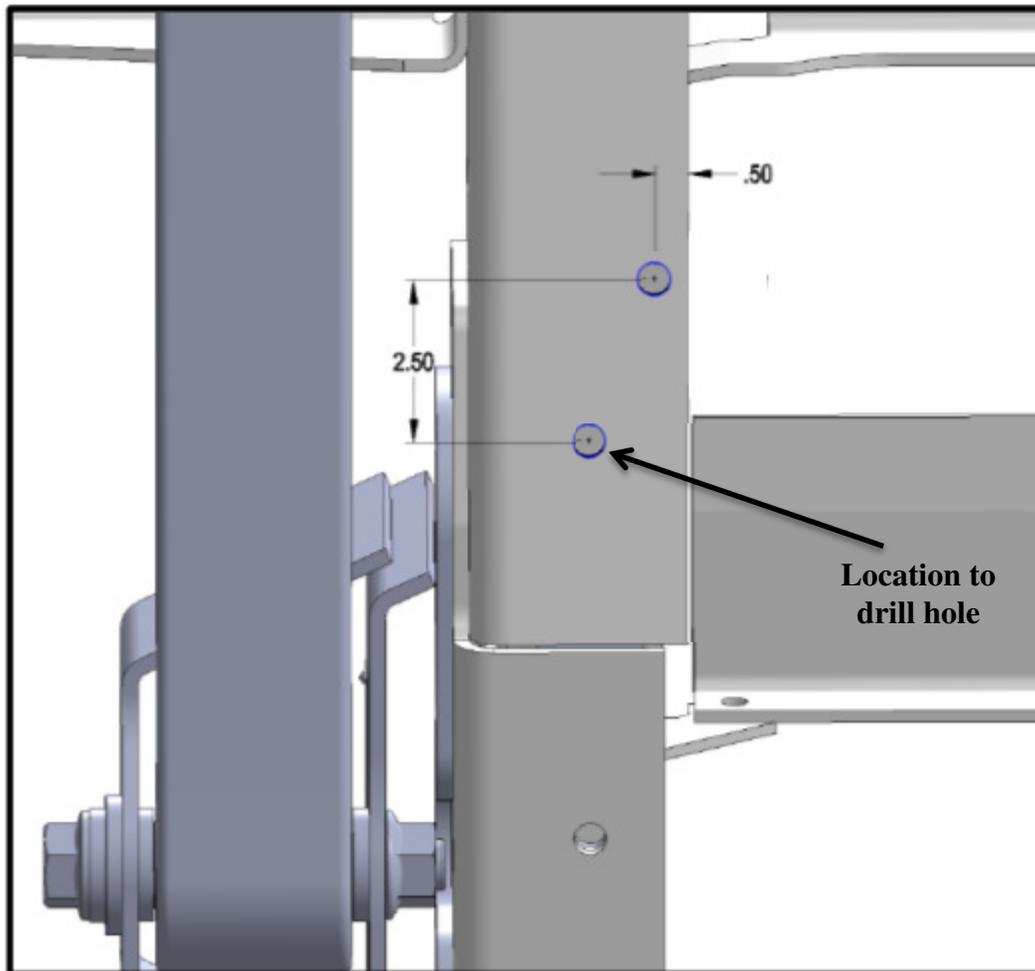
FIG. 2-1

1. Using dimensions in FIG. 2-1, drill left hand bottom frame rail (0.41 diameter hole).

Ensure area above frame rail is clear when drilling as to not puncture any hoses, electrical harnesses, lines etc.

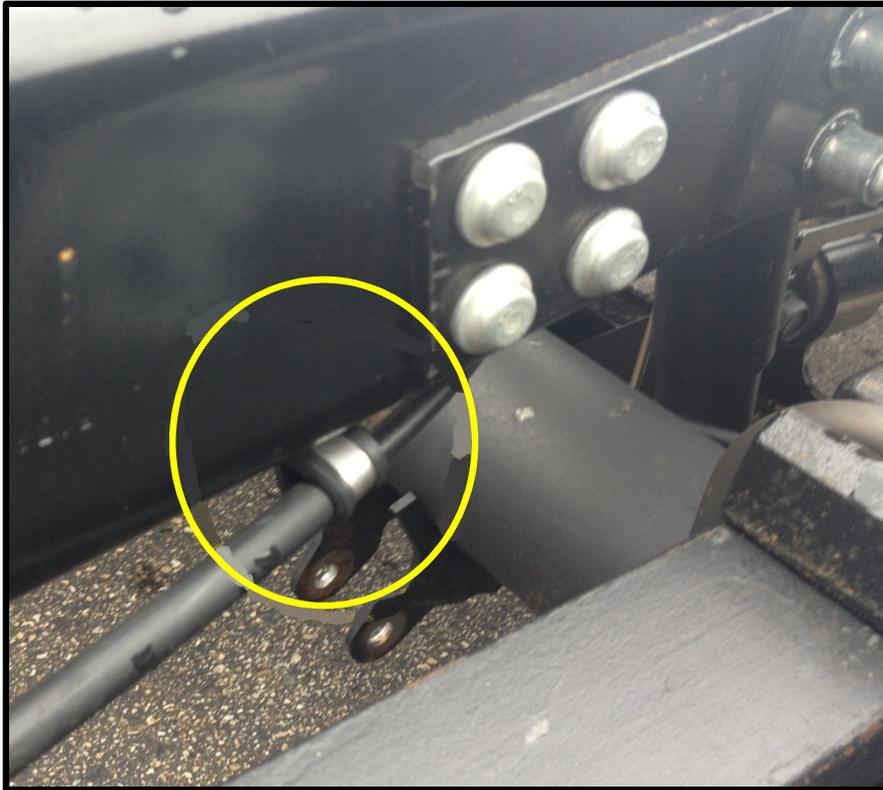
FIG. 2-2

2. Install S464SSG16 clamp around park brake cable and orientate perpendicular to frame rail.
Refer to FIG. 2-2.
3. Install clamp to frame rail using provided bolt and nut. Refer to FIG. 2-2.
Torque to 38 lbs. ft.

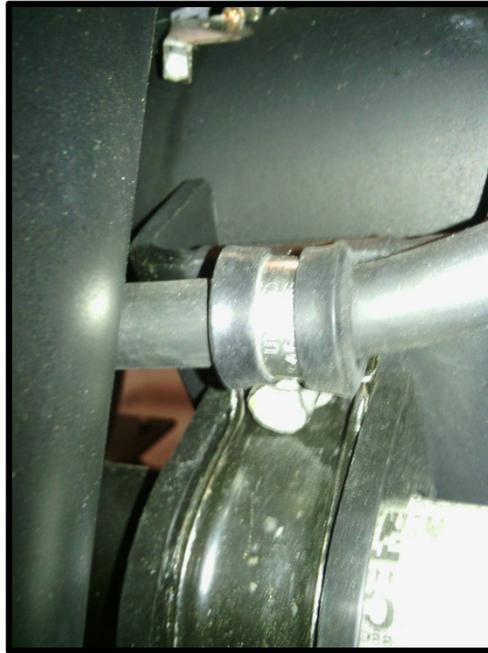
FIG. 3-1

4. Remove upper mounting bolt from left rear sway bar bushing, retain for reuse.
5. Install S464SSG8 clamp around park brake cable and place according to FIG. 3-1.

6. Bolt clamp to sway bar. Torque to 34 lbs. ft.
