Safety Defect and Noncompliance Report Guide for Vehicles
PART 573 Defect and Noncompliance Responsibility and Reports¹

On Dec 13th, 2013, Tiffin Motorhomes [MFR] decided that a defect which relates to motor vehicle safety exists in the motor vehicles listed below, and is furnishing notification to the National Highway Traffic Safety Administration in accordance with 49 CFR Part 573 Defect and Noncompliance Responsibility and Reports.

Heat Shield for 33AA

PURPOSE: To provide instructions for installing a fireplace heat shield on 33 AA's.

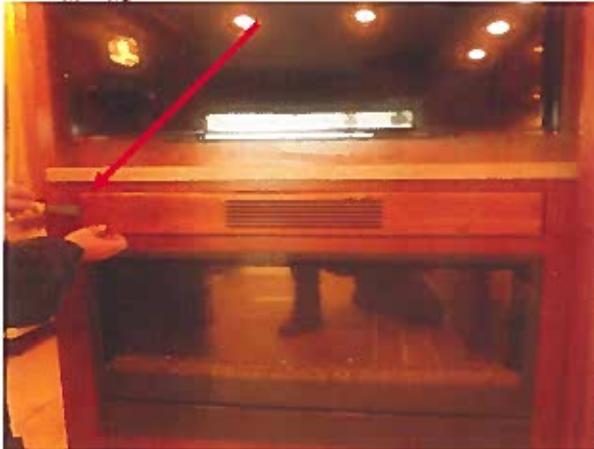
1. Remove louver above fireplace with putty knife.

See photo below

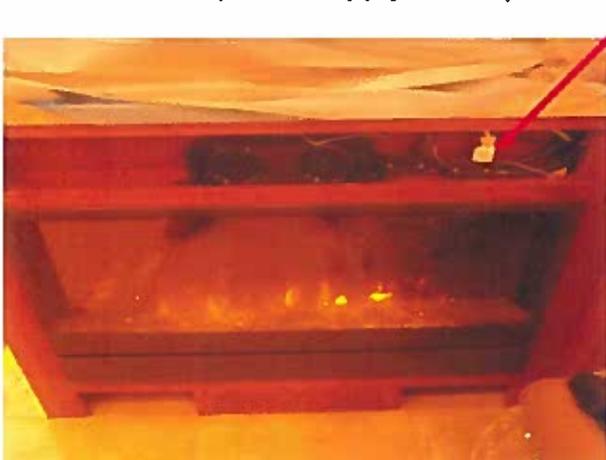
2. Disconnect power supply for fireplace. *See photo below*

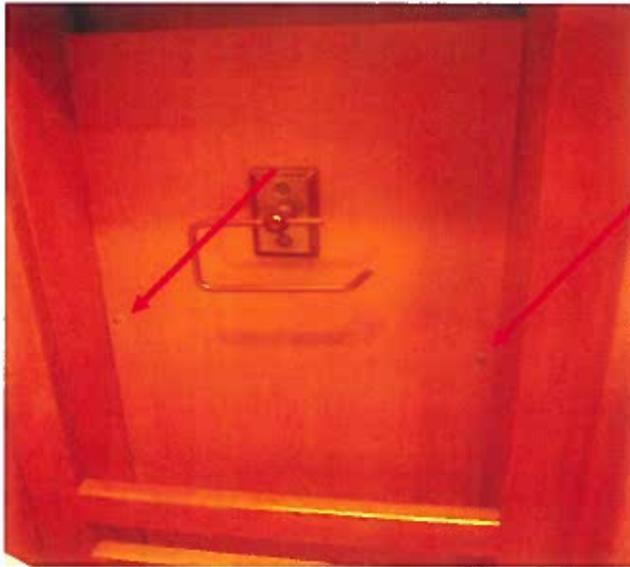
3. Located inside bathroom remove two screws to remove panel and gain access to fireplace.
See photo below

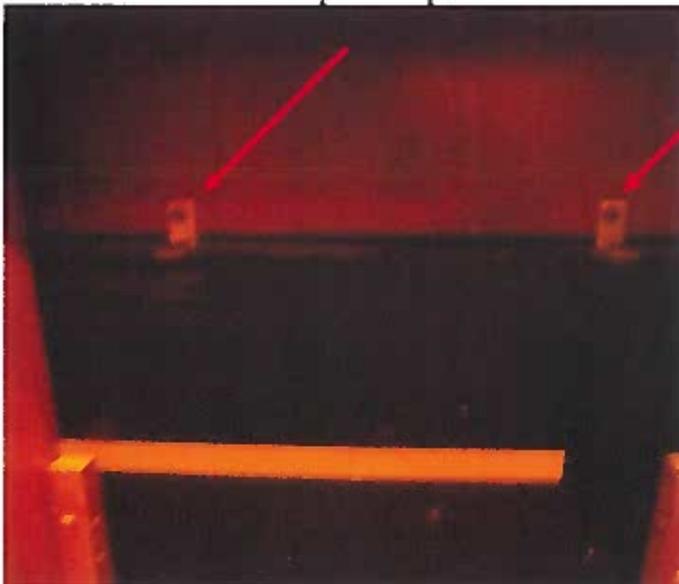
4. Once removing paneling in step 3 remove screws holding angle brackets securing fireplace.
See photo below

Note: When removing these screws fireplace needs to be secured firmly in place because these screws secure fireplace in position.

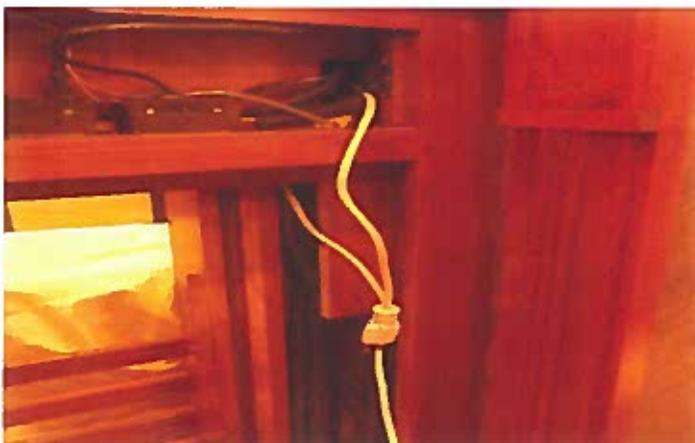
5. After unsecuring fireplace in step 4 position fireplace to gain access to metal shield behind lower louver, but leave extension cord in wall **as seen below**.

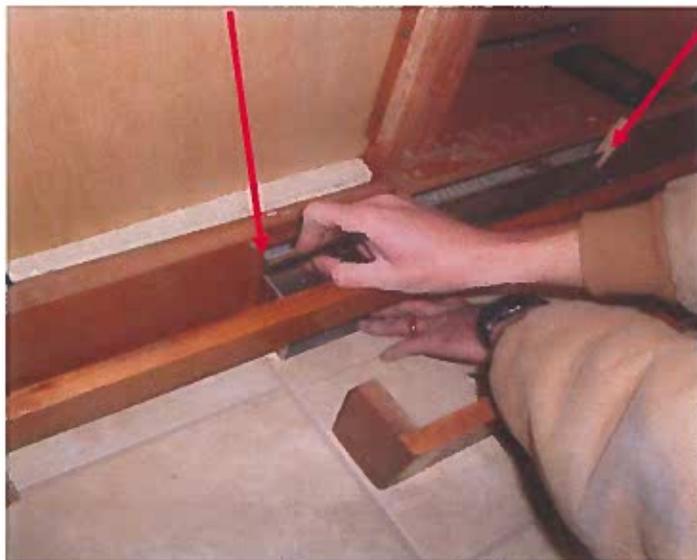
A. Mark sides of current heat shield before using electric drill to remove lower louver and metal shield to make necessary cuts, **see photos below**.

Note: Picture as seen below shows petition already cut out, but if petition isn't cut it will need to be cut (see step in 6c below for cutting).

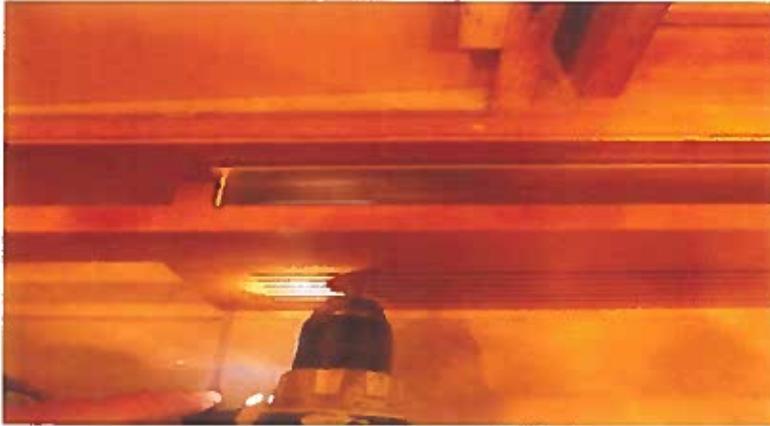
B. Using electric screwdriver remove screws holding heat shield to petition wall.

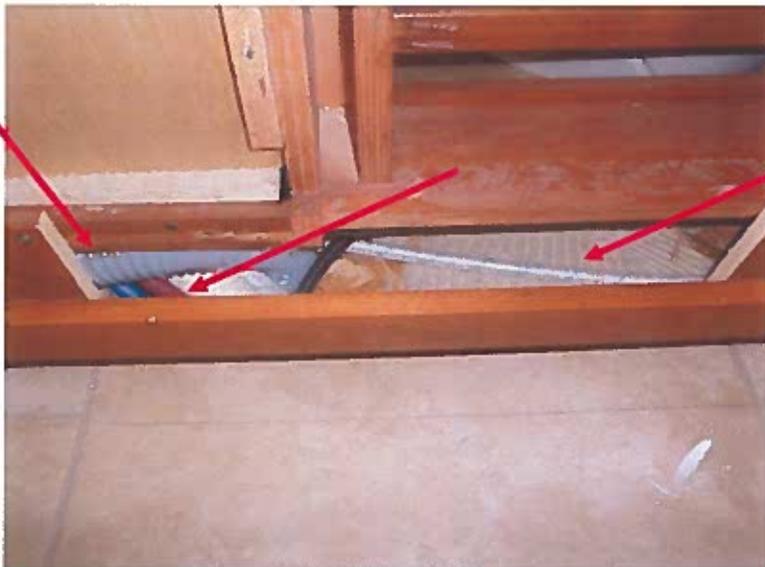
C. Cut petition wall as seen below and dispose of wooden louver and original metal shield

Note: When cutting petition wall be cautious not to cut into vacuum/plumbing lines behind petition wall, see pic below pointing to lines.

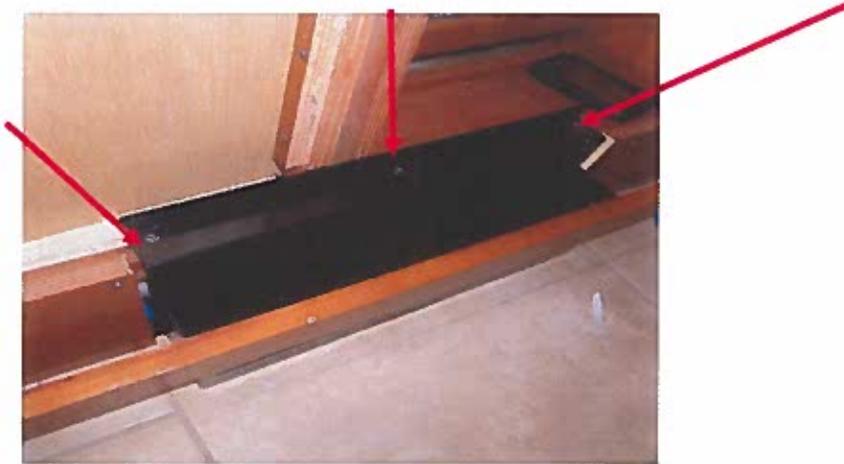
- A. Secure new heat shield with three screws part #13661 as **seen in pic below.**

Note: Three 1.5"x3"x3/8" spacers will be needed to fill gap between shield and petition wall top, **see pics below.**

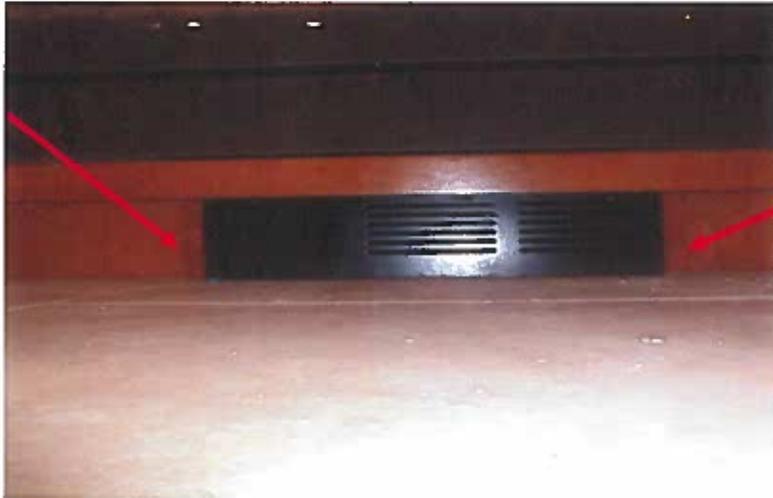
D. If needed alder trim can be added to sides of heat shield to get tight fit/clean look.

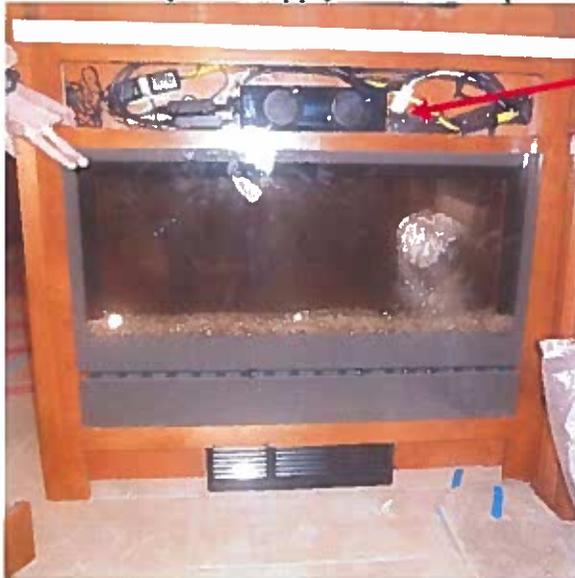
A. Connect power supply back for fireplace, *see pic below.*

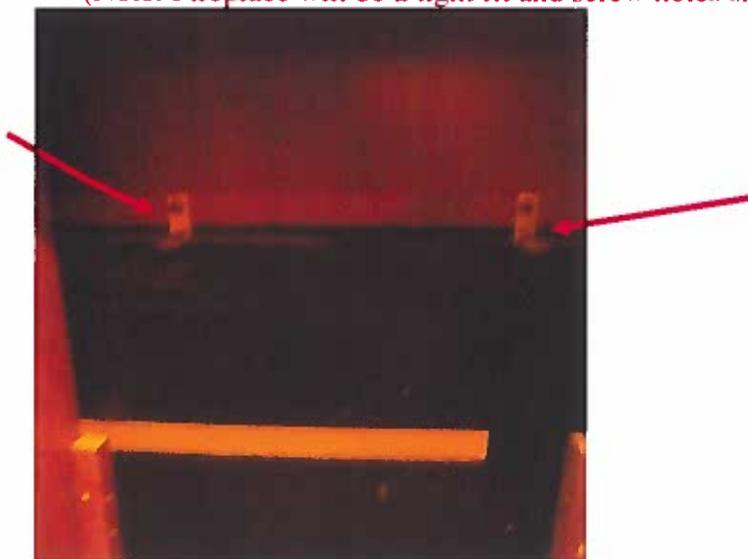
- B. Install Fireplace back into opening and hold in place while securing inside bathroom , [see pic below](#).

(Note: Fireplace will be a tight fit and screw holes should align to original holes.)

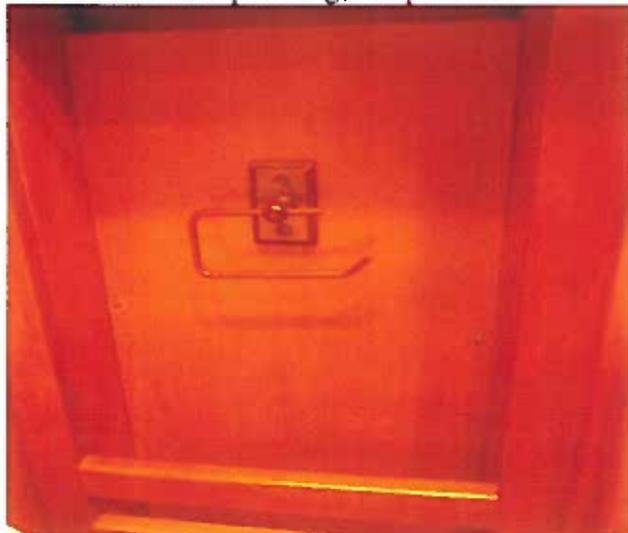
8. Secure bathroom paneling, [see pic below](#)

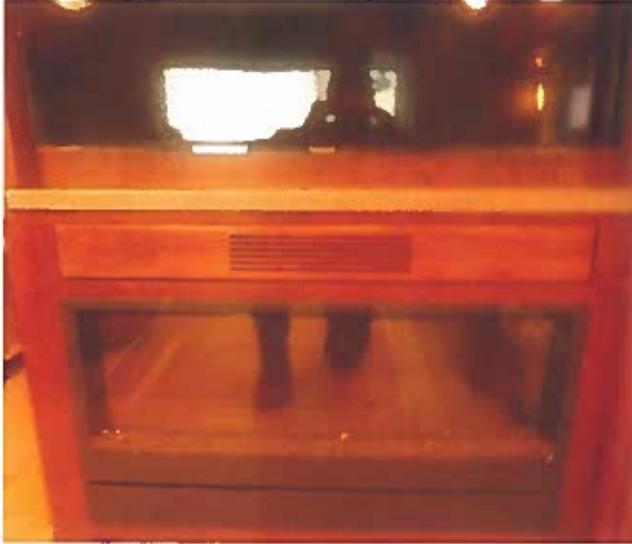
9. Secure top louver above fireplace, **see pic below**
