GROUP  
Safety Recall Campaign

NUMBER  
SC 098 (REV 1, 11/4/2013)

## VOLUNTARY SAFETY RECALL CAMPAIGN

### STOP LAMP SWITCH REPLACEMENT (SC098)

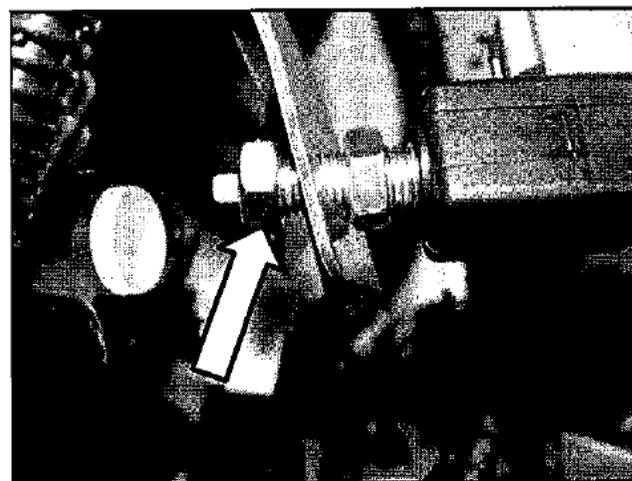
- Remove the lower mounting nut for the stop lamp switch.

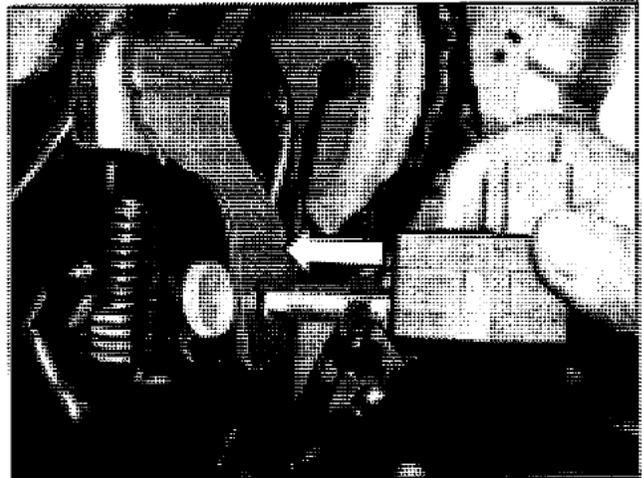
7. Install the new stop lamp switch assembly by reversing the order of removal.

**For Soul Vehicles ONLY:** If stop lamps remain on without brake pedal being depressed, the switch polarity may be incorrect; if so, select the other (Soul) switch P/N.

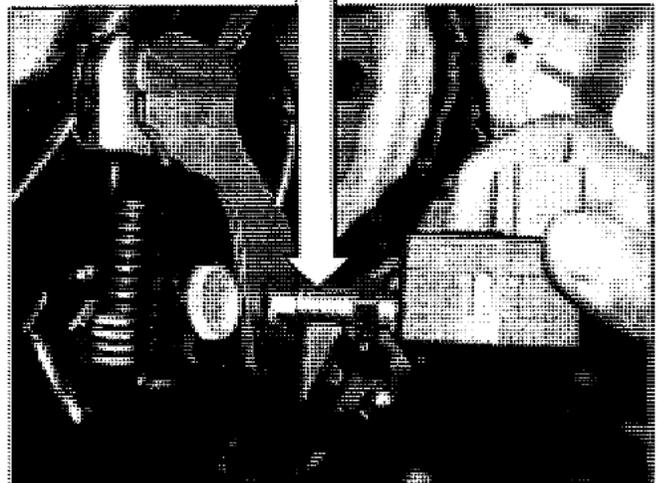
8. Install one end of the ground wire between the stop lamp's upper mounting nut and the mounting bracket, as shown.

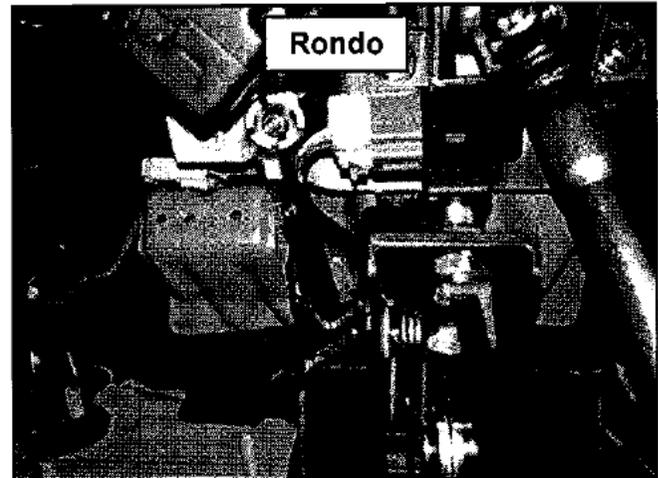
9. On Rondo vehicles, locate and remove the mounting nut for the BCM and install the other end of the ground wire to the stud. Reinstall and tighten the nut.

Failure to properly install ground wire may result in improper brake lamp operation.

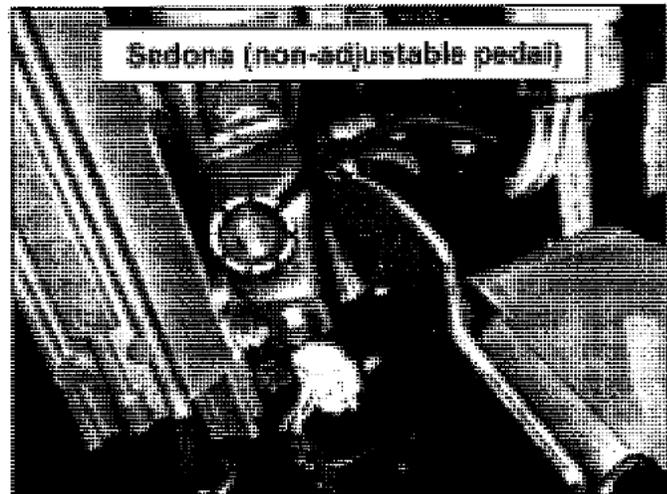
10. On Sedona (non-adjustable pedal) vehicles, remove the bolt identified in the image and install the other end of the ground wire to the bolt. Reinstall the bolt and tighten it.

**Tightening torque:**  
13 ~ 18 Nm (9.6 ~ 13.2 lb-ft)

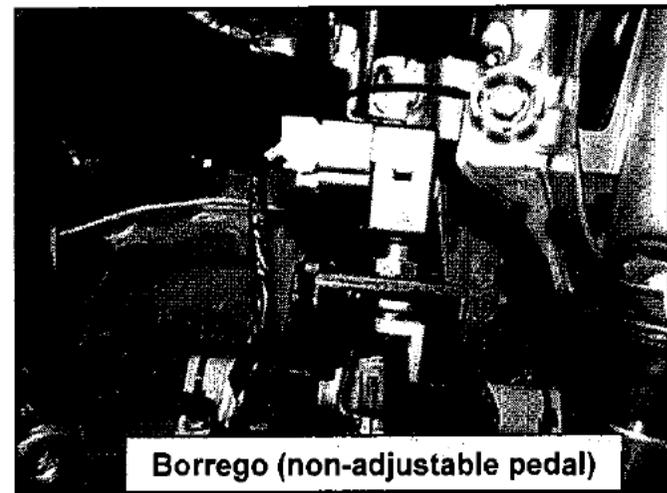
11. On Borrego vehicles (non-adjustable pedal), remove the bolt identified in the image and install the other end of the ground wire to the bolt. Reinstall the bolt and tighten it.

**Tightening torque:**  
13 ~ 18 Nm (9.6 ~ 13.2 lb-ft)

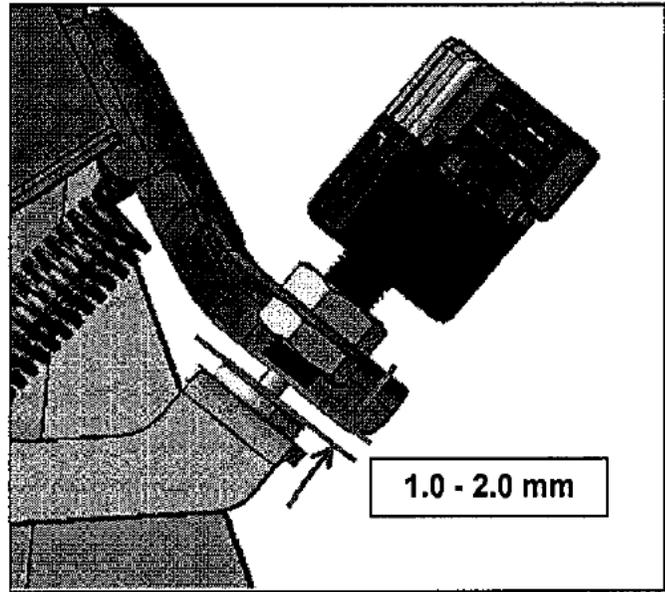
- Adjust the gap to 1.0 - 2.0 mm (0.04" - 0.08") between the stop lamp switch lower mounting end and the brake pedal switch stopper, without applying the brake pedal.

Failure to properly adjust the switch may result in check engine and/or ESC malfunction indicator lamp illumination.

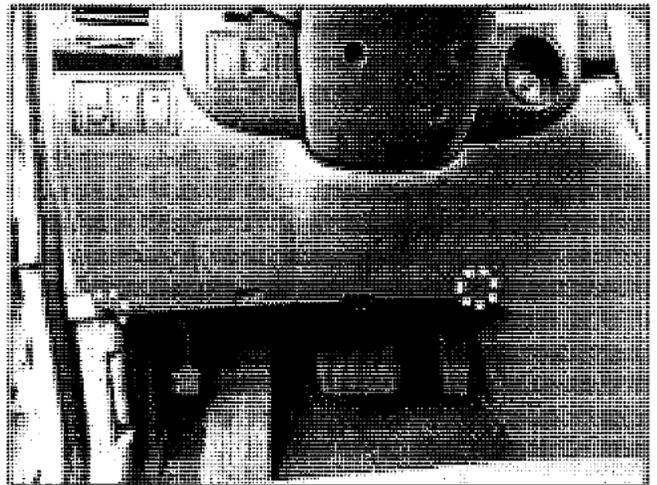
5. Remove two (2) screws securing the lower panel to the lower mounting locations on the dash.

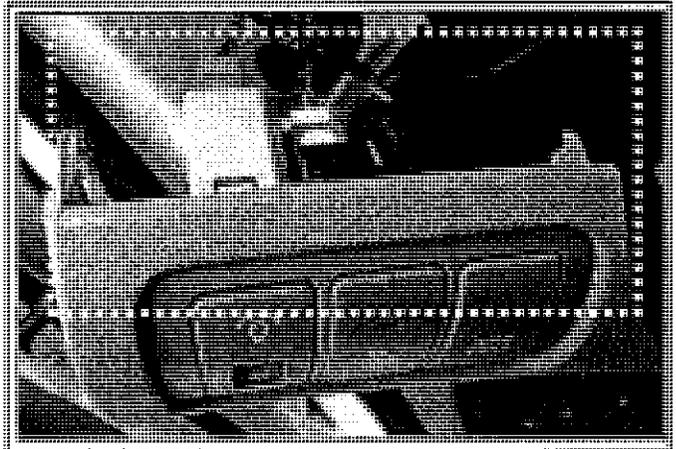
- 6. Carefully remove the switch panel from the dash and remove three (3) connectors from behind the switches.

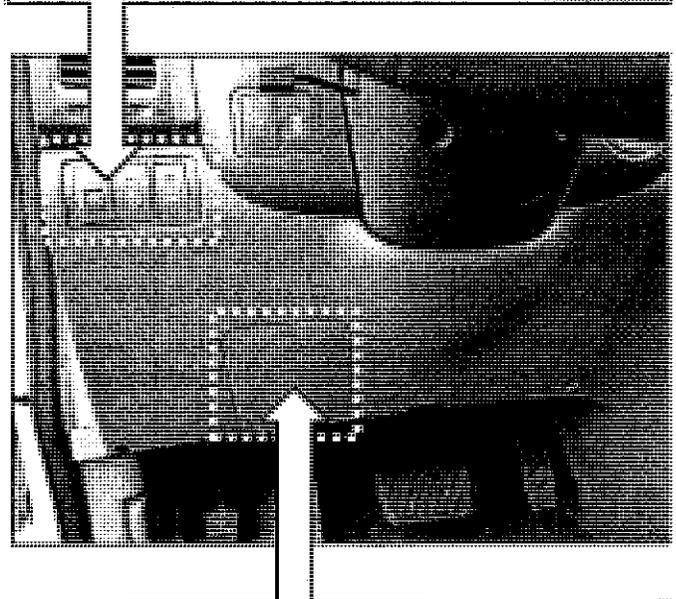
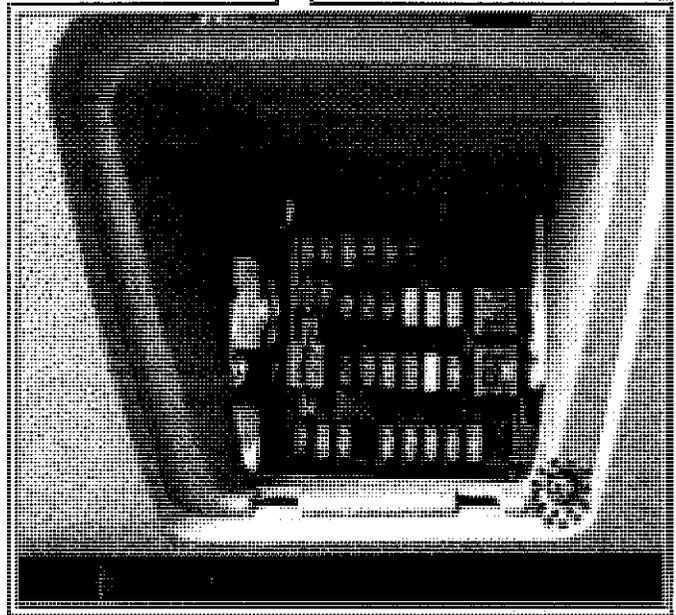
- 7. Remove the fuse box cover and remove one (1) screw securing the lower panel.

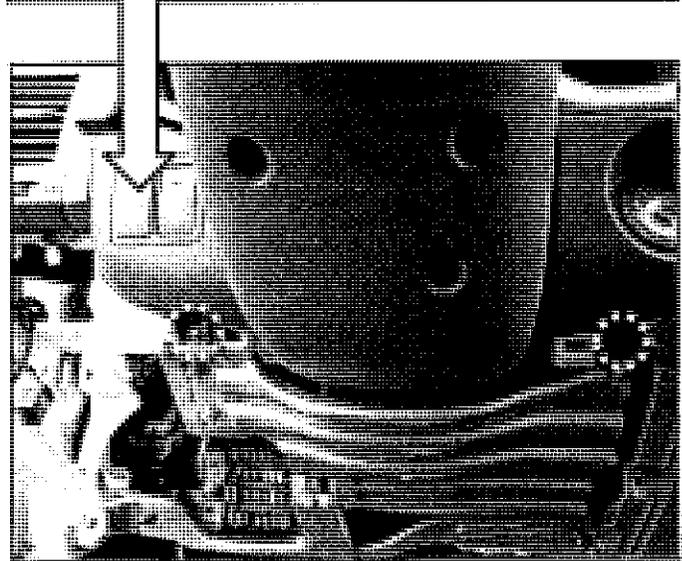
9. Remove two (2) screws securing the lower mounting points for the cluster bezel and remove the cluster bezel.

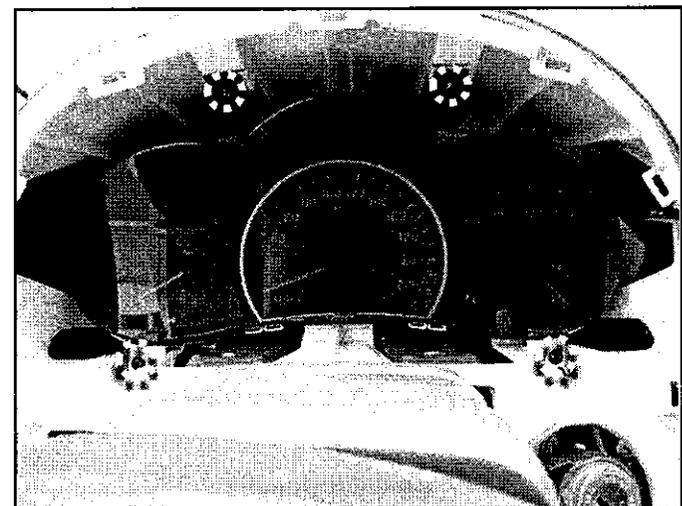
10. Carefully remove four (4) screws securing the cluster and remove the connector from the back of the cluster.

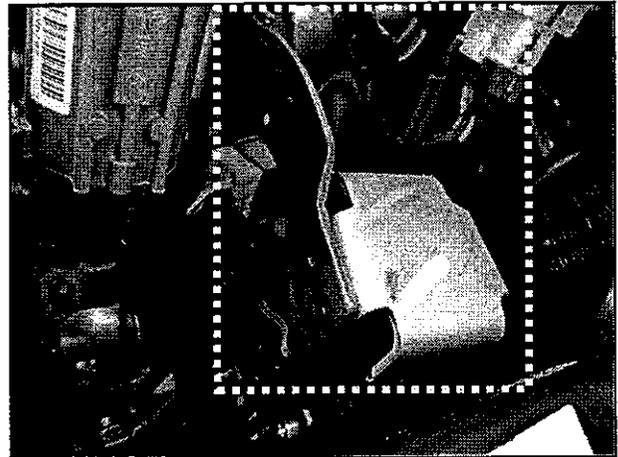
11. Locate the brake pedal stopper bracket underneath the dash and note its mounting location in the area behind the cluster opening.

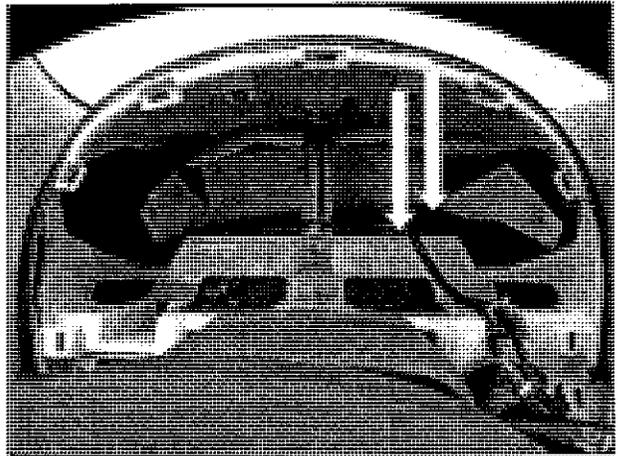
12. Locate one (1) 12mm hex head bolt and one (1) 12mm nut securing the brake pedal stopper bracket to the dash frame. Remove the bolt but ONLY loosen the nut to allow for the stopper bracket to move freely.

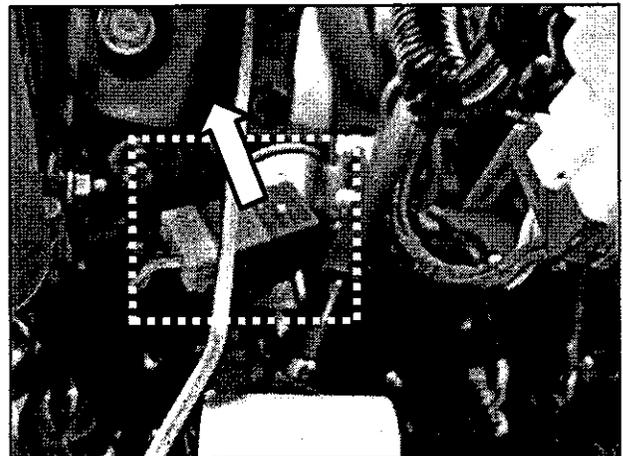
13. Move the brake pedal stopper bracket to the left to gain access to the stop lamp switch.

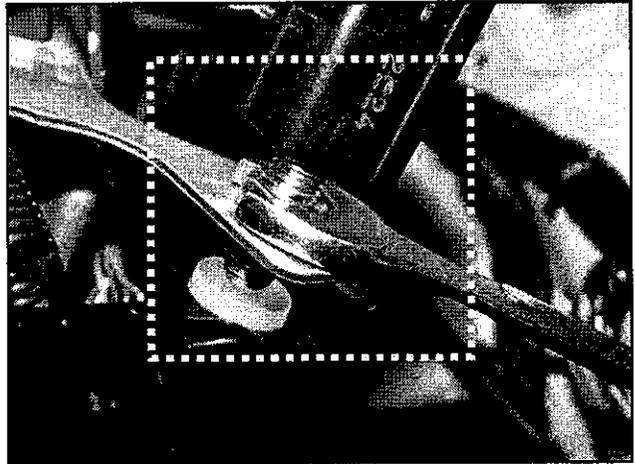
14. Using an open end wrench, loosen the upper mounting nut for the stop lamp switch.

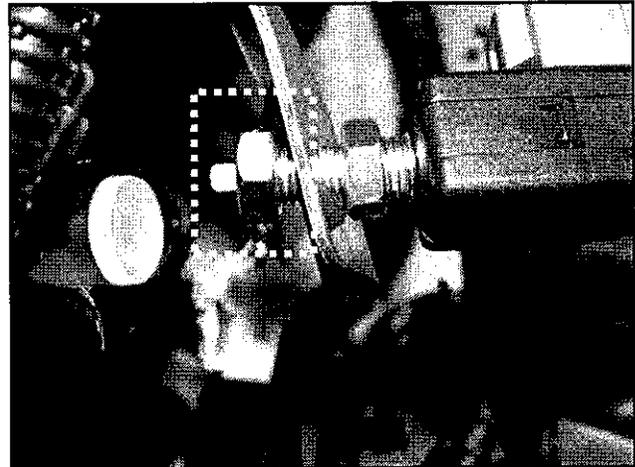
15. Remove the lower mounting nut for the stop lamp switch.

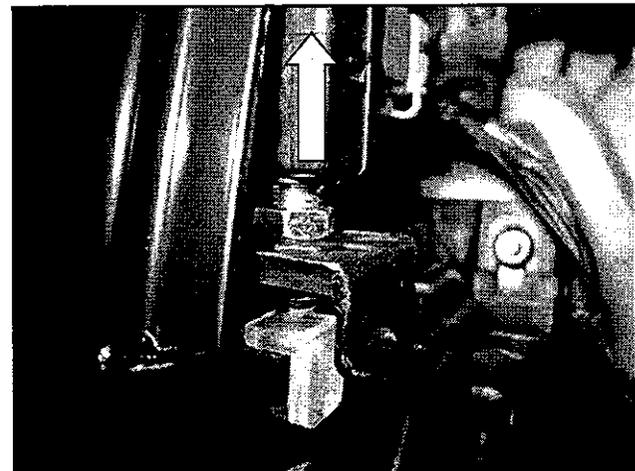
16. Remove the stop lamp switch assembly by pulling it away from the mounting bracket, as shown.

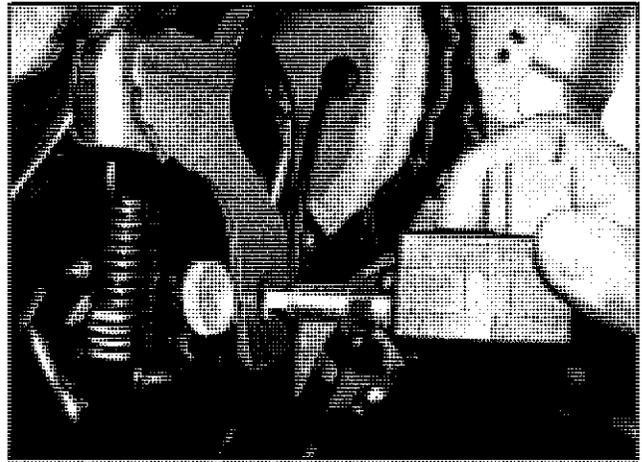
17. Install the new stop lamp switch assembly by reversing the order of removal.

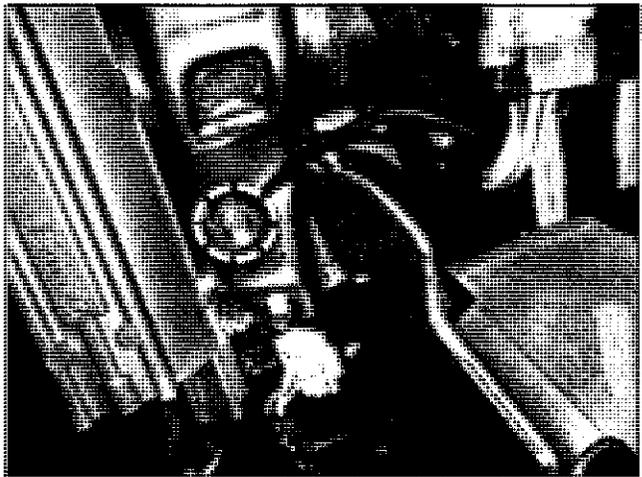
19. Remove the bolt identified in the image and install the other end of the ground wire to the bolt. Reinstall and tighten the bolt.

**Tightening torque:**  
**13 ~ 18 Nm (9.6 ~ 13.2 lb-ft)**

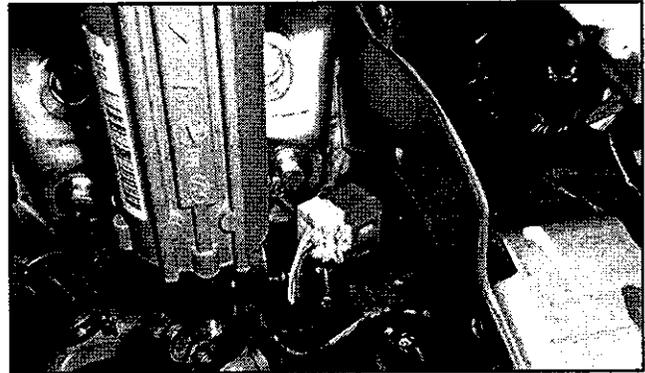
20. Position the stop lamp switch in the orientation shown to maximize the clearance between the switch and the brake pedal stopper bracket.

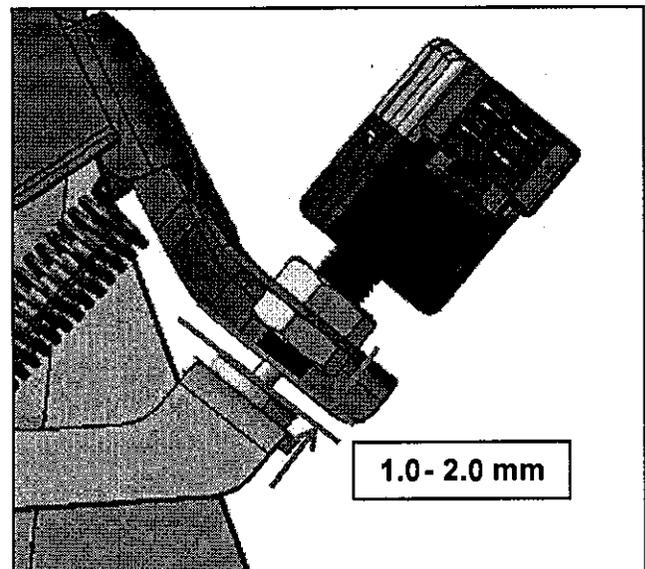
21. Adjust the gap to 1.0 - 2.0 mm (0.04" - 0.08") between the stop lamp switch lower mounting end and the brake pedal switch stopper, without applying the brake pedal.

Failure to properly adjust the switch may result in check engine and/or ESC malfunction indicator lamp illumination.

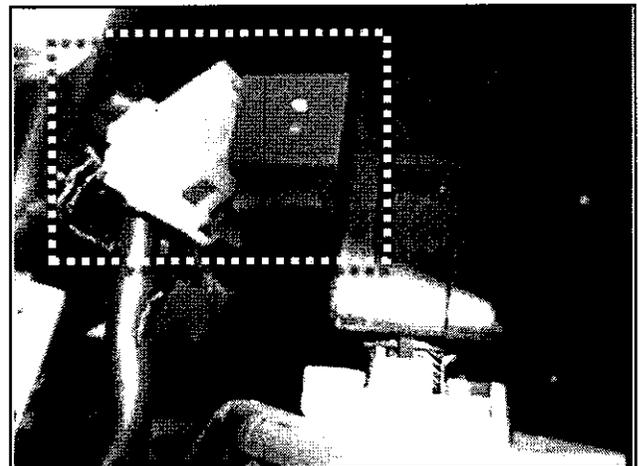
3. Disconnect the stop lamp switch wiring connector.

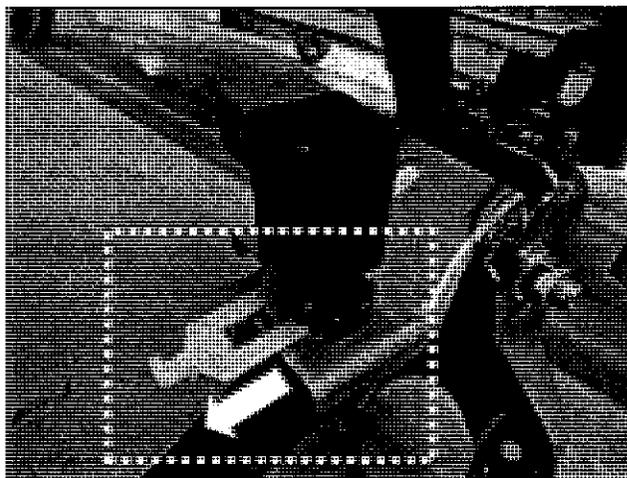
4. Pull the locking plate away from the locking ring, as shown.

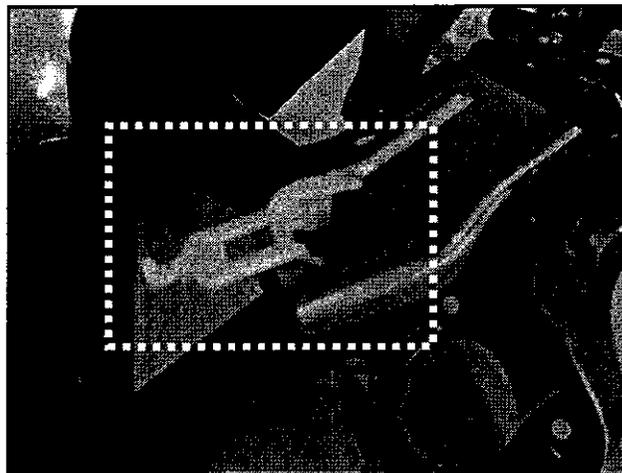
6. Remove the locking plate and discard it.

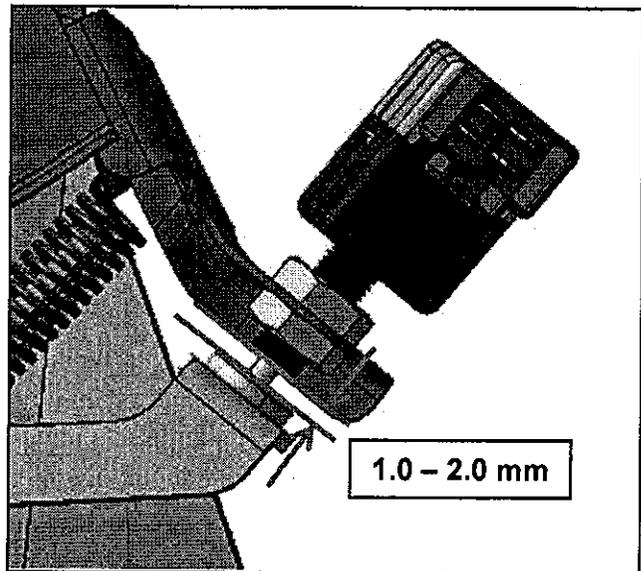
8. Adjust the gap to 1.0 - 2.0 mm (0.04" - 0.08") between the stop lamp switch lower mounting end and the brake pedal switch stopper, without applying the brake pedal.

Failure to properly adjust the switch may result in check engine and/or ESC malfunction indicator lamp illumination.
