R13WS

IMPORTANT SAFETY RECALL NOTICE

NHTSA NO. 13V-577 NON-SCHOOL BUSES
NHTSA NO. 13V-579 SCHOOL BUSES

Driver's Seat Belt Buckle Noncompliance

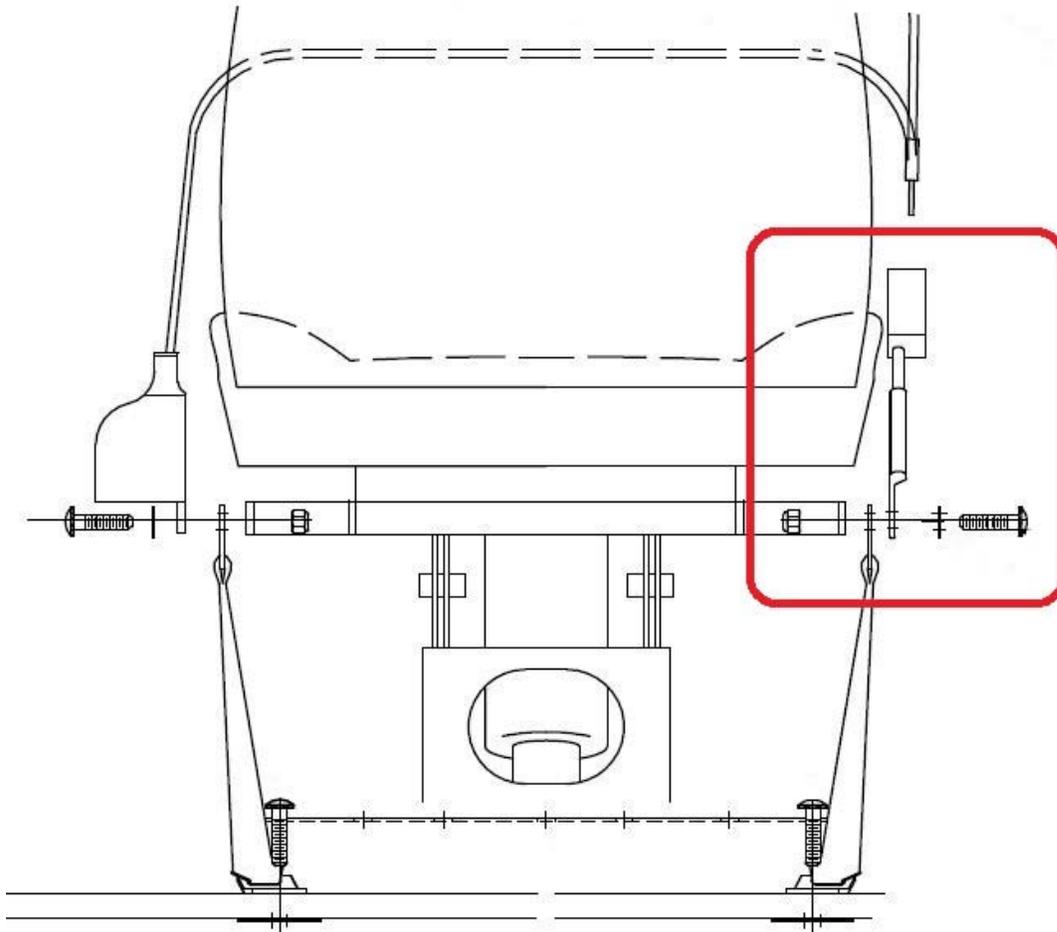
Reference installation drawing below as viewed from the rear of the driver's seat.

BELT BUCKLE REPLACEMENT PROCEDURE A

(For buses equipped with buckle mounted to driver's seat)

1. Park the bus on a level surface, apply parking brakes, remove ignition key.
2. Locate driver's seat belt buckle on right side of driver's seat. Remove and retain the 7/16" bolt securing the buckle to the seat frame. Discard the lock nut and buckle.
3. Install new buckle with new lock nut and torque to 37-41 ft- lbs. Verify belt tongue locks securely into buckle.

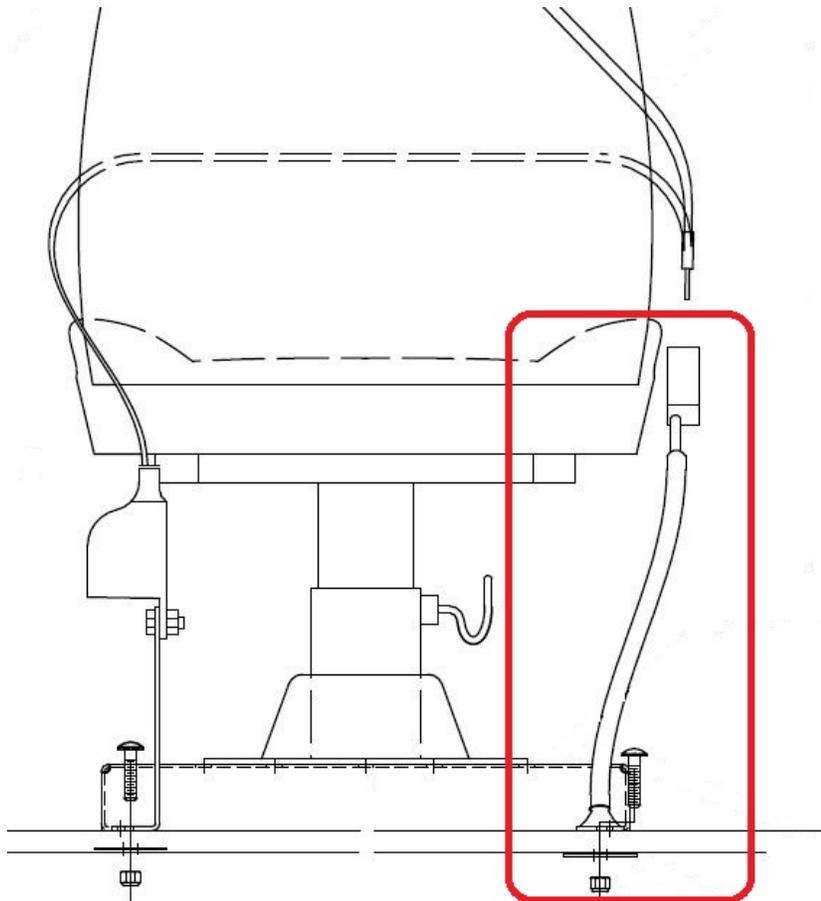
Reference installation drawing below as viewed from the rear of the driver's seat.

BELT BUCKLE REPLACEMENT PROCEDURE B

(For buses equipped with buckle mounted to floor)

1. Park the bus on a level surface, apply parking brakes, remove ignition key, and chock wheels.
2. Locate driver's seat belt buckle on right side of driver's seat. Remove and retain the 7/16" bolt securing the buckle to the floor of the bus. Discard the lock nut and buckle.
3. Install new buckle with new lock nut and torque to 37-41 ft-lbs. Verify the buckle is routed through the cable stay and belt tongue locks securely into buckle.
