13V-550

GROUP Safety Recall Campaign	MODEL 2006~2012MY Sedona (VQ)
	NUMBER SC100 (Rev 1, 01/08/2014)	DATE December 2013

SUBJECT: FRONT LOWER CONTROL ARM INSPECTION, REPLACEMENT  
OR APPLICATION OF PREVENTATIVE ANTI-CORROSION MATERIAL (SC100)

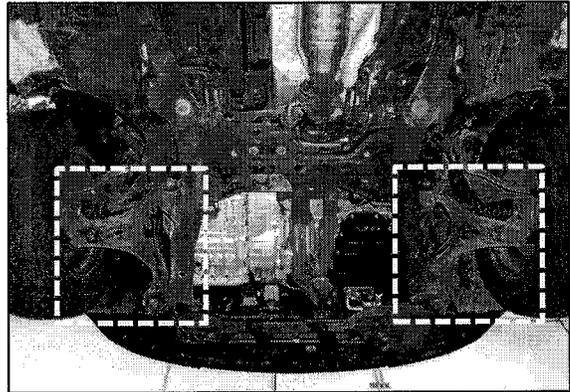
1. Place the vehicle on a lift and inspect the condition of the lower control arms. If any perforations or open cavities are present on either control arm, proceed to the Service Procedure on Page 4. If not, proceed to step 2.

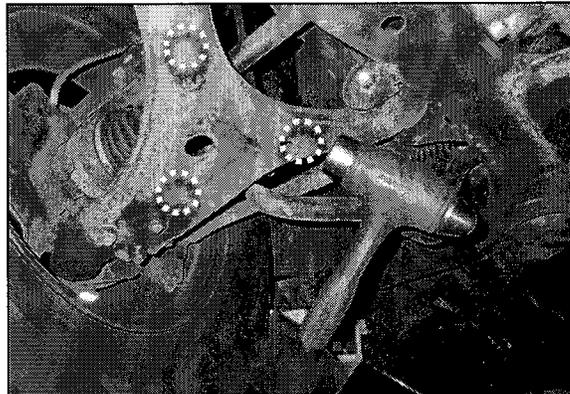
2. Use a hammer to strike the lower control arm at multiple spots. Check for weak spots in the metal and overall integrity of the lower control arm. If the lower control arm fails, proceed to the Service Procedure on Page 4. If overall integrity is confirmed, proceed to step 3.

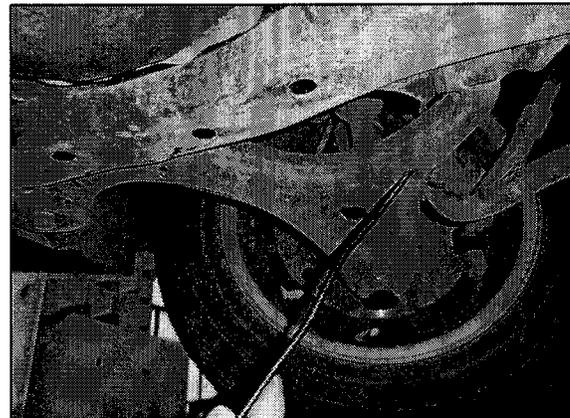
3. Insert a magnetic pick up tool inside the lower control arm to remove any loose rust flakes.

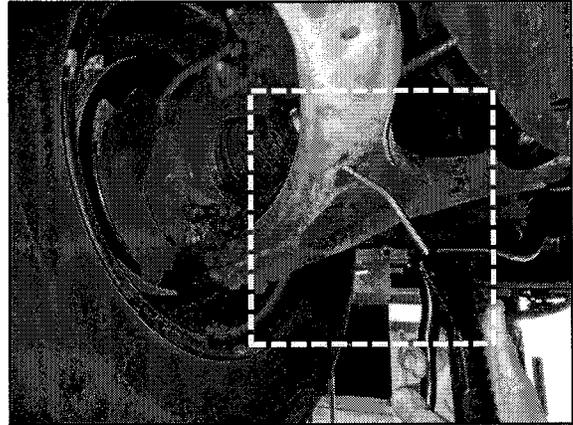
- Remove any remaining debris from the inside of the lower control arm using an air gun. Make sure to insert the nozzle in multiple holes and rotate it in all directions to completely remove any foreign material or rust flakes.

Repeat step 4 a total of three (3) times per lower control arm.

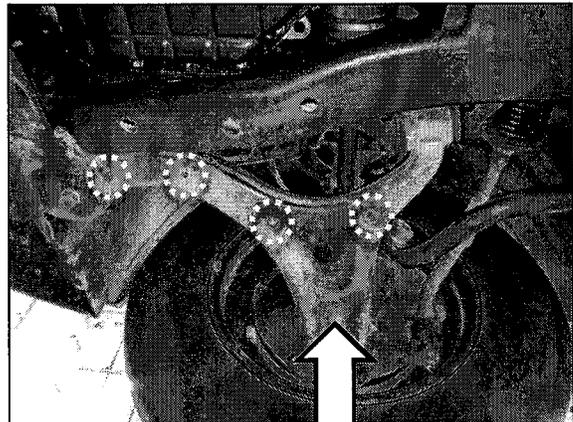
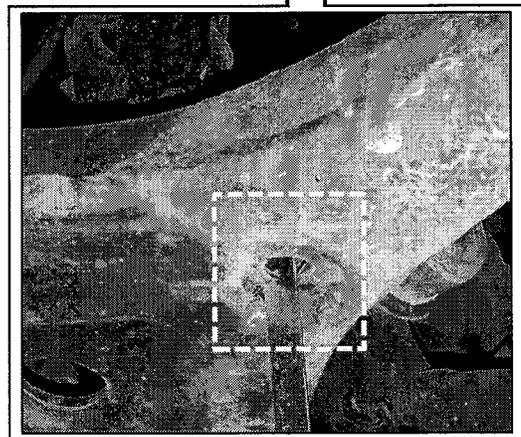
SST P/N: 54500 18GAP

- After removing all loose rust flakes from inside the lower control arm, use the SST gauge (see below) to check the material thickness at all holes in the lower control arm, as shown.

- If the gauge can be inserted over the material's edge, proceed to the Service Procedure on Page 4.
- If the gauge cannot be inserted over the material's edge, and the lower control arm passed the visual inspection and the hammer strike test, proceed to the Reconditioning Procedure on Page 7.

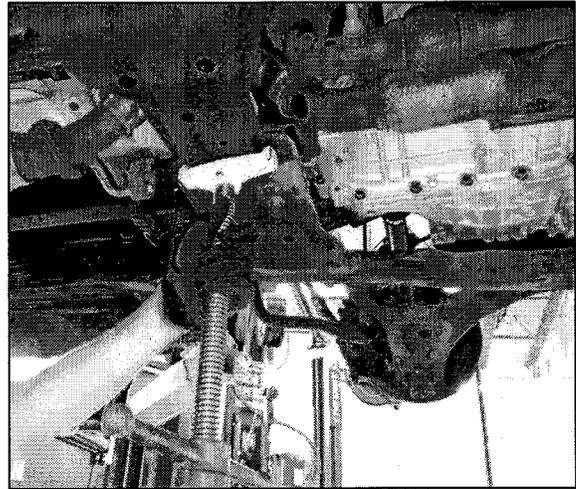
1. Remove the front wheels.
2. Place a transmission jack under the sub-frame for support.

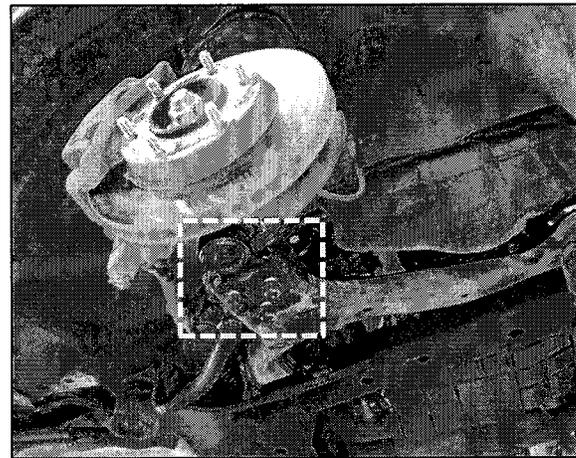
3. Loosen but do not remove the three (3) nuts securing the lower control arm to the ball joint.

**Tightening torque:  
65.1 ~ 86.8 lb-ft (90 ~ 120 Nm)**

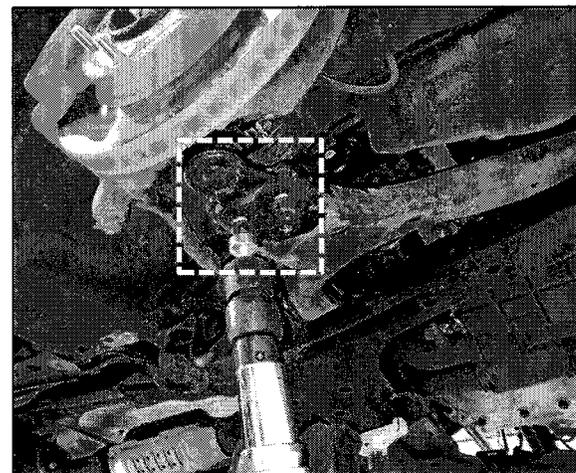
4. Remove the rear bolt and nut and from the lower control arm. Then, use a mallet or air hammer to remove the two (2) front "wheel-stud" type bolts and the nuts.

**Make sure to use the bolts and nuts included with the replacement parts kit when reinstalling the lower control arm to the ball joint.**

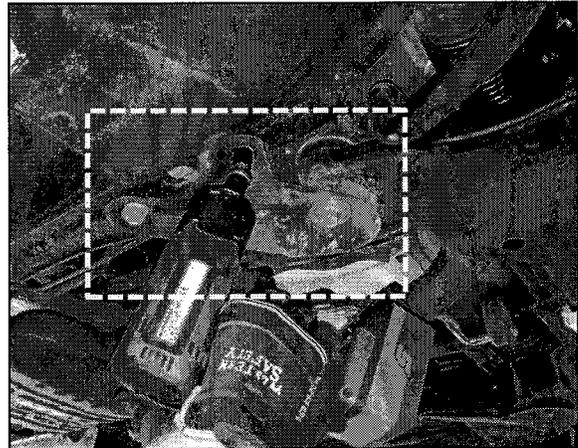
5. Remove three (3) bolts securing the sub-frame and the sub-frame bracket.

**Tightening torque:**  
**115.7 ~ 130.2 lb-ft (156.9 ~ 176.5 Nm)**

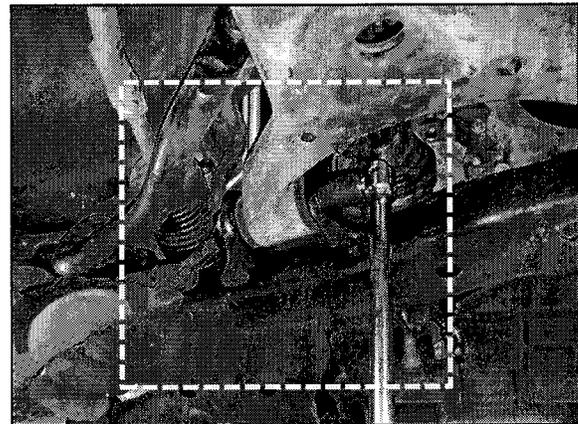
6. Remove the bolt and nut securing the rear mounting location for the lower control arm.

**Tightening torque:**  
**115.7 ~ 130.2 lb-ft (156.9 ~ 176.5 Nm)**

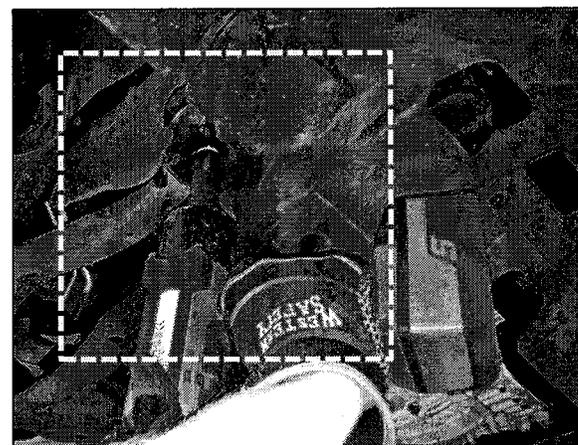
7. Remove the bolt securing the front mounting location for the lower control arm.

**Tightening torque:**  
**115.7 ~ 130.2 lb-ft (156.9 ~ 176.5 Nm)**

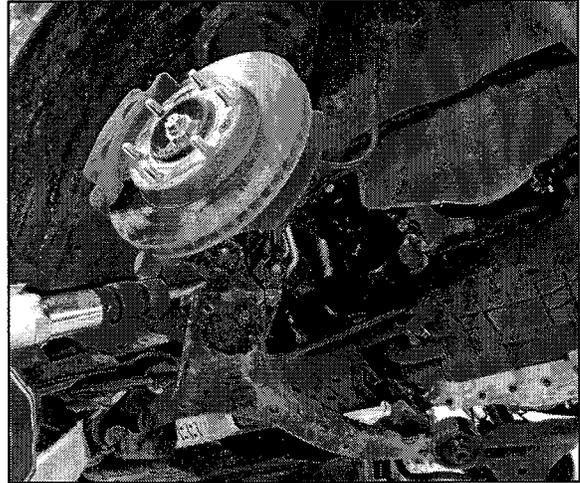
8. Use an air hammer with a chisel bit to remove the lower control arm from the ball joint.

To avoid possible injury, make sure to support the lower control arm prior to removing it from the ball joint.

9. Perform the reinstallation of the lower control arms in the following sequence:
  1. Front mounting location.
  2. Ball joint mounting location (use new hardware included with kit).
  3. Rear mounting location.
  4. Sub-frame bracket and bolts.
10. Reinstall all other removed components.

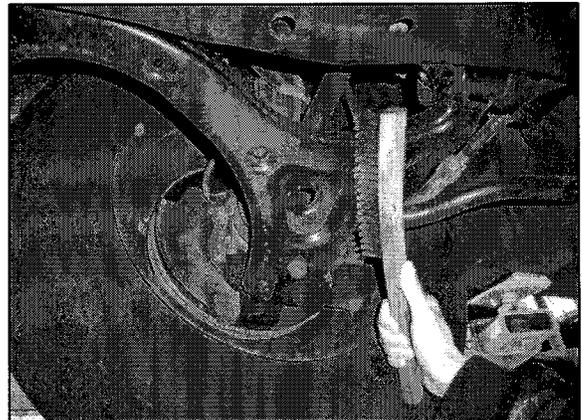
1. Use a metal bristle brush to remove any surface rust from the lower control arms.

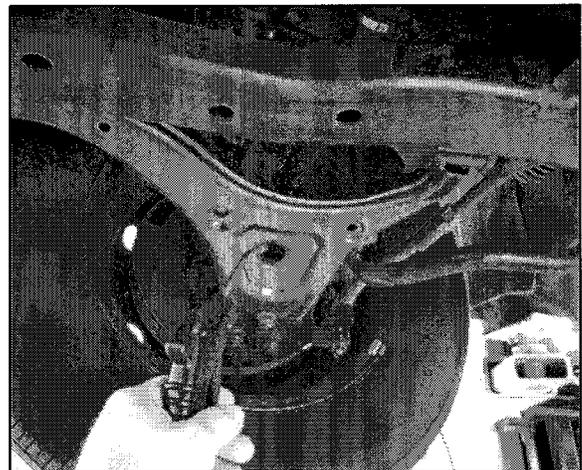
2. Use shop air to remove any loose dust from the lower control arm surfaces.

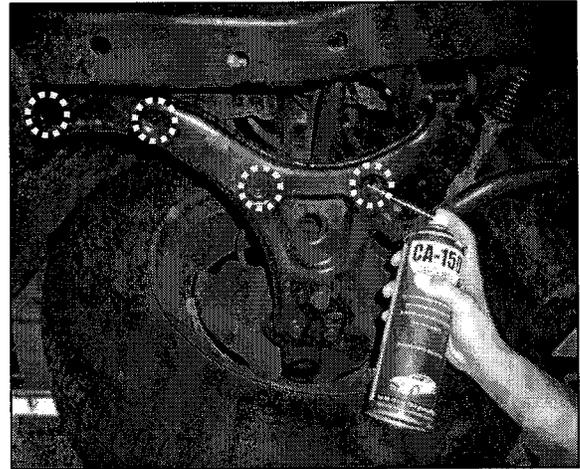
- Spray cavity wax into every hole in the lower control arm, as shown. To evenly apply cavity wax, turn the nozzle in all directions while spraying and make sure to use ONLY half (½) of the contents in each can per lower control arm.

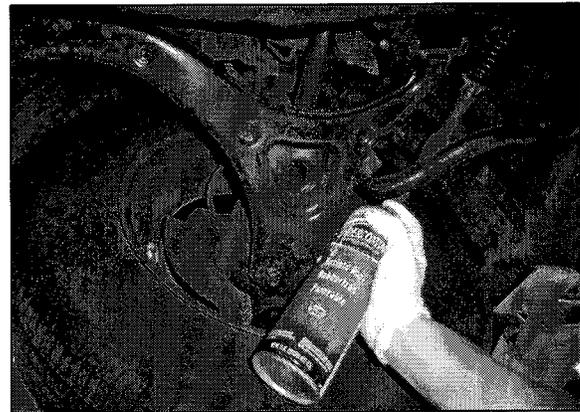
- Spray underbody coating onto the upper and lower surfaces of the lower control arm. Avoid over-spraying other parts of the vehicle.
