Thor Motor Coach Recall Repair Instructions

Recall #	14V—	
Description/Title:	Axis/Vegas Step Cover Adhesive	
Affected Product Line(s):	Axis and Vegas Gas Class A	
Service Campaign # :	RC000090	Released Date:
Failure Code:	TMCRC804	Document Date:
Time Allowed:	0.3 hours	Document Revision: A

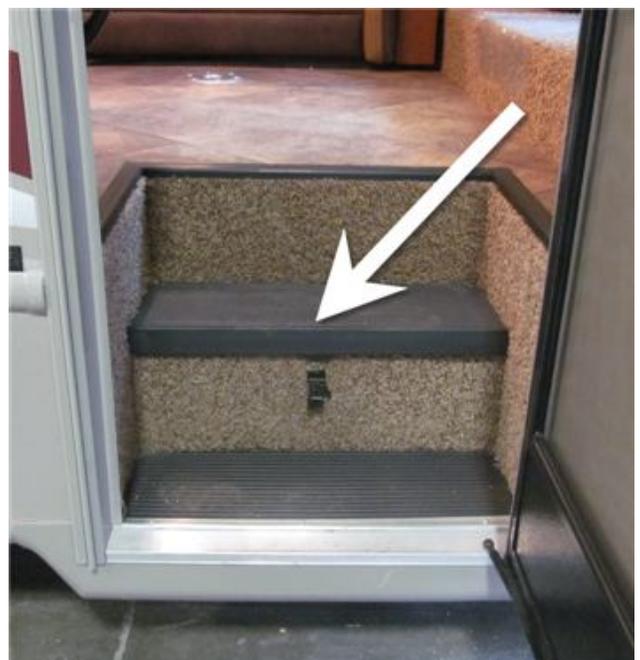
- 1. Remove the step tread from the top step.**
- 2. Thoroughly clean the surface of the step. Make sure there is no residual adhesive or other dirt, oil, or debris on the area.**

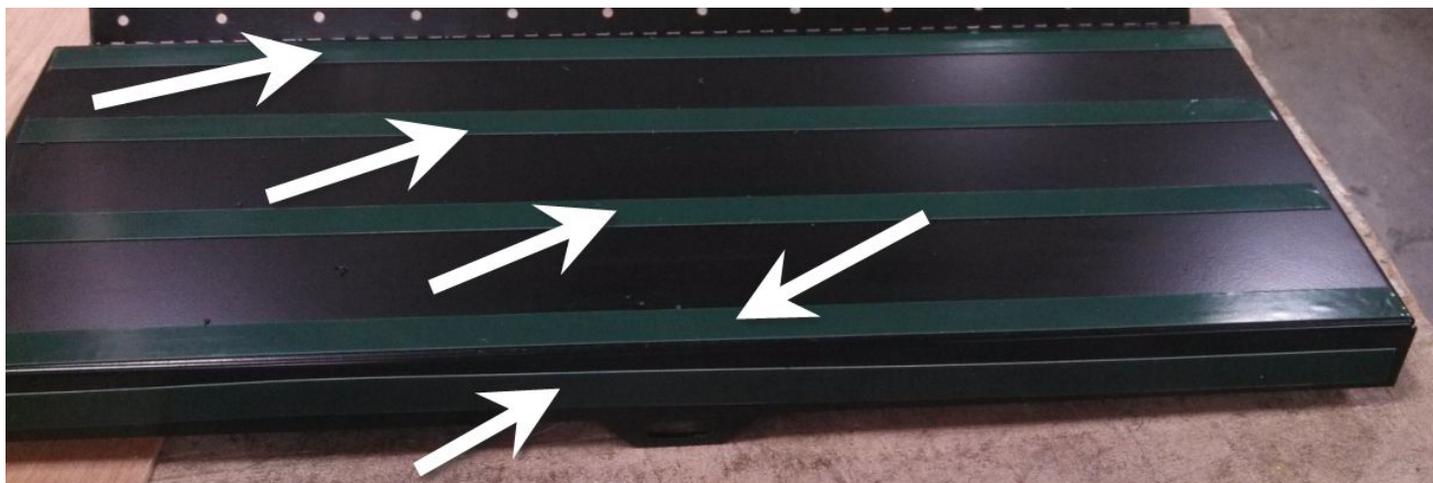
3. Apply the double sided tape to cleaned step cover as follows:

- A. Put four strips along the top.**
- B. Put one strip on the lip.**

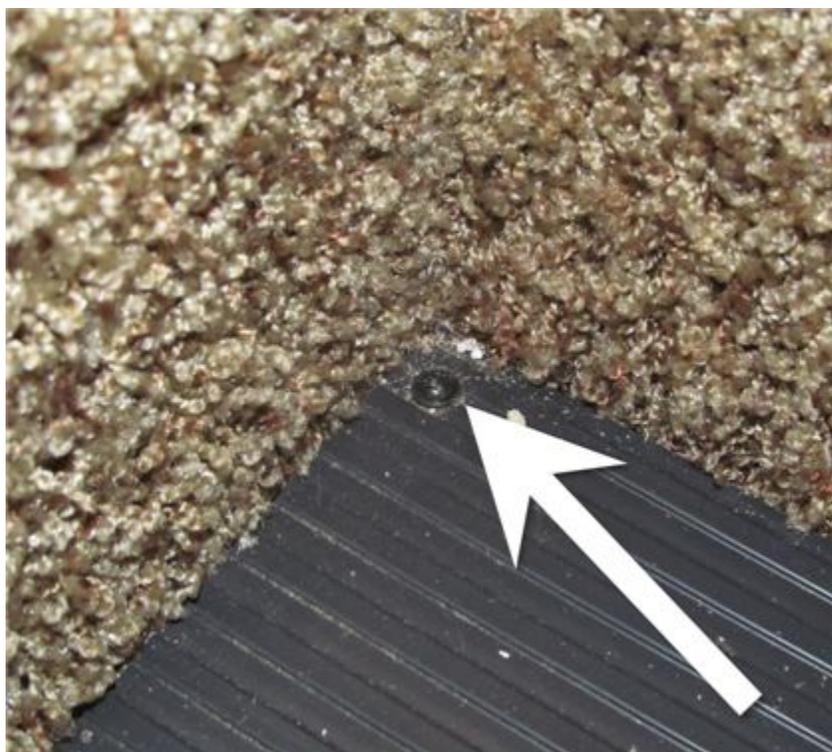
7. Install screws at the back corners of the step.
