PART 573 Defect and Noncompliance Report

On or about July 1, 2014, Vermeer Manufacturing Company, d/b/a Vermeer Corporation, determined that there is a defect which relates to motor vehicle safety with respect to certain motor vehicles listed below, and is furnishing notification to the National Highway Traffic Safety Administration in accordance with 49 CFR Part 573 Defect and Noncompliance Reports.

Make:	Vermeer	Model Years Involved:	2013 – 2014	
Units Involved (Estimated)				
Model	Production Dates		VIN Range	
	Beginning	Ending	Beginning	
R9X12T	11/28/2012	3/21/2014	1VRB533B0D1000122	1VRB533B3E1000147
R400T	8/27/2013	6/16/2014	1VRA533U0D1000098	1VRA533U4E1000106
R600HC	10/28/2013	4/25/2014	1VRT53398E1000100	1VRT5339XE1000101
Vehicle Type:	Trailer – Triple axle drilling fluid reclaimer

Manufacturing documents did not provide sufficient information for manufacturing personnel to accurately weld suspension pivot bolts after torqueing. Bolts were properly torqued during manufacturing assembly. Welds are placed as a secondary means of securing bolt. See attached drawing marked as Exhibit A showing area of three pivot bolts per side of reclaimer.

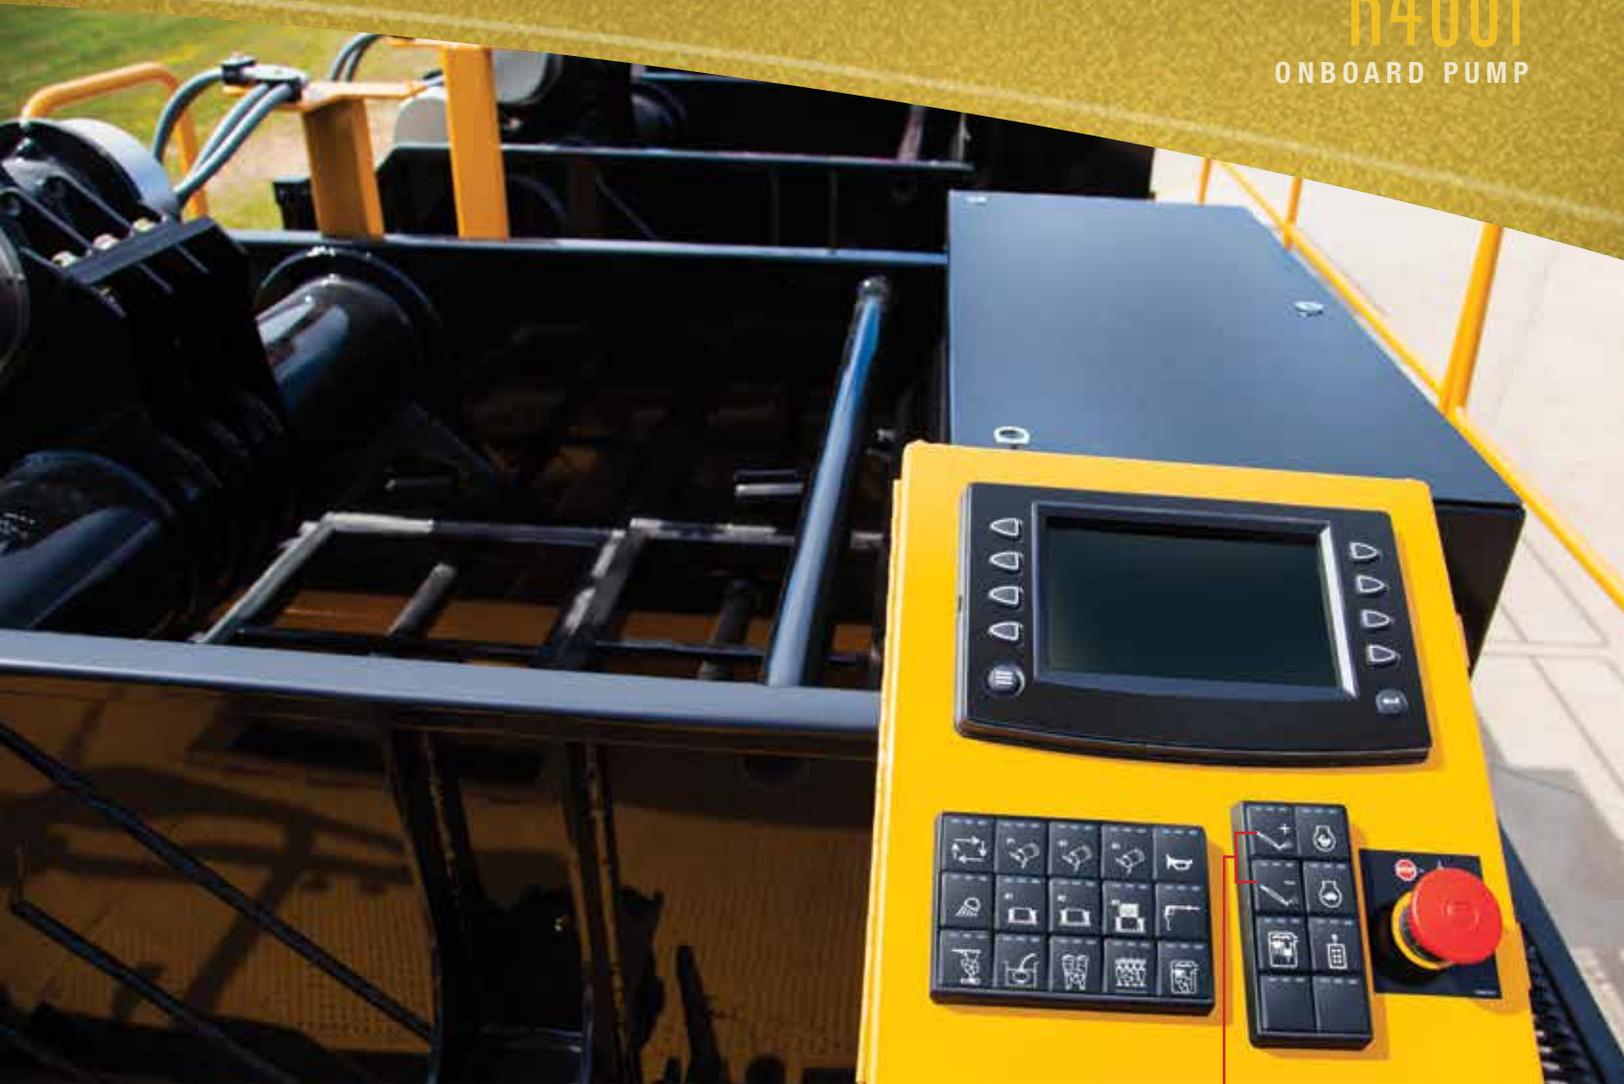
ONBOARD PUMP

The R400T has an onboard pump built into the unit delivering the same power and performance of a stand-alone high pressure mud pump.

The onboard pump reduces the amount of support equipment needed on jobsites — minimizing hauling and trucking costs and making it easier to work in tight right-of-ways.

The pump is hydraulically driven, allowing for infinitely variable amounts of mud flow and enabling contractors to operate with precision no matter the ground conditions.

A wireless remote mud pump control allows drill operators to monitor pressure and mud flow from within the driller's cabin.

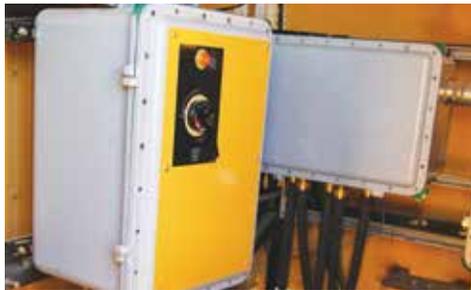
DESIGNED FOR THE OIL AND GAS INDUSTRY. The explosion-proof R600HC is designed without an onboard power source for operation. Key components are suited for use in potentially explosive atmospheres. The R600HC is designed in accordance with IECEx (International Electrotechnical Commission) guidelines making it fit to work in the oil and gas fields.

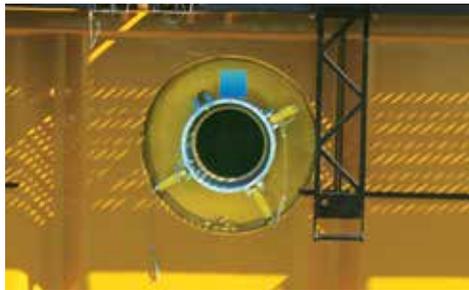
ALL HANDS ON DECK. The inlet guiding flow into mud tanks is below deck, allowing fluid to be divided into one tank, two tanks or neither tank, depending on job needs. Placement allows for greater freedom on the working deck and keeps a clear pathway for workers.

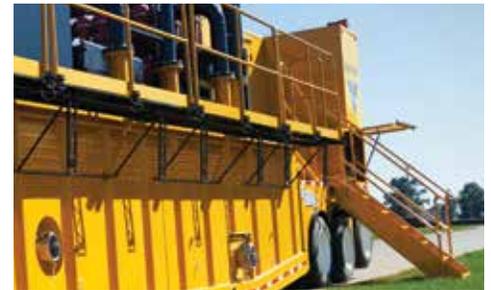
TWO POINTS OF ACCESS. The R600HC features an elevated work platform with two means of entry; this industry-exclusive feature provides workers admittance to the working deck.

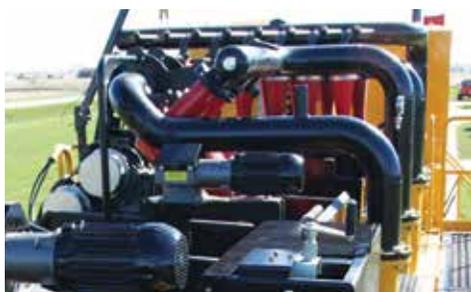
CLEANING CAPACITY. Using dual first-cut shakers and a series of desander and desilter cones, the R600HC is able to support an industry-leading 600 gpm (2271.2 L) pump, which makes for a more productive fluid cleaning process, while helping to reduce the amount of wear machine components experience.

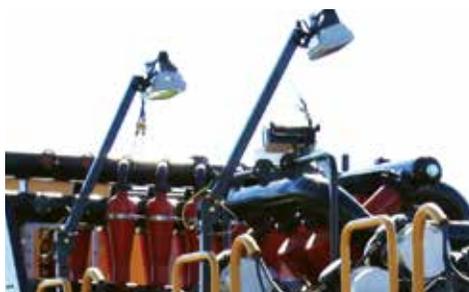
LEAVE THE LIGHT ON. LED amber colored work lights are battery powered enabled, illuminate the working deck and can be run without using a standalone generator, while attracting fewer insects.

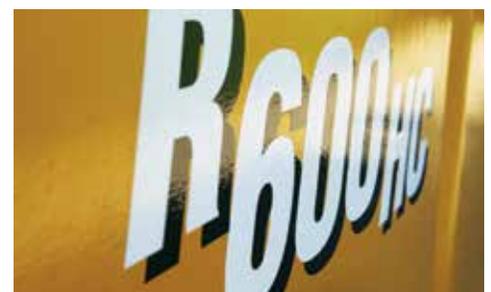
PROTECT YOUR INVESTMENT. The R600HC design uses an optional marine grade epoxy barrier coating which helps reduce corrosion from drilling fluids and also improves durability and abrasion resistance.
