Subject: NHTSA Recall #- Pending

Service Communication: 2014-001: Vespa 946 Fuel Line Recall

Affected Models: A select range of 2013 Vespa 946 Models

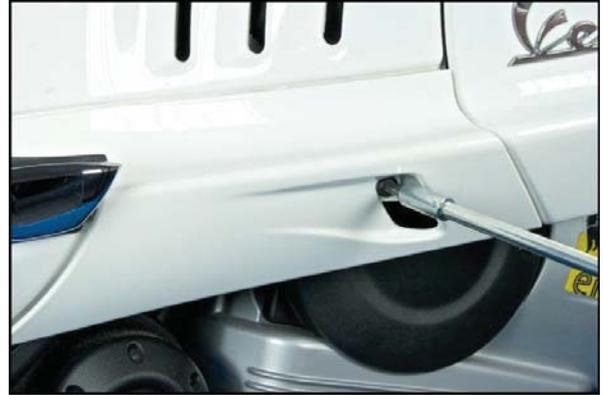
Remove the fastening screws on both side moldings that join with the floorboard.

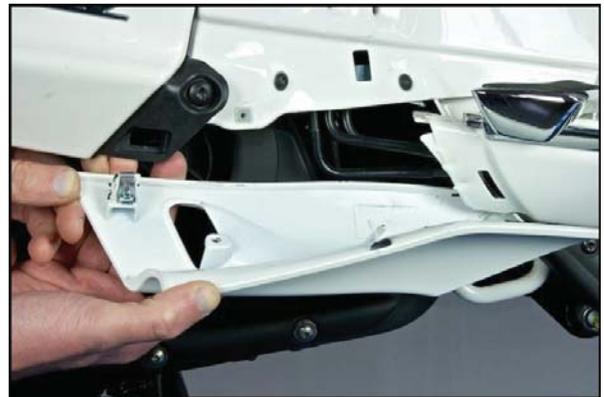
Remove the moldings by releasing the standard spring couplings.

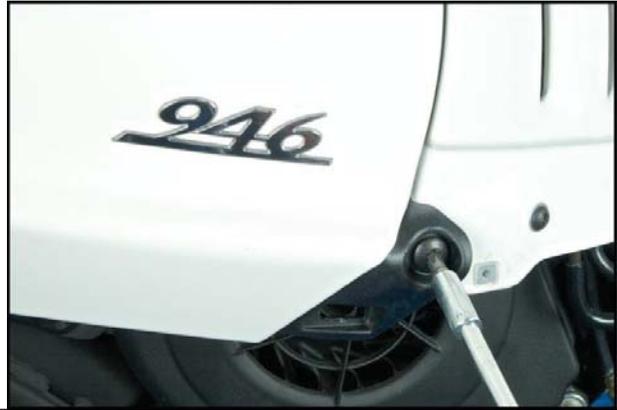
Remove the front screws fastening the lateral moldings.

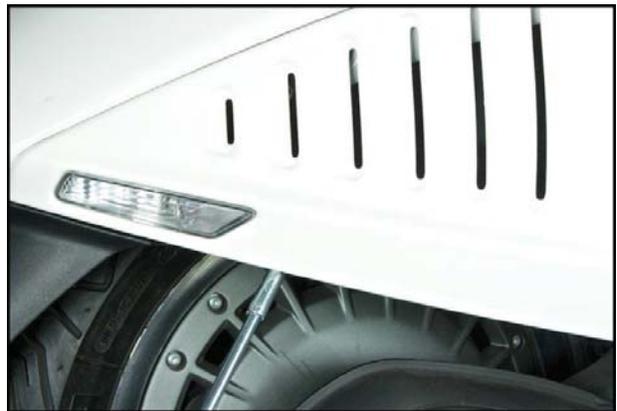
Remove the rear screws fastening the lateral moldings.

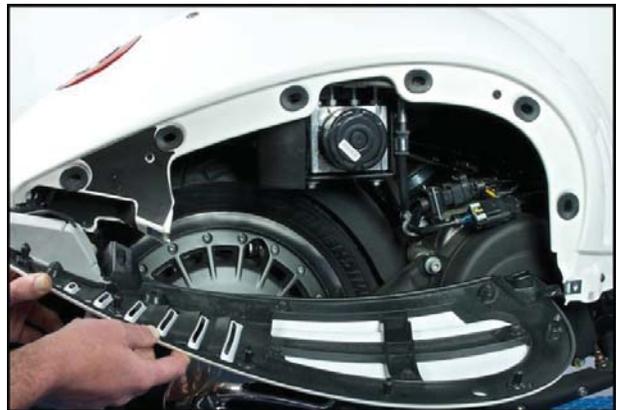
Detach the lateral coverings from the body by freeing the compression fittings.

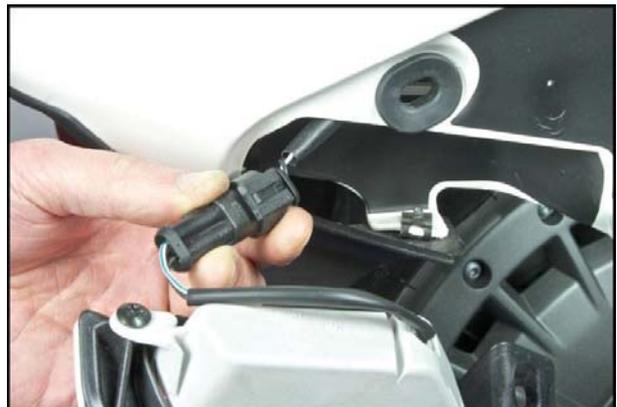
Remove the side coverings by disconnecting the turn signal power supply connectors (if applicable)

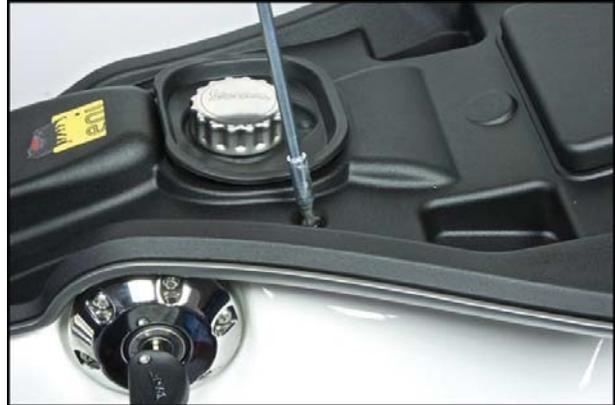
Remove the tank cap and the 8 screws fixing the under seat trim.

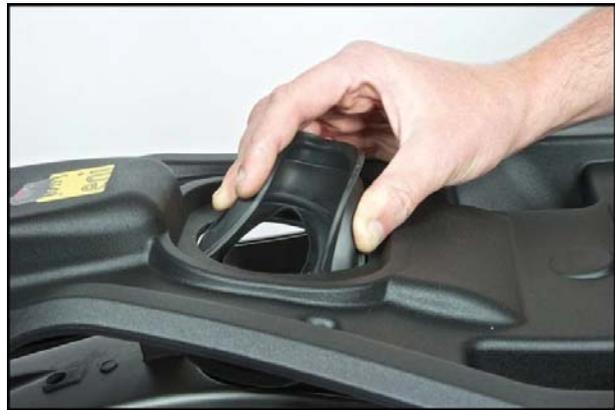
Remove the under seat trim.

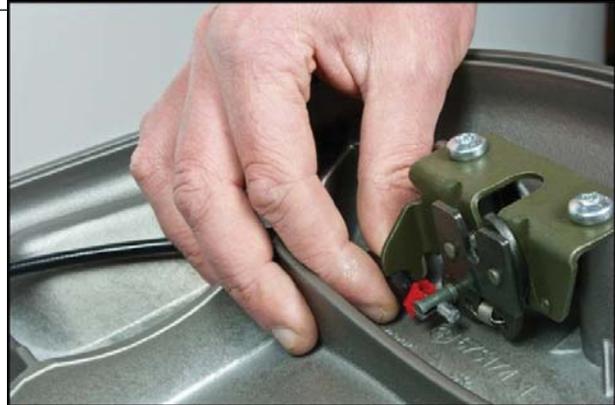
Disconnect the seat lock control transmission.

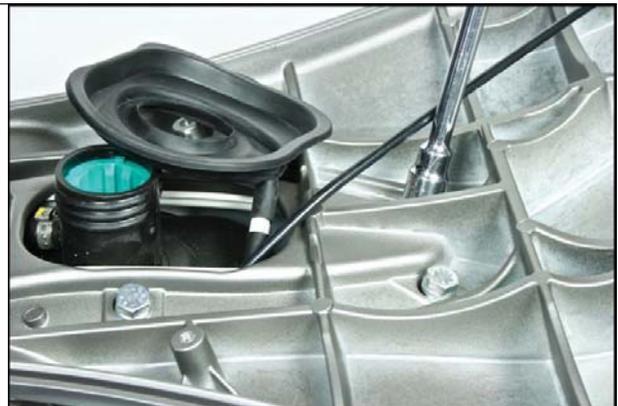
Remove the 6 screws and their washers along with the seat support and all of its components.

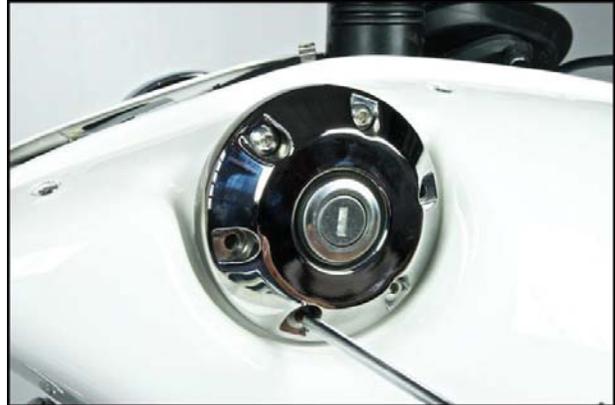
Remove the seat release cylinder support molding and the right side counterpart acting on the fixing screws shown in the image.

Note: Several screws have been applied only for aesthetics which are not used to attach the molding to the frame.

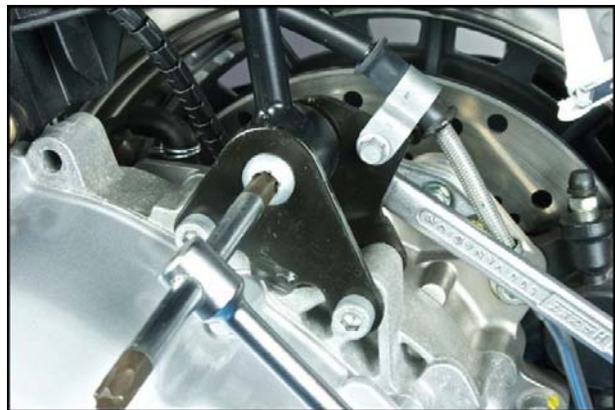
Support the body appropriately and remove the bottom bolt that connects the rear suspension connecting rod.

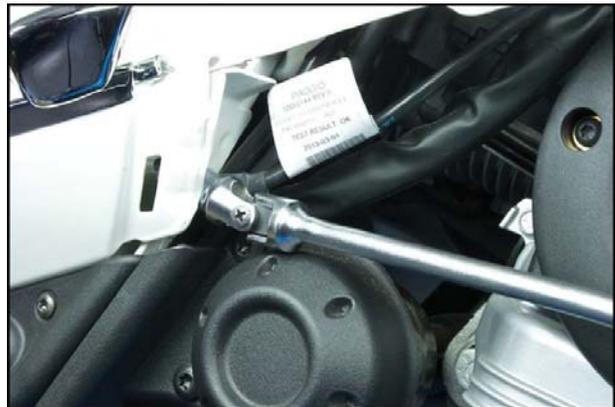
Remove the connecting screw of the ground wire to the body.

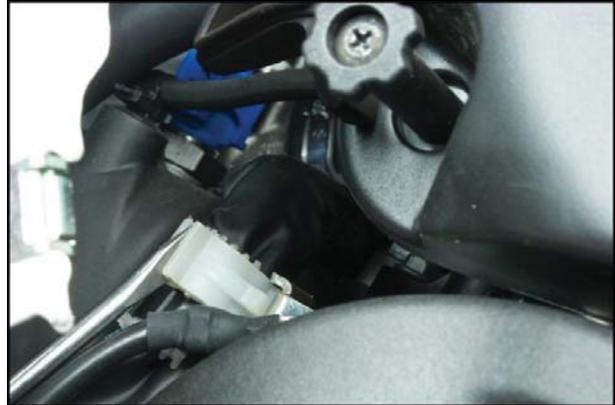
Open the wiring harness support clamp to the side of the cylinder and lift the body, until reaching the limits determined by the brake hose or rear tone wheel pickup sensor wiring.

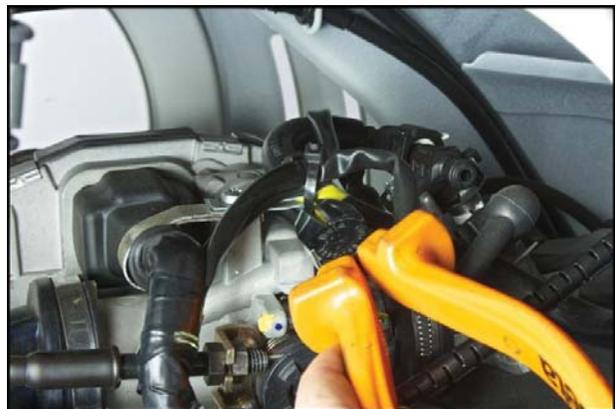
Open the clip that connects the electric system to the fuel pipe near the throttle body.

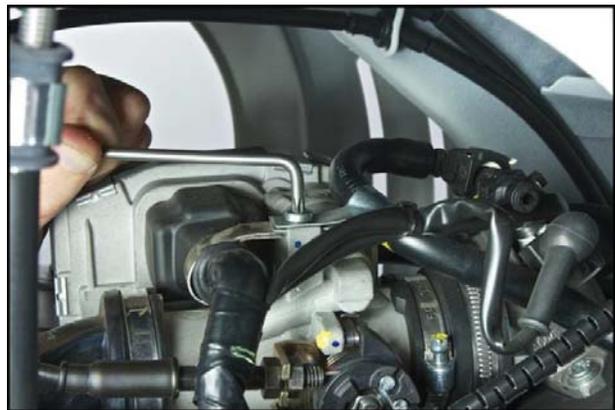
Remove the screw and clamp that fixes the fuel pipe to the throttle body.

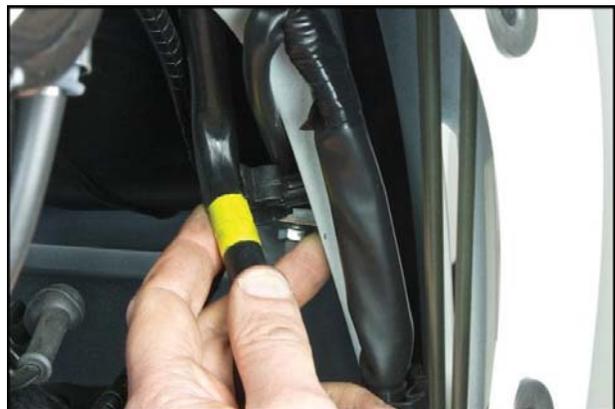
Open the clamp that fixes the fuel pipe to the body.

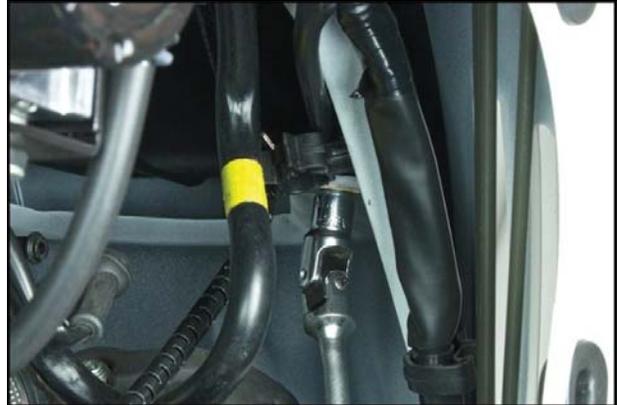
Remove the nut and support bracket of the tone wheel pickup sensor wiring.

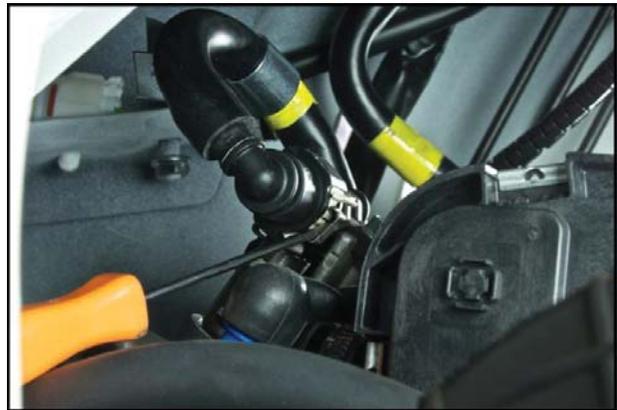
Use a flat-head screwdriver to extract the safety latch of the fuel pipe female quick coupling release tabs.

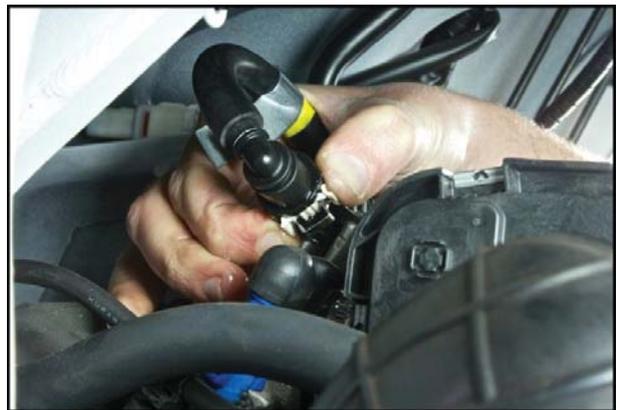
Acting on the two tabs, remove the fuel pipe quick coupling from the injector support.

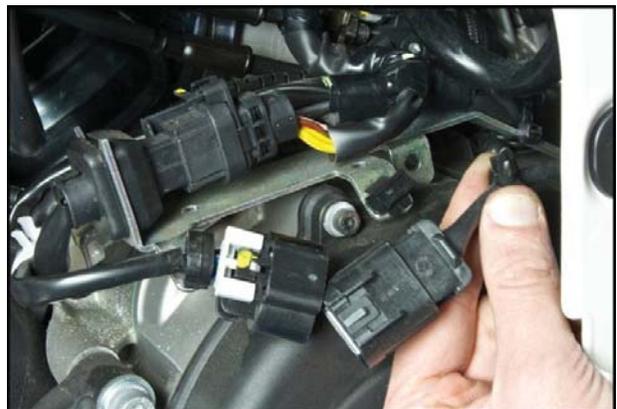
Disconnect the the oxygen sensor and remove the connector from the support bracket.

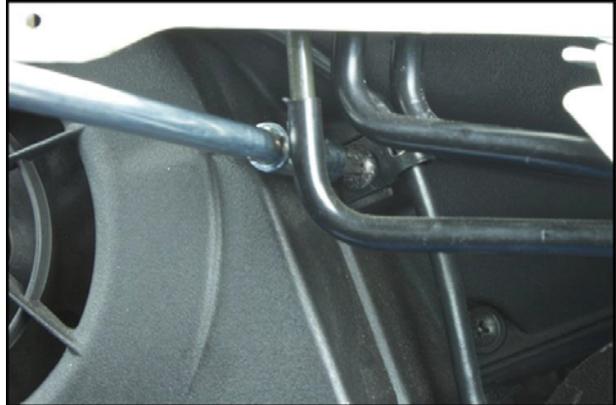
Remove the screw and metal clamp that secures the oxygen sensor cable to the cooling sleeve.

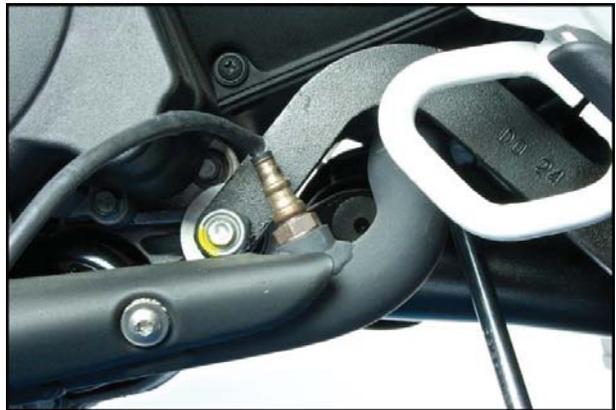
Remove the 2 nuts fastening the exhaust pipe to the head.

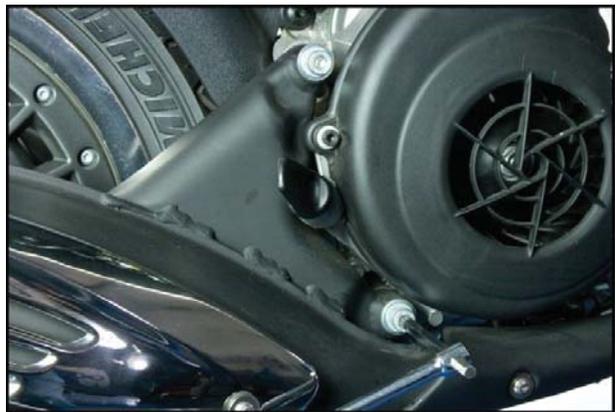
Remove the silencer complete with oxygen sensor acting on the 2 screws that fasten to the engine casing.

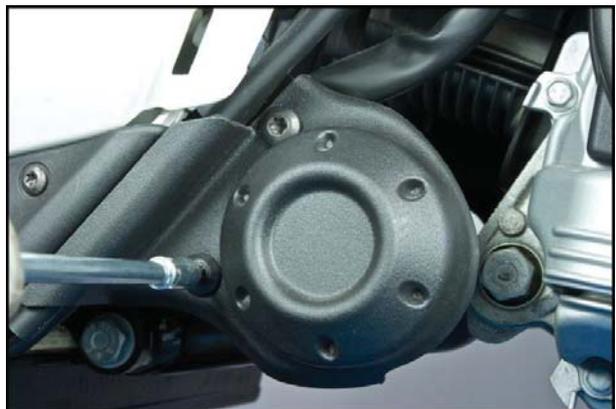
Remove the 2 fixing screws and covering of the rubber damper of the suspension arm.

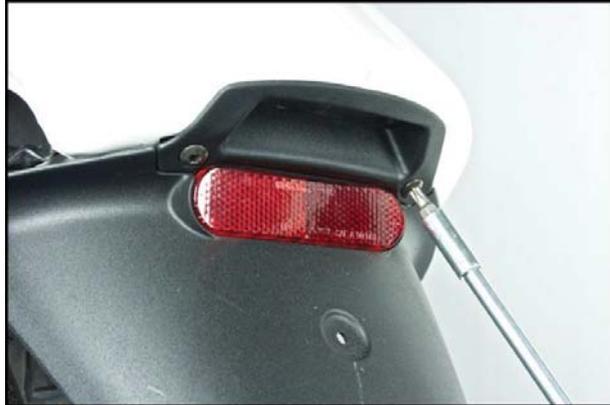
Remove the 2 screws and the number plate light.

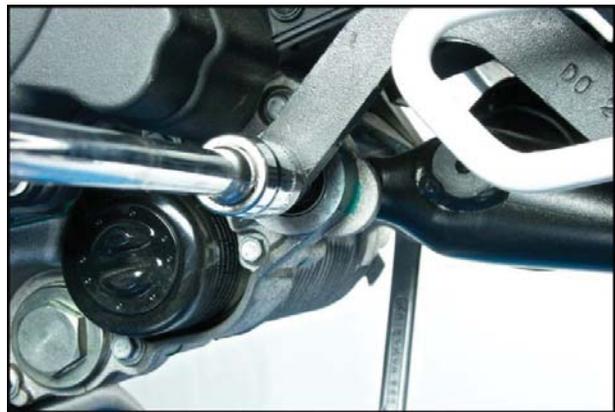
Remove the bolt that anchors the engine to the suspension arm.

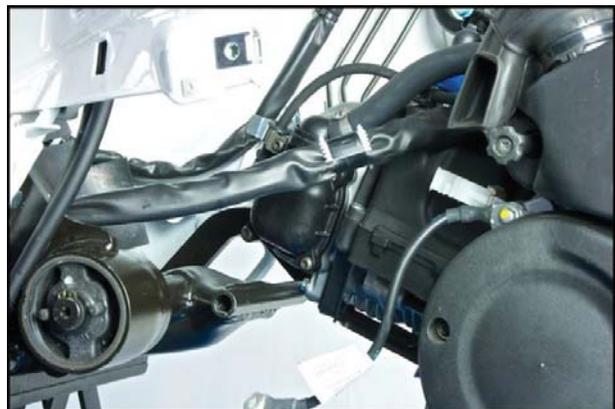
Move the engine slightly away from the suspension arm and move the engine and lift the body until the engine is positioned as in the image.

Note: Engine position is influenced by the limits imposed by the wiring and rear brake caliper supply hose extension limits.

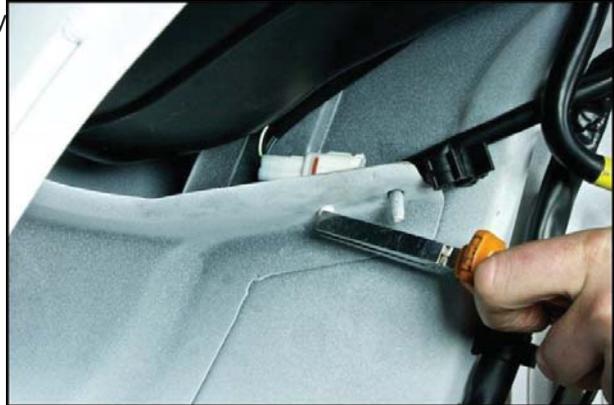
Release the anchoring clip of the tank electric supply connector from the body.

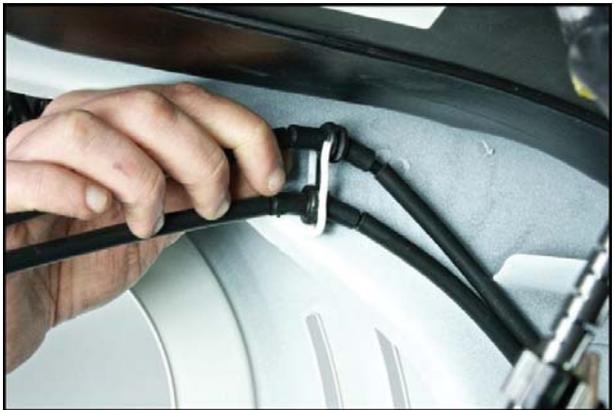
Remove the elastic transmission cables from the relative support on the body.

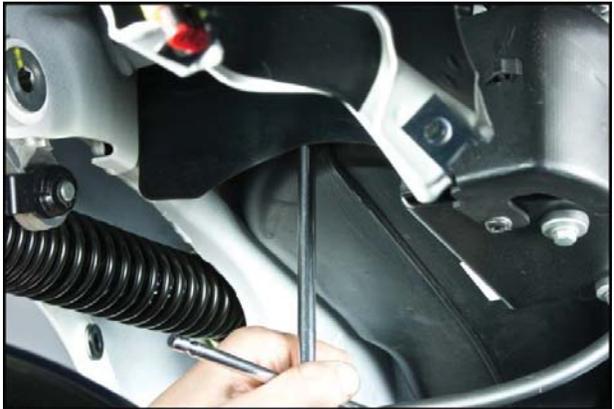
Remove the rear screw that fixes the tank to the body.

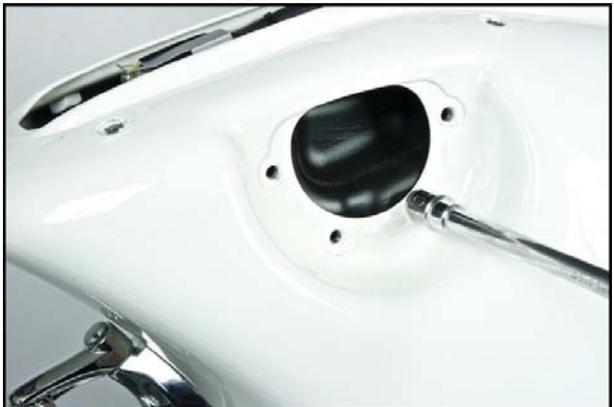
Remove the 2 front screws that fix the tank to the body.

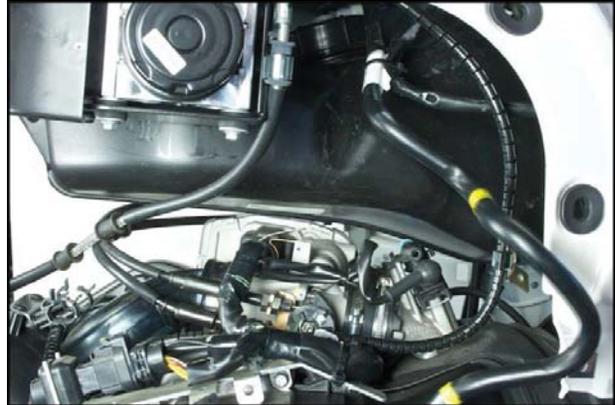
Remove the tank from the body and set it atop the engine.

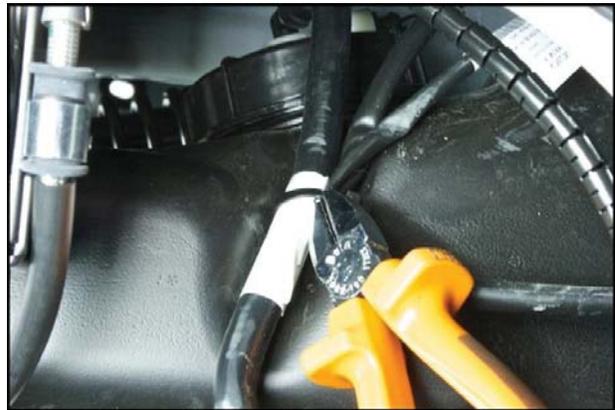
Remove the zip tie that connects the wiring to the fuel pipe, located to the side of the tank.

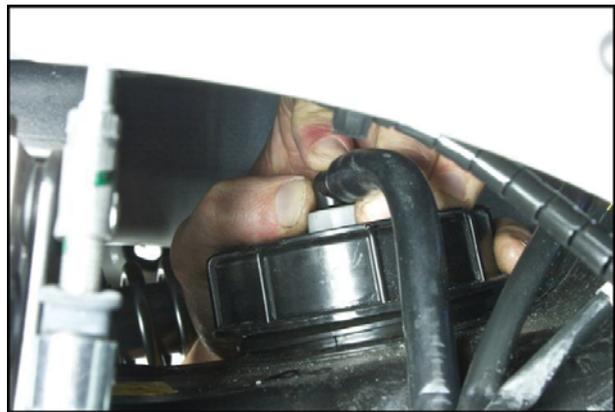
Based on vehicle use, ensure proper cleaning of the pump mount.

Press the retaining collar downwards and ease out the male fitting of the pipe with slight rotations until the seal is released. Slide the male fitting out gently.

Warning: Abnormal force can damage the retaining system, compromising the safety of the vehicle.

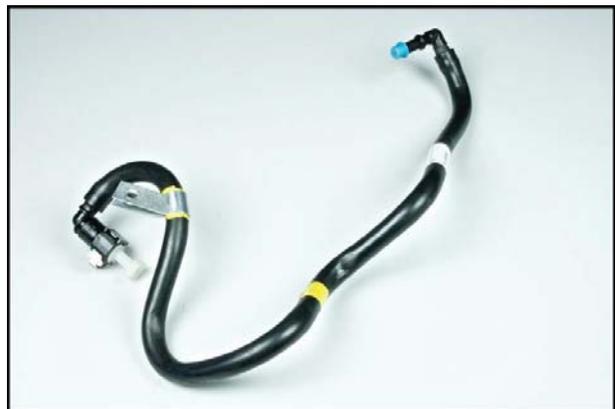
Prepare the new line with the original metal clamp and protection plugs.

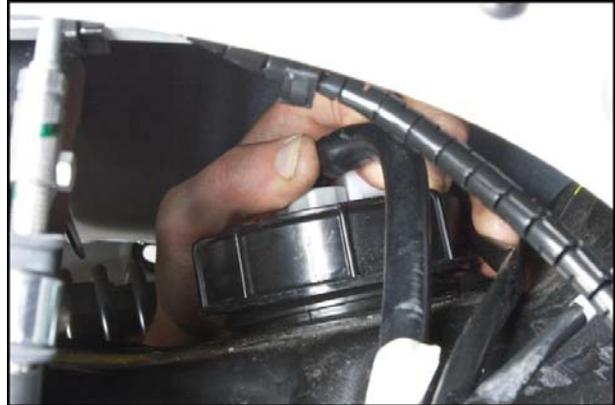
Remove the protection from the new male pipe coupling and insert the coupling onto the pump mount.

Check the retainer system thoroughly.

Important: Ensure that you hear a click when inserting and lift the male coupling until you feel the stopping point.

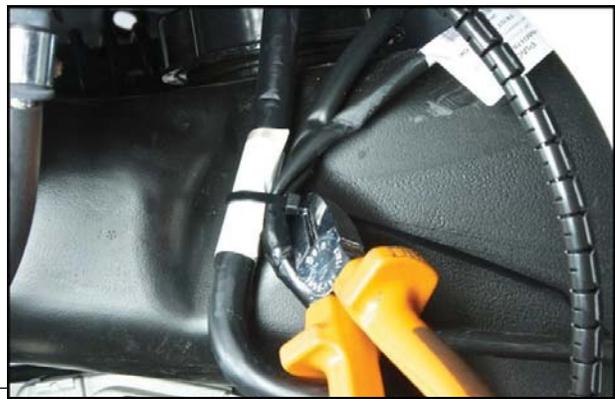
Position the fuel pipe in the compartment to the side of the tank and apply a zip tie.

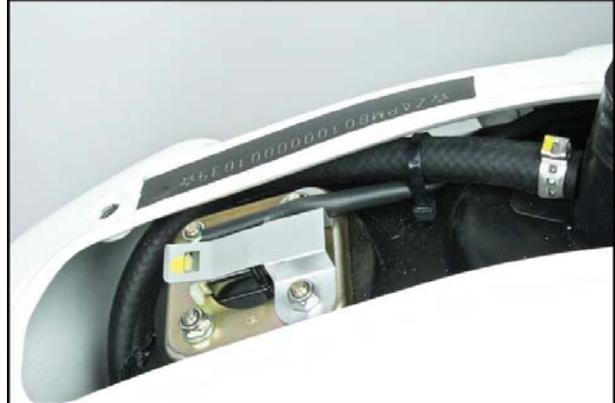
Refit the tank into the body while paying attention to proper positioning of the vent pipe and fuel pipe. Insert the tank starting from the front part to reduce interference of the transmission cables support bracket.

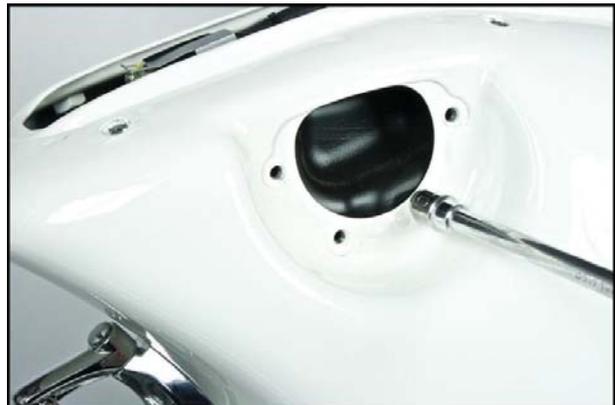
Refit the 2 front screws that fix the tank.

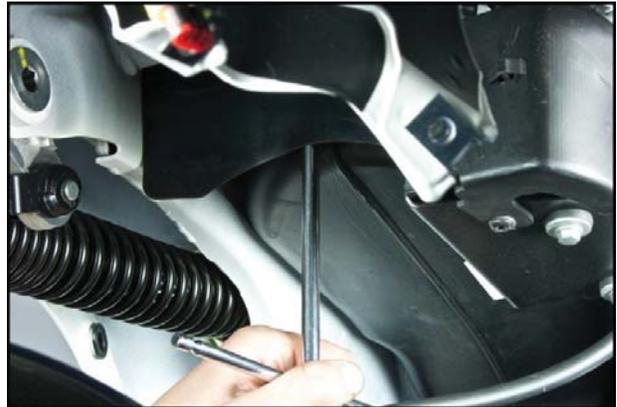
Refit the rear screw that fixes the tank.

Note: To ease the operation, lift the tank by hand and use a shallow socket to allow adequate thread protrusion, otherwise most of threads will be covered by the socket and re-fitment will be difficult.

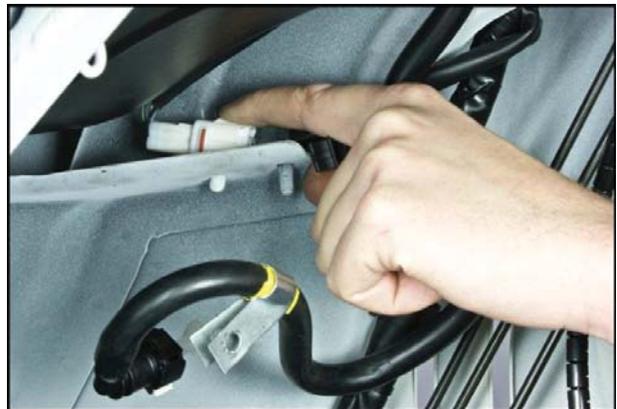
Reposition the tank electric supply connector.

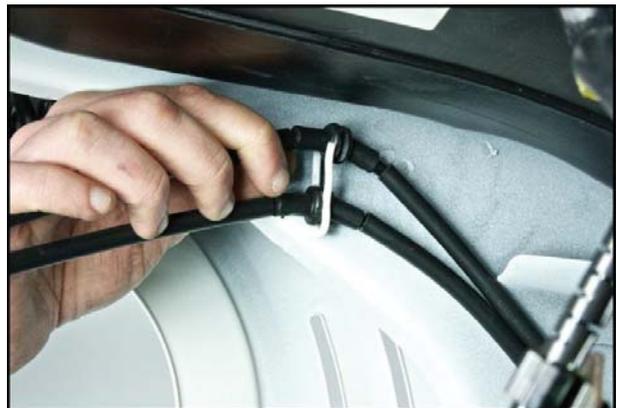
Move the engine close to the suspension arm and reposition the elastic transmission cables to the relative body support.

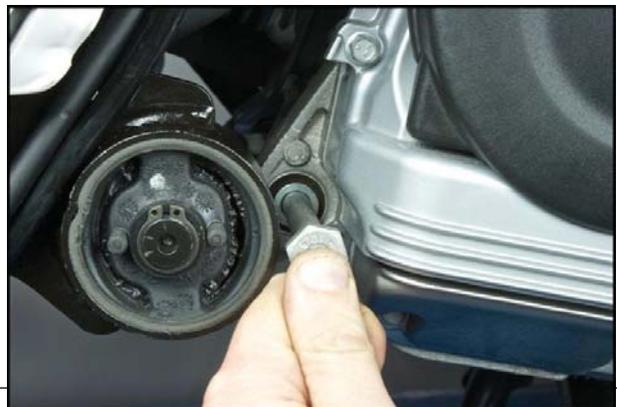
Connect the engine to the suspension arm and fit the locking nut for the bolt.

This nut will be torqued in a later step.

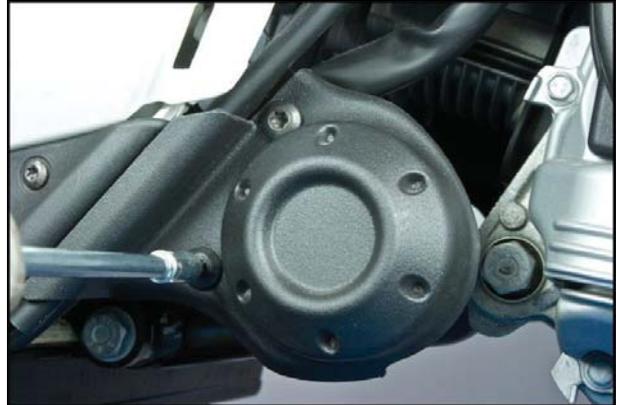
Refit the 2 screws and cover of the rubber damper of the suspension arm.

Note: The cover also allows proper positioning of the tank air pipe and filler tray drainage.

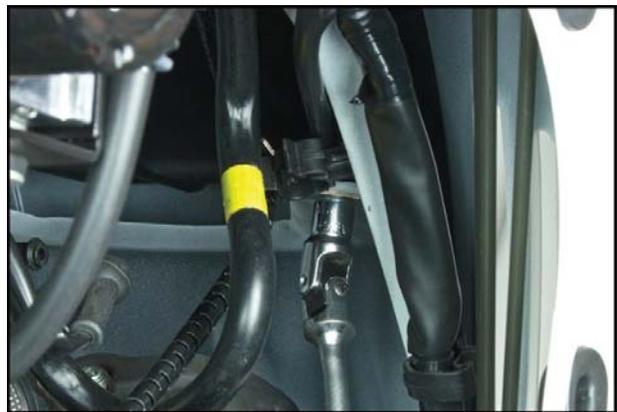
Lift the body and refit the nut and support bracket of the tone wheel cable.

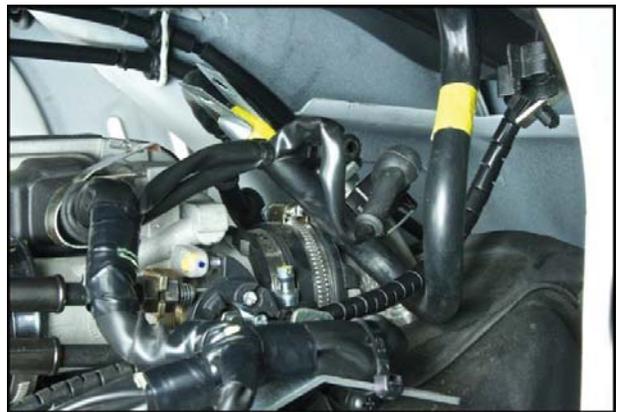
Insert the fuel pipe under the wires of the tone wheel pickup sensor and injector.

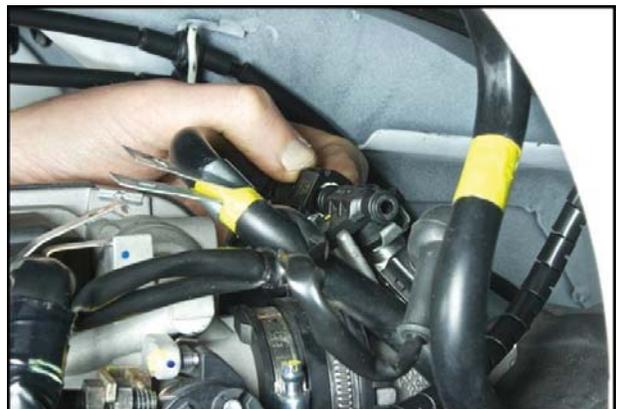
Remove the pipe guard and connect the snap coupling, without reaching the stopping point. Keeping the connector inserted, activate the pump by switching ON a few times.

With the key in the OFF position, gently disconnect the snap coupling until all the air is vented and fuel supplied.

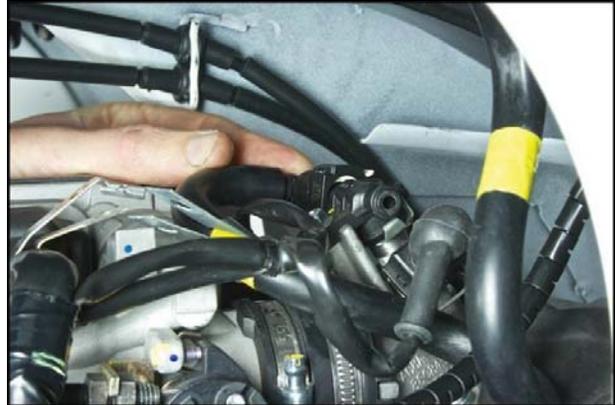
Insert the snap coupling until hearing a "click" of the retainer system.

Ease the coupling to the retainer system engage point and reposition the safety spring of the snap coupling.

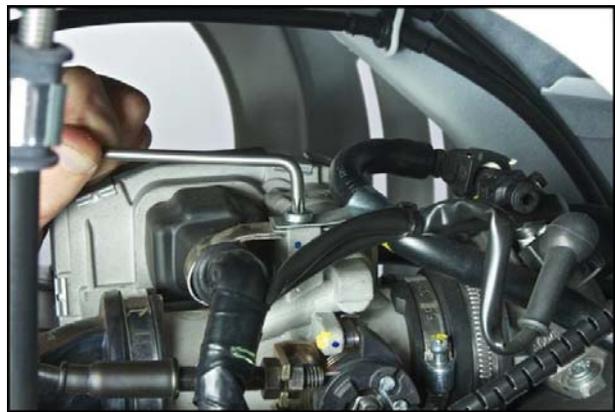
Refit the screw and metal anchor clamp that fixes the fuel pipe to the throttle body.

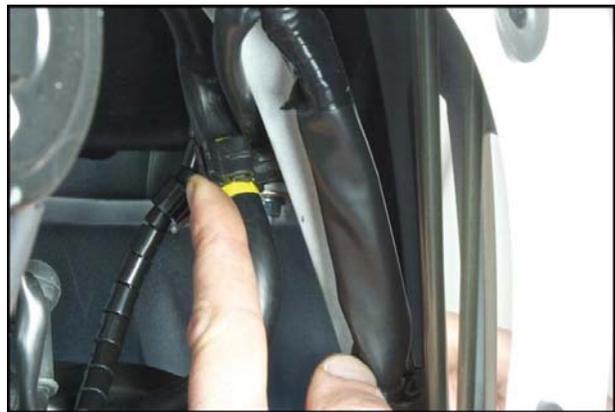
Open the clamp that fixes the fuel pipe to the frame.

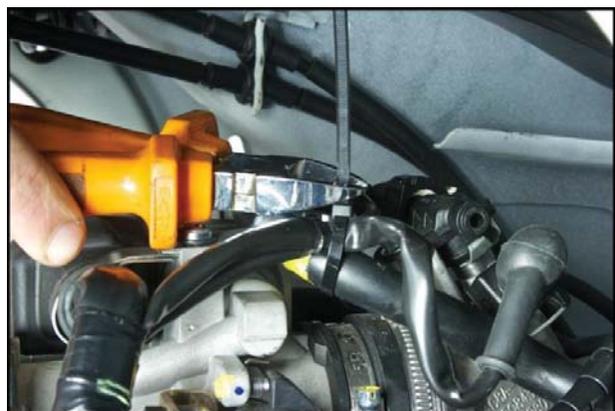
Apply the zip tie that fixes the wiring to the fuel pipe.

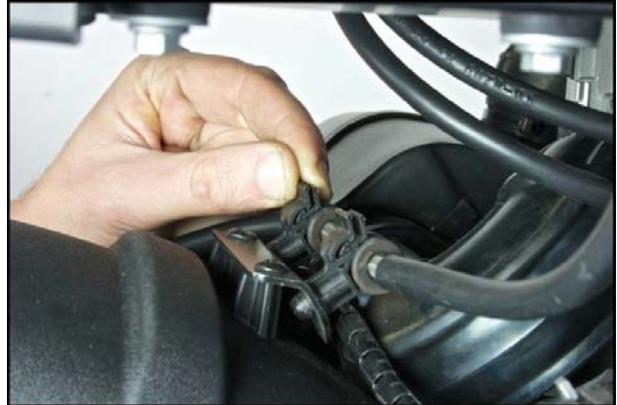
Lower body height and close the 2 metal support clamps of the rear brake caliper supply hose.

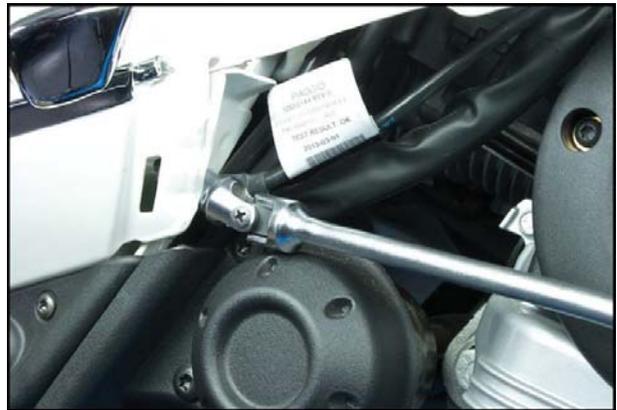
Refit the connecting screw of the ground wire to the body.

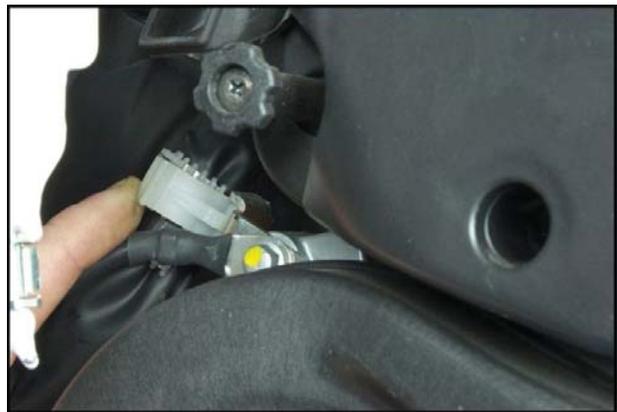
Close the support clamp of the wiring located to the side of the thermal group.

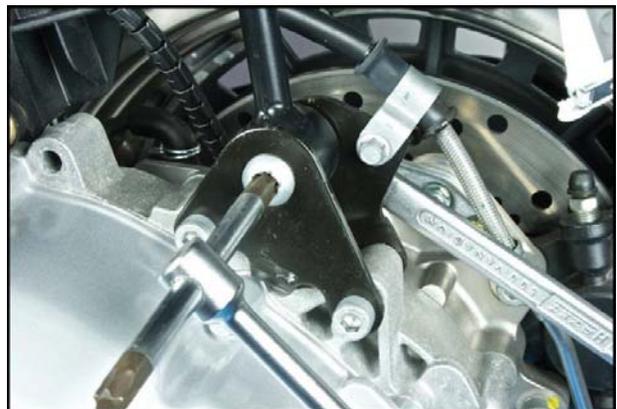
Lower the body and re-connect the rear suspension connecting rod.

Tighten the bolts with 67 - 73 Nm torque.

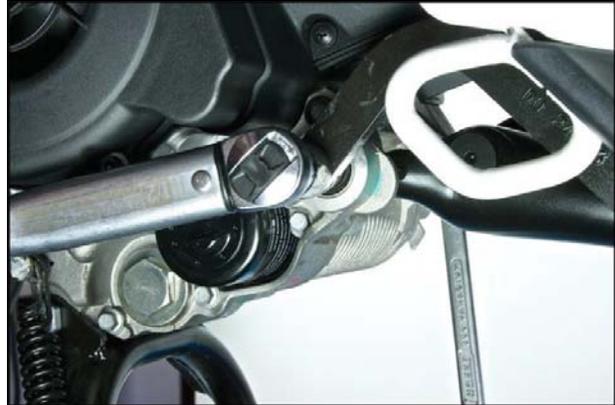
Lock the bolt that anchors the engine to the suspension arm.

Torque to 40 - 45 Nm.

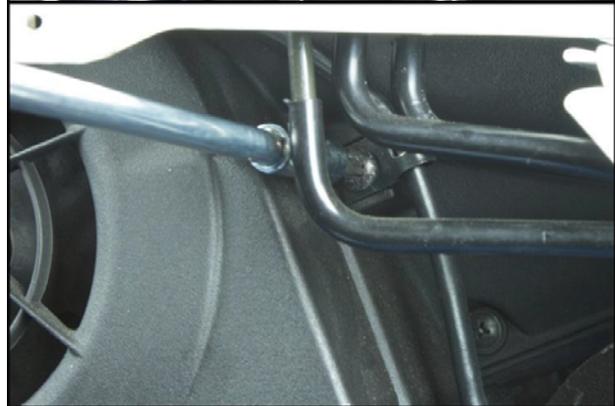
Mount the screw and metal clamp that secures the oxygen sensor cables to the cooling sleeve.

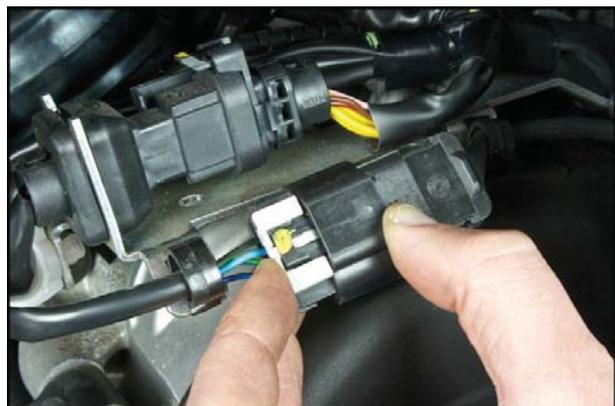
Insert the support clamp and connect the oxygen sensor connector.

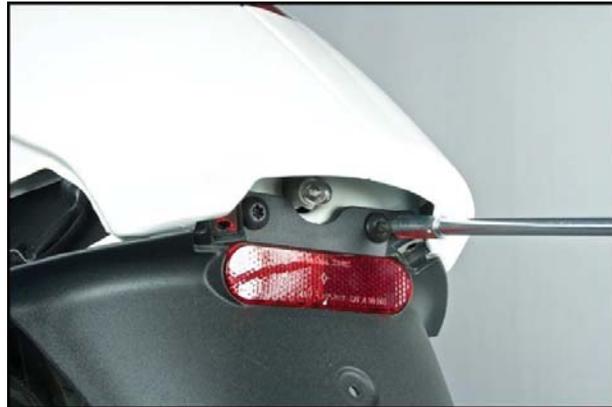
Remount the 4 screws that fix the rear mudguard.

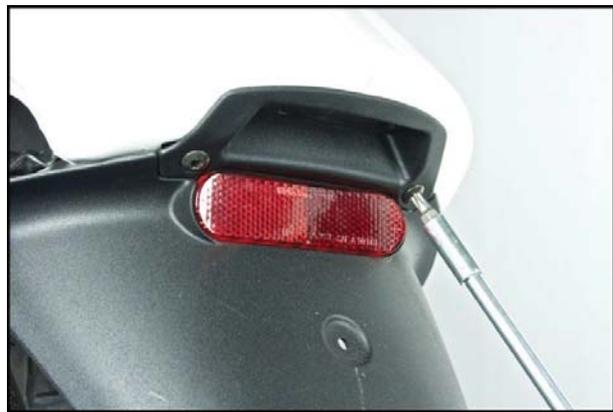
Remount the 2 screws that fix the number plate light.

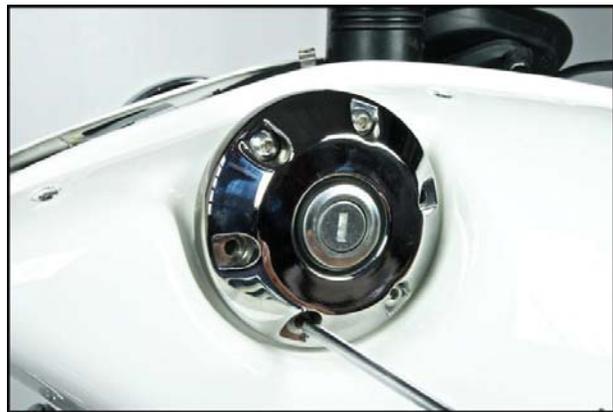
Mount the support molding of the seat release cylinder and right side counter-part.
Lock the 6 fixing screws.

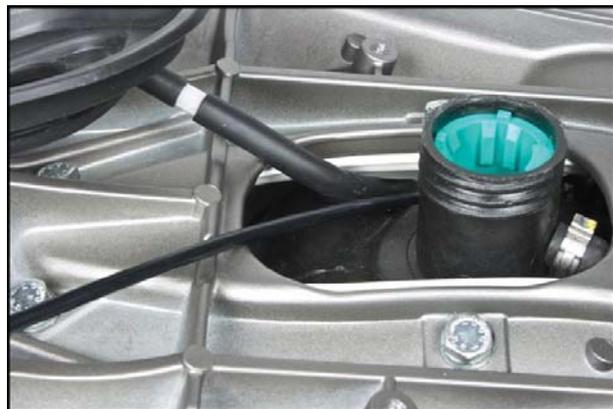
Mount the 6 screws and the support of the seat while paying close attention to the position of the elastic transmission and drain pipe of the tank filler tray.

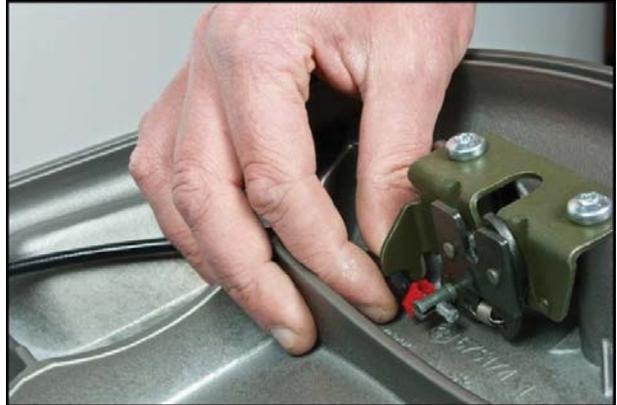
Connect the seat lock control transmission.

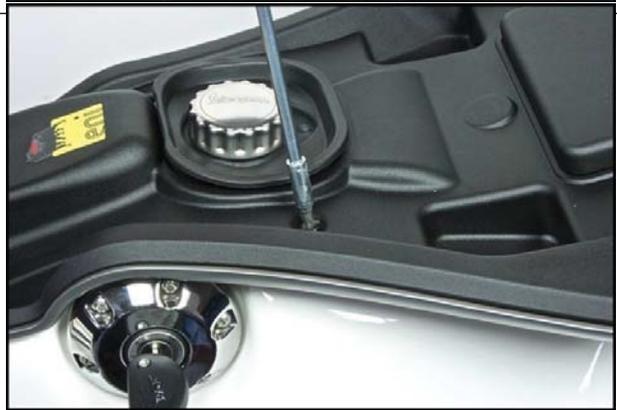
Mount the 8 screws and under seat trim.

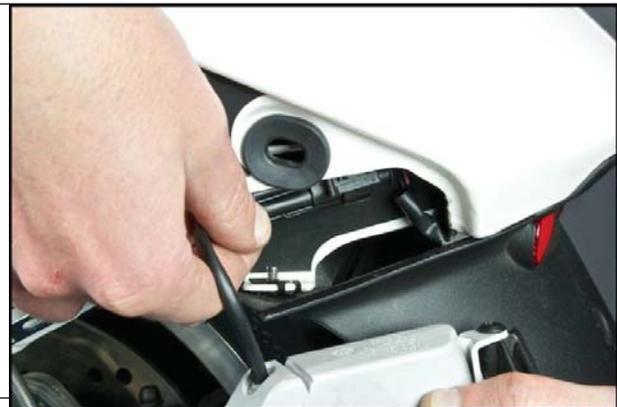
Remount the side coverings while paying attention that the blinker connectors are positioned in the top section of the blinker compartment.

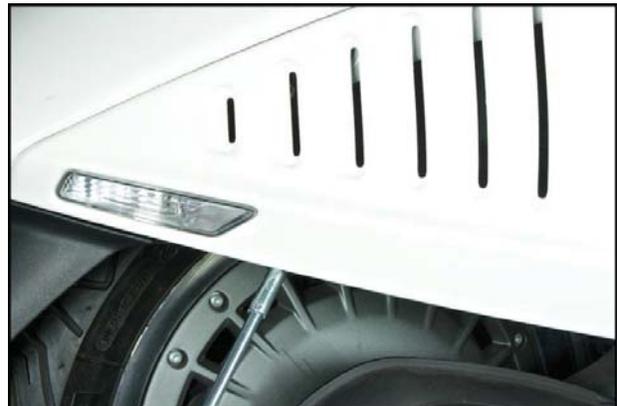
Mount the rear screws fastening the lateral moldings.

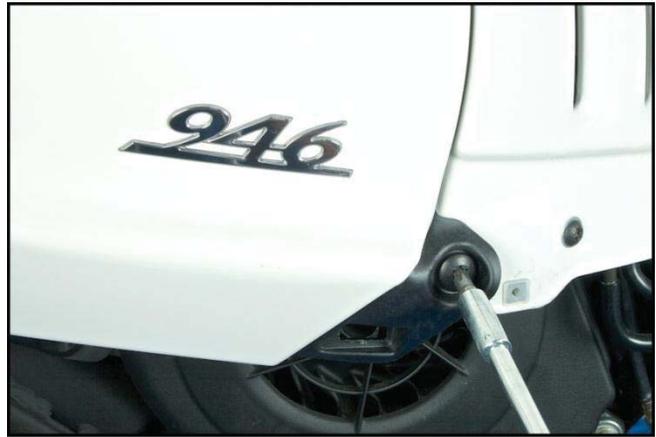
Mount the front screws fastening the lateral moldings.

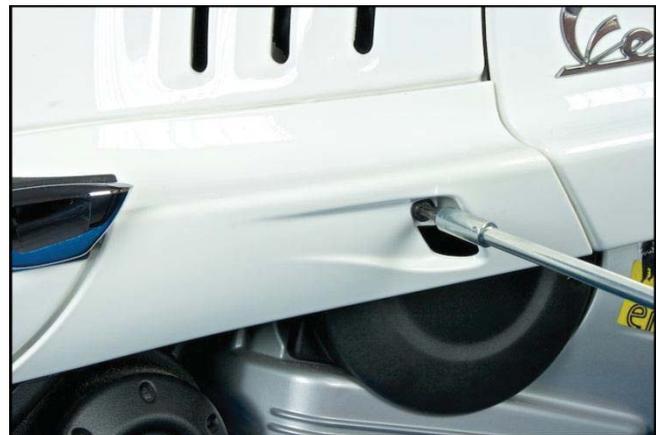
Remount the side moldings and fixing screws.
