RECALL CAMPAIGN BULLETIN

NTB14-065

VOLUNTARY SAFETY RECALL CAMPAIGN 2014 NV PASSENGER VAN; SEATBELT RETRACTOR BOLT

CAMPAIGN I.D. #: PC308

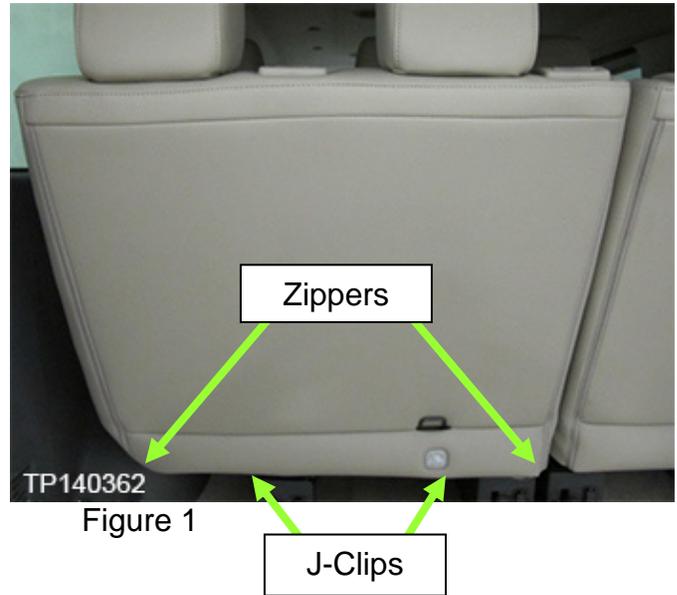
1. Unzip the seat back covers using a suitable tool (tool shown in Figure 4).
2. Unhook the J-clips that attach the seatback to the bottom of the seat frame.

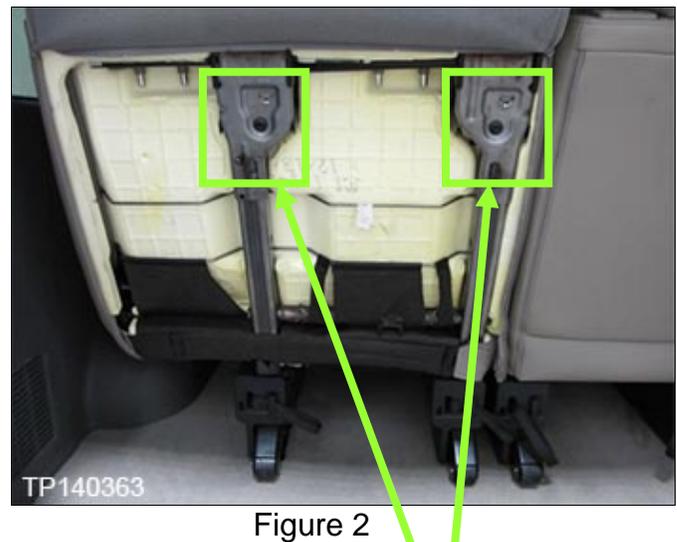
3. Fold the seat back cover forward over the seat to allow a visual inspection of the seat belt retractor retaining bolts (Figure 2).
4. Verify that the seatbelt retractor retaining bolts are in place (Figure 2).

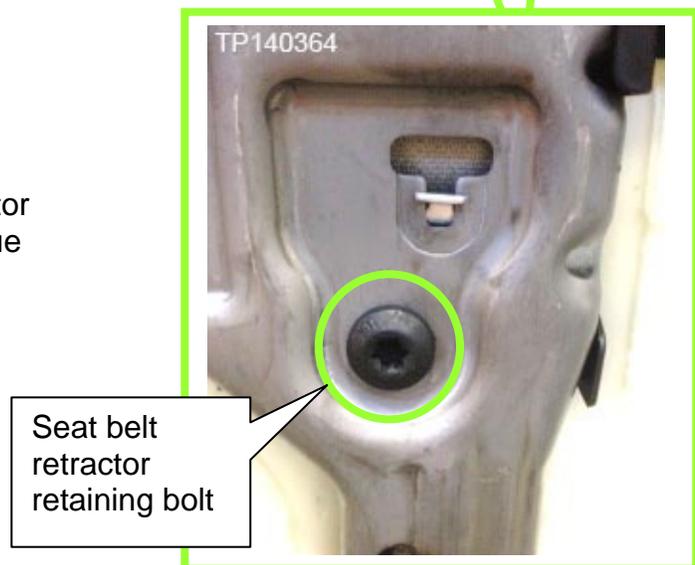
Figure 3

5. Verify the correct torque of each retractor retaining bolt (TORX® T50) with a torque wrench (Figure 3).

Retractor Retaining Bolt Torque:
55 N•m (5.6 kg-m, **40 ft-lb**)

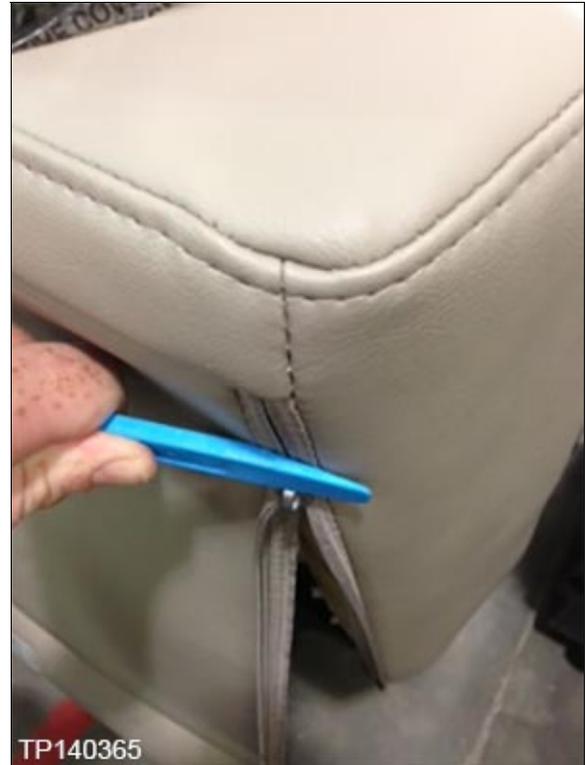
Figure 4

6. Return the rear seat back cover to its original position.
7. Re-hook the J-clips that attach the seatback to the bottom of the seat frame.
8. Zip the seat back covers using a suitable tool (Figure 4).

IMPORTANT: Ensure that the seat back cover is positioned such that the child seat upper tether anchor is clearly visible/exposed and accessible.

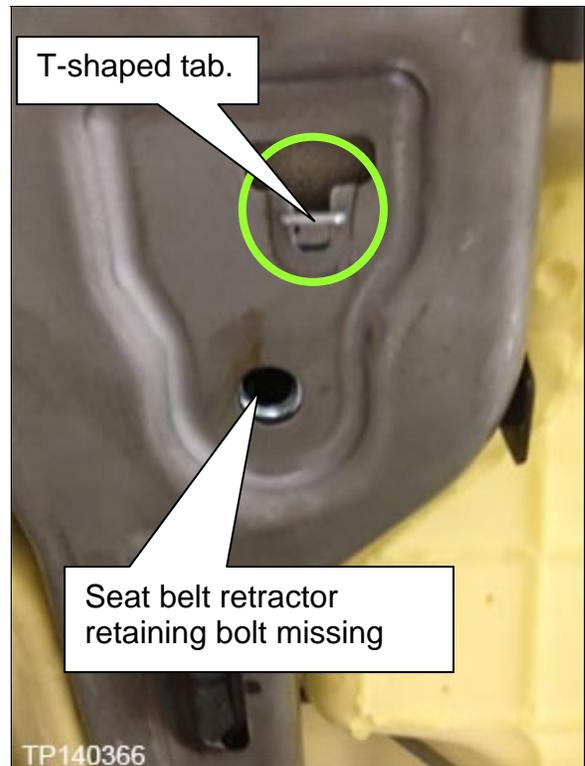
If any of the retractor bolts are missing, as shown in figure 5, replace the bolt(s) with one from the Parts Information table.

IMPORTANT: Confirm that the T-shaped tab is positioned as shown in Figure 5 before tightening the bolt(s).

Retractor Retaining Bolt Torque:
55 N•m (5.6 kg-m, **40 ft-lb**)

DESCRIPTION	PART #	QUANTITY
Seat Belt Retractor Bolt	88798-1PC1A	As needed
