Technical Service Bulletin

GROUP	NUMBER
CAMPAIGN	14-01-030
DATE	MODEL(S)
JULY 2014	ELANTRA (FD)

SUBJECT:	ADHESIVE STRIP ATTACHMENT ON HEADLINER BRACKETS (RECALL CAMPAIGN 117)
-----------------	--

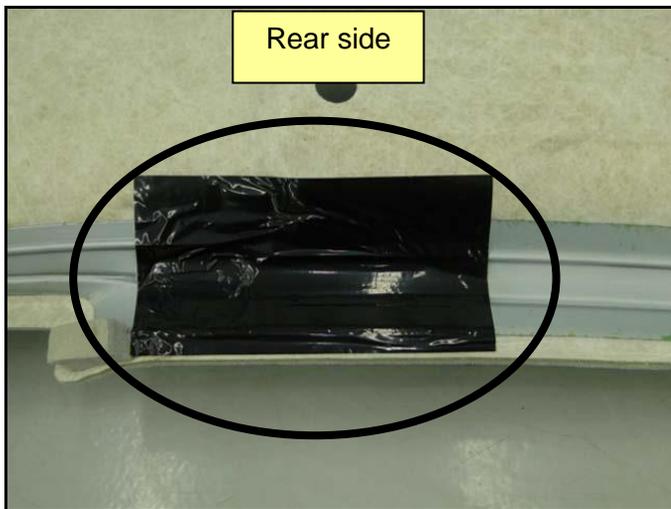
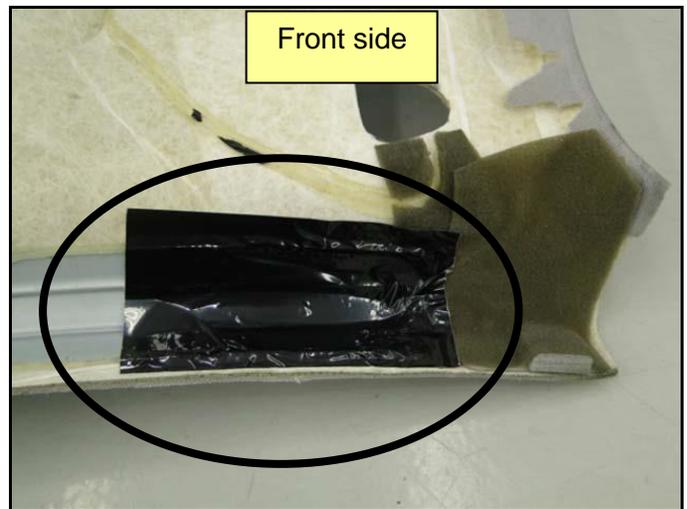
Description: The headliner in certain Elantra Touring vehicles contains a strengthening metal bracket attached to the headliner. During a side impact, the bracket may become dislodged and travel in the direction of an occupant. If the bracket makes contact with an occupant during a side airbag deployment, the occupant could be injured. This bulletin provides the service procedure to apply industrial adhesive strips to the inside portion of the headliner for both the Driver and Passenger side.

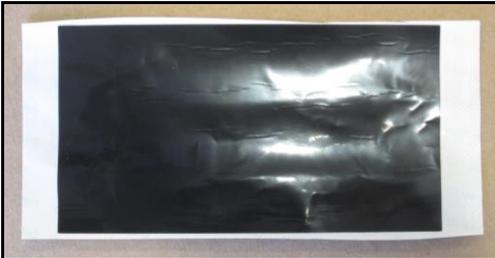
85350-3X006-QQH	- Length: 150mm - Width 80mm - Quantity: 4ea
Plug-Trim Mounting

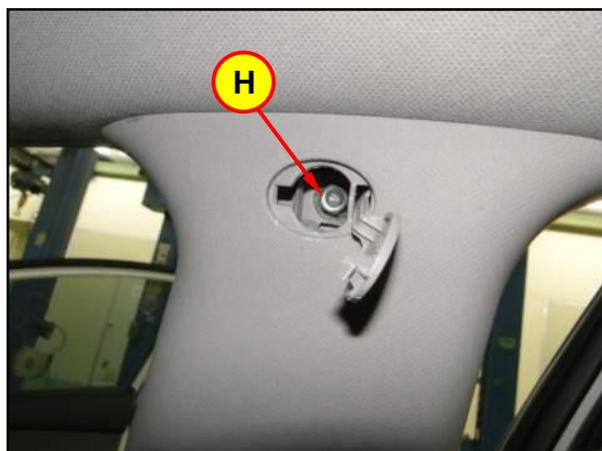
- Carefully separate the upper side of the center pillar upper trim from the body without removing it completely.

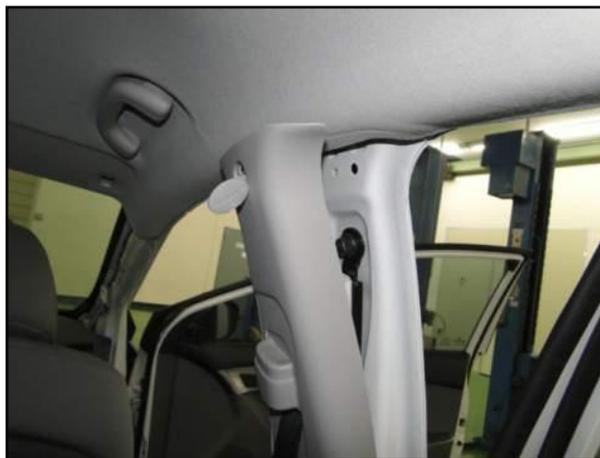
When reinstalling the center pillar trim, make sure that the seat belt height adjuster bolt (I) fits into the hole (J) of the center pillar trim.

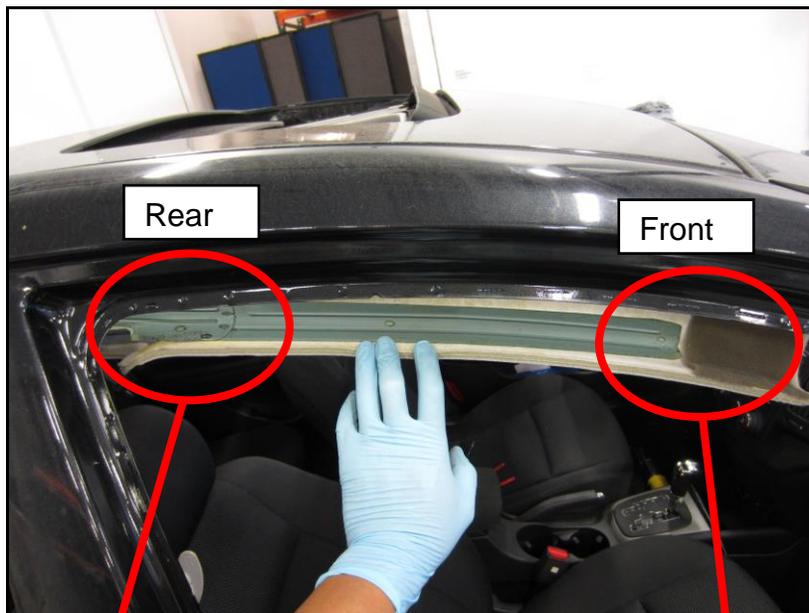
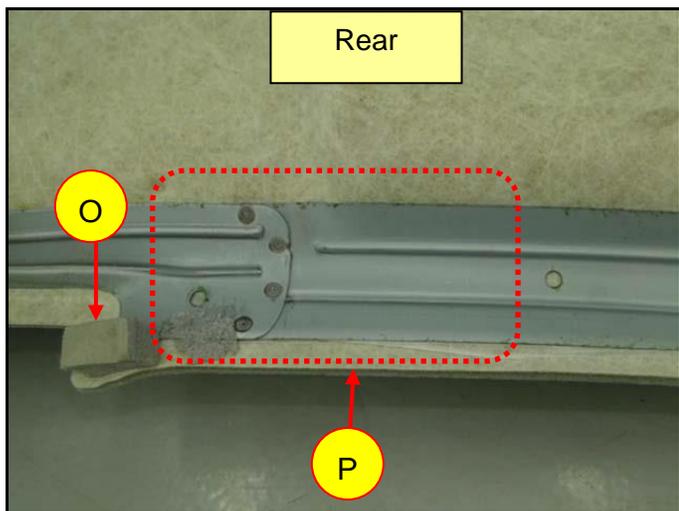
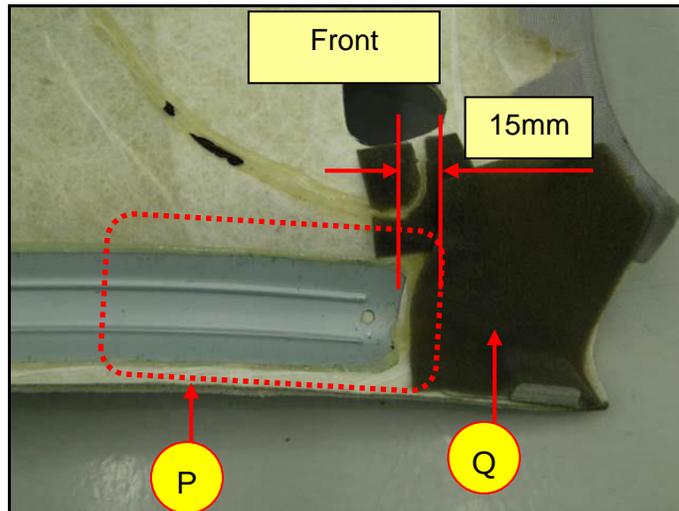
15. Adhesive Strips installed on Passenger (RH) Side.

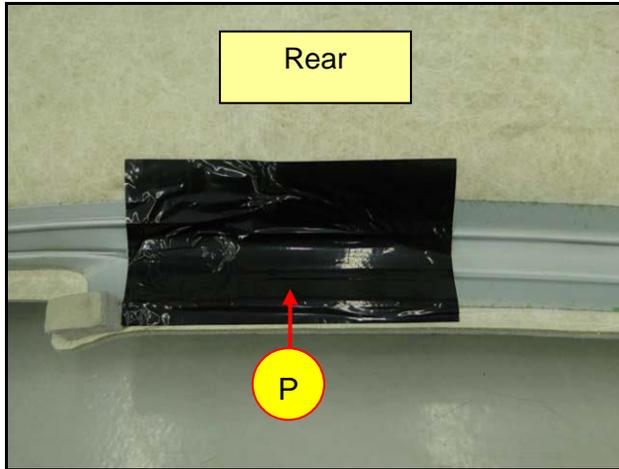
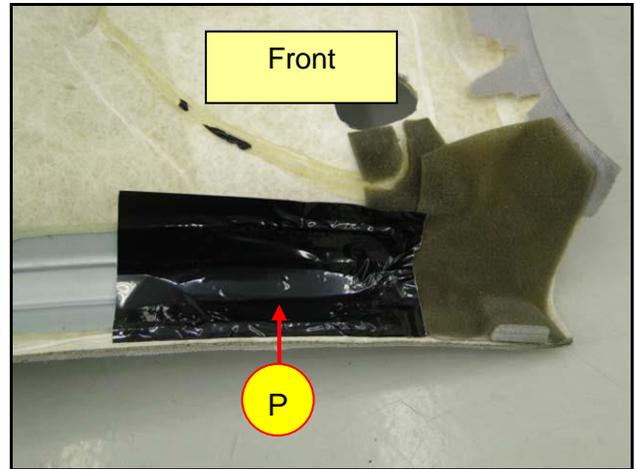
16. Repeat for Driver (LH) side.

17. Re-install all components in reverse order of removal.
