**RECALL
BULLETIN:
140609ARG**

2013 American Eagle,
American Revolution,
American Tradition
and
2014 American
Eagle and American
Revolution
manufactured
between
October 16, 2012 and
May 6, 2013

SUBJECT:
Inspection/
correction of seat
belt mounting
hardware

ISSUE DATE:
July 2014

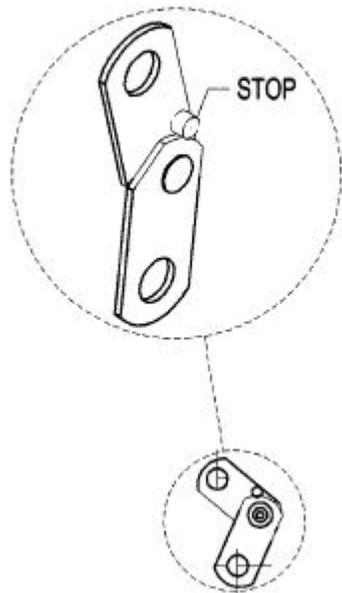
CORRECT INSTALLATION OF THE ABTS HINGE LINK

The ABTS hinge link is installed correctly when the upper link with the stop is toward the seat frame and the lower link is outboard from the seat frame.

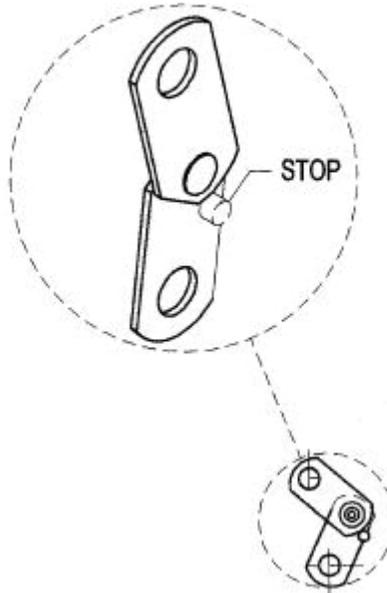
INCORRECT INSTALLATION OF THE ABTS HINGE LINK

The ABTS hinge link is installed incorrectly when the upper link is outboard from the seat frame and the lower link with the stop is inboard from the seat frame.

Figure 1
Left side of driver's seat shown.
Right side passenger seat the same.

1. Remove the hardware fastening the seat belt to the seat base assembly. Discard the original bolt, bushing, and washers.
 Note: The new bolt supplied with the repair kit is longer than the original bolt; this will enable full thread engagement into the J-bracket nut.
2. Ensure the seat belt is free of twists, then slide the belt sheath (included with the recall kit) onto the seat belt as shown in Figures 2 and 3.

3. Referring to the installation diagram in Figure 2 and the photos (Figures 3 & 4), reinstall the seat belt to the seat base using the new hardware included in the recall kit. Ensure the assembly order is correct. Torque the attachment bolt to 20 ft-lbs.
