## Technical Bulletin TB06112014 PTO Pressure Switch Recall

<b>Classification:</b>	<b>NHTSA Recall 14V-328</b>
Subject:	PTO Pressure Switch Recall
To:	IMT Distributors and Customers
From:	IMT Technical Support (800-554-4421 or 641-923-4633)
Date:	July 28, 2014
Affected models:	Dominator Propane Series

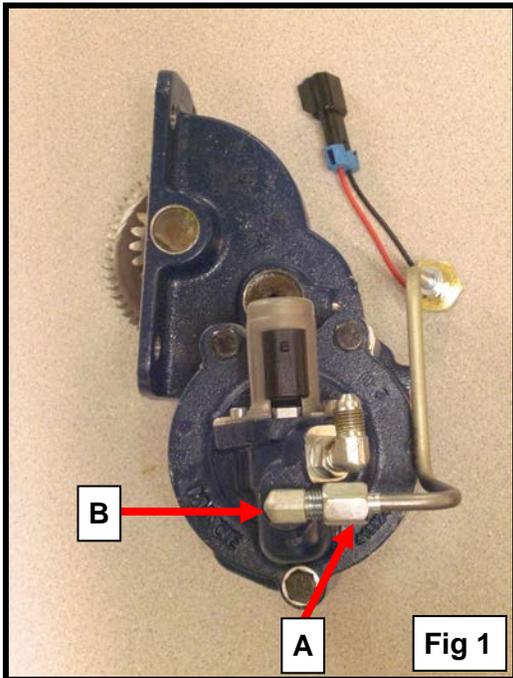
1. Remove pressure switch tube assembly using 9/16" open-end wrench. (A in Fig 1)
2. Remove elbow from PTO using 1/2" open-end wrench. (B in Fig 1) The pressure switch tube assembly and elbow can be discarded.
3. Apply pipe sealant compound to threads of pipe plug and insert in port. Tighten plug using 3/16" allen key. (Fig 2)
4. Discard pressure switch. Do not reuse.

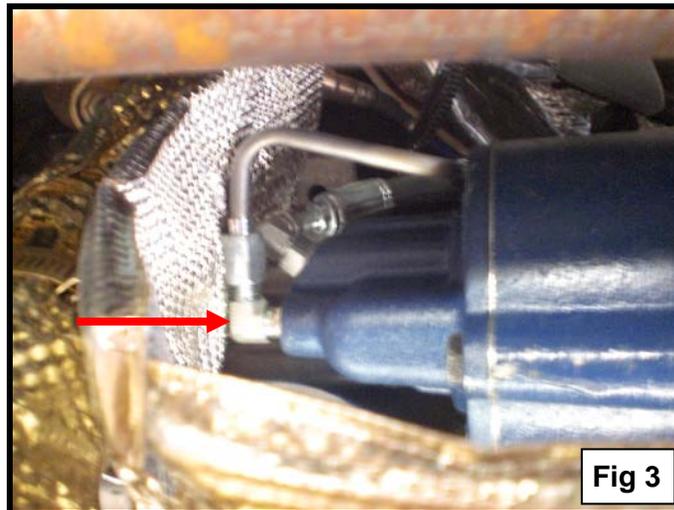
- When the following procedure is done efficiently, a minimal amount (approximately 1 ounce) of transmission fluid will be lost.
- For clarity, Fig 1 & Fig 2 images in the procedure were taken prior to the PTO being installed.
