# Service Bulletin

## SAFETY RECALL

### 2001-2012 GL1800 DRAGGING REAR BRAKE (INTERIM BULLETIN)

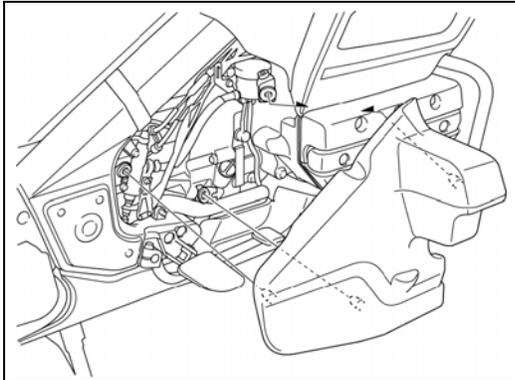
Remove the right engine side cover.

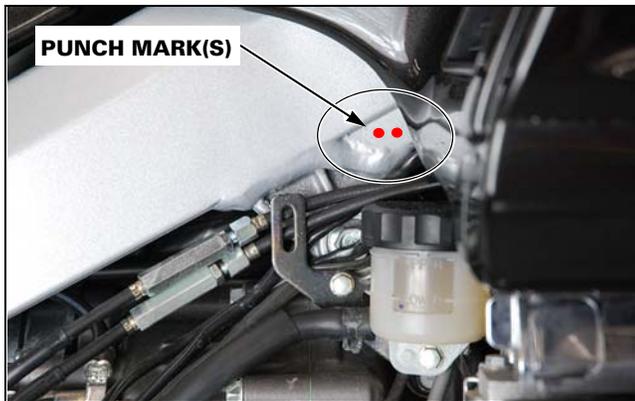
Look for a punch mark(s) on the right frame spar, just above the rear master cylinder reservoir as shown.

- **If there are two punch marks** and there is no customer concern about dragging brakes, no further action is necessary.
- **If there are two punch marks** and the customer has a concern about dragging brakes, contact TechLine.
- **If there is only one punch mark** and the customer has a concern about dragging brakes, proceed to INSPECTION PROCEDURE.
- **If there is no punch mark**, the vehicle has not been inspected/repaired according

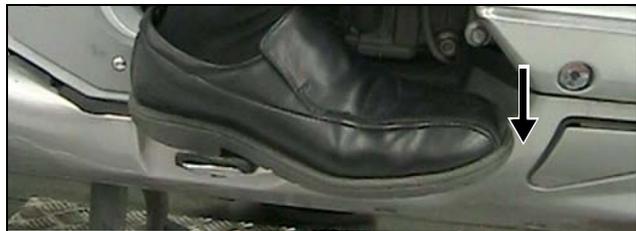
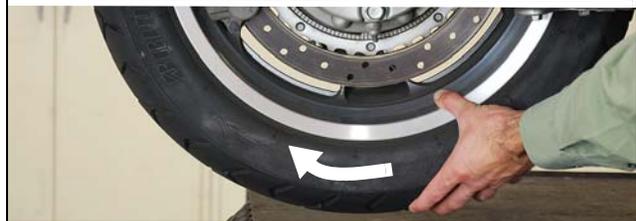
With the motorcycle in neutral on its center-stand, depress with normal foot pressure and slowly release the brake pedal five times, then with the pedal released, wait five seconds, then try to rotate the rear wheel as shown.

- **If the rear wheel drags or is locked**, contact TechLine for interim repair procedures.
- **If there are obvious visual indications of a dragging rear brake** (blue rotor, excessive brake component wear considering mileage), take photos of any

damaged parts, note your findings on the repair order, and contact TechLine for interim repair procedures.

- **If the rear wheel rotates freely**, confirm the brake performance by test riding the vehicle for 15 miles at varying speeds. Be sure to firmly apply both front and rear brakes several times during the test ride to get heat into the brake components and move fluid through the system. After the test ride, perform the INSPECTION PROCEDURE one more time from the beginning.
  - If after the test ride and second inspection procedure the rear wheel drags or is locked, contact TechLine for interim repair procedures.
  - If after the test ride and second inspection procedure the rear wheel rotates freely, apply the IDENTIFICATION punch mark to the frame and then return the vehicle to the customer. Advise the customer to continue performing pre-ride and post-ride inspections for dragging brakes until Honda contacts them about a final remedy.

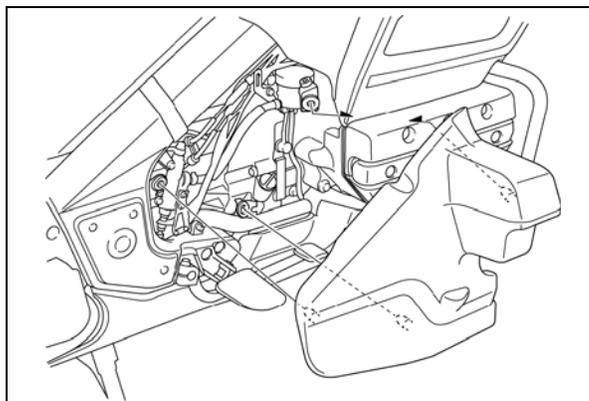
Remove the right engine side cover.

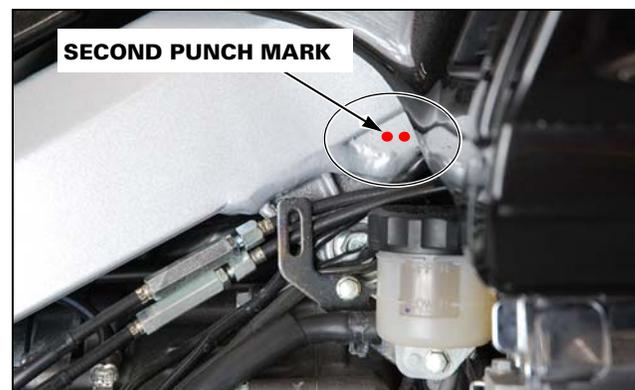
After you have completed the inspection procedure, apply a second punch mark on the right frame spar, just above the rear master cylinder reservoir as shown.
