Applies To: **2001–02 Accord** – Check the iN VIN status for eligibility
2001–03 Civic – Check the iN VIN status for eligibility
2003 Civic Hybrid – Check the iN VIN status for eligibility
2002–04 CR-V – Check the iN VIN status for eligibility
2002 Odyssey – Check the iN VIN status for eligibility

Safety Recall: Replacement Driver's Airbag Inflator Can Be Over-Pressurized

(Supersedes 10-039, dated December 21, 2011, to revise the information marked by the black bars)

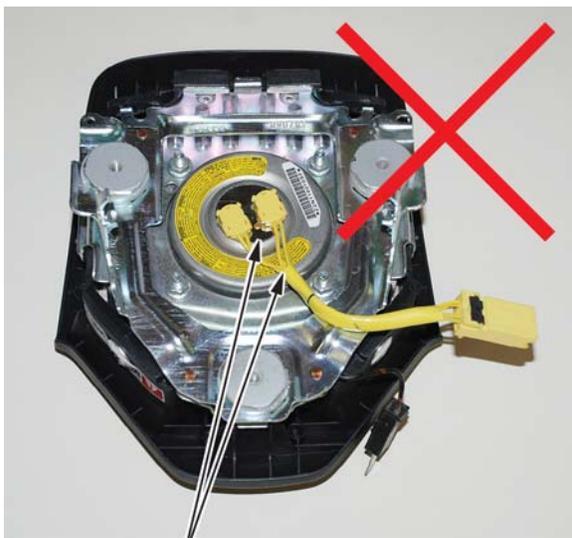
2. Visually inspect the airbag and the inflator for any unusual writing or markings.
 - If there is nothing unusual about the airbag or the inflator, go to step 3.
 - If there is unusual markings, like an incorrect label or a model year written in marker, the airbag and inflator may not be the correct airbag and/or inflator for the vehicle or it may be a counterfeit part. For more information about counterfeit airbags, you can refer to safercar.gov, enter keywords **MANAGING COUNTERFEIT**, and select *Recommended Dealer Guidance for Managing Counterfeit Air Bags* from the list. **If you suspect that the airbag or inflator is counterfeit, do not continue this procedure.** Contact your DPSM for assistance.

NON-STANDARD WIRES

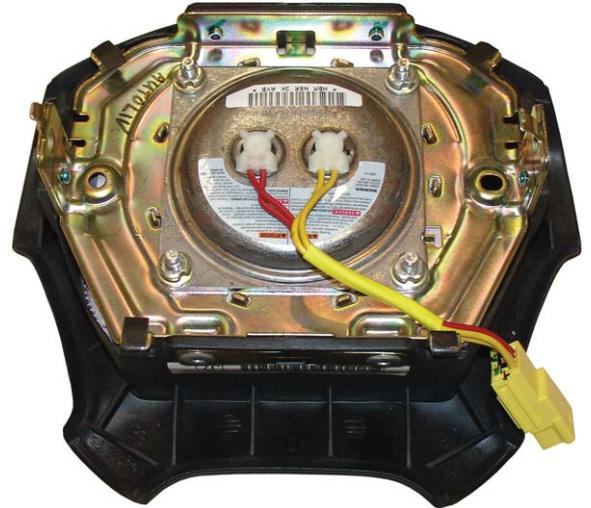
3. Determine if the airbag is made by Autoliv or Takata by comparing inflators to those in the images below.

NOTE: The Autoliv serial number label is different from the Takata label.

AUTOLIV (not affected)

- If the airbag is made by Autoliv, the airbag is OK. Go to REPAIR PROCEDURE A.
- If the airbag is made by Takata, go to step 3.

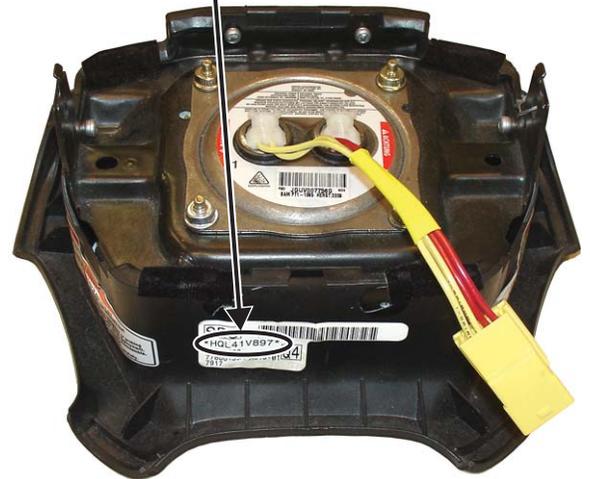
TAKATA

Locate serial number here.
